# 2ND INTERNATIONAL CONFERENCE ON IRON-SULFIDE REACTIONS IN CONCRETE

## Proceedings

The 2nd International Conference on Iron-Sulfide Reactions in Concrete — ICISR 2026 — was hosted by the University of Connecticut in Mystic, Connecticut, USA, from May 12 to 14, 2026. Building on the foundation established by the first ICISR, held at Université Laval in Quebec City, Canada, in 2024, ICISR 2026 continued this international exchange by bringing together researchers, practitioners, public agencies, industry partners, homeowners, and policy stakeholders.

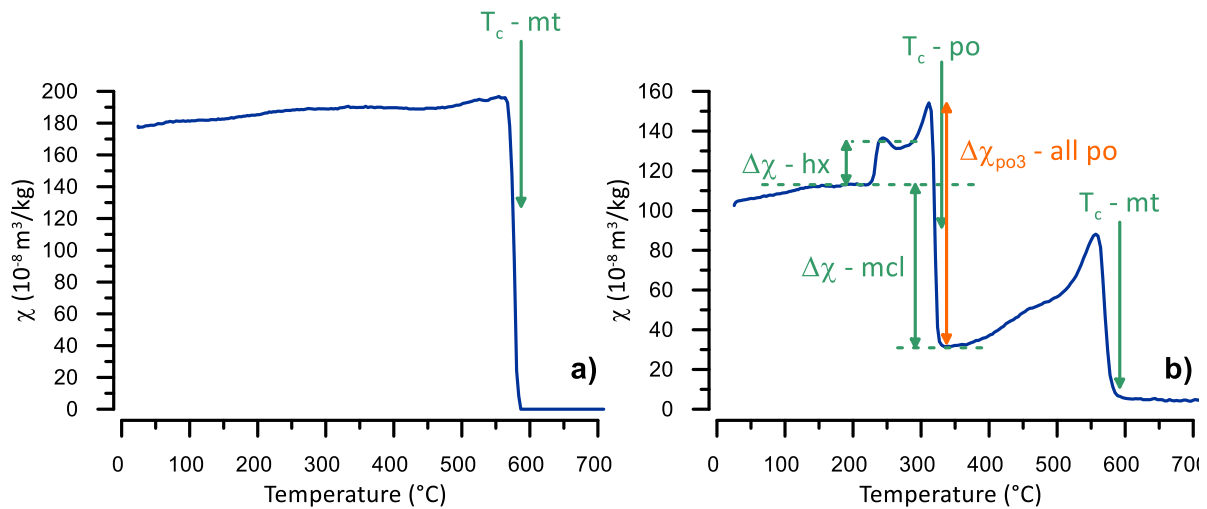
Figure. 1: Examples of thermomagnetic curves. a) sample containing magnetite b) sample containing both pyrrhotite and magnetite. For further information see text.

Figure 1 shows examples of thermomagnetic curves. Fig. 1a represents a pyrrhotite-free sample. Magnetic susceptibility ( $\chi$ ) remains relatively constant between room temperature and 580°C, the Curie-temperature of magnetite (mt) [9]. Fig. 1b represents a sample containing both pyrrhotite (po) and magnetite (mt).  $\chi$  remains relatively constant between room-temperature and 220°C where hexagonal pyrrhotite undergoes a phase transition and becomes partially magnetic [7]. The transition is marked by a sharp increase in  $\chi$ .  $\chi$  increases further until it reaches a maximum just below 325°C, the Curie-temperature ( $T_C$ ) of pyrrhotite [5], where  $\chi$  drops sharply. The remaining changes in  $\chi$  are due to the

conversion of iron-bearing minerals to magnetite and the demagnetization of magnetite at 580°C, the Curie-temperature of magnetite.

Figure 1b also suggests a method to discriminate between hexagonal and monoclinic pyrrhotite phases. Hexagonal phases are initially non-magnetic and do not contribute to the susceptibility signal of the sample. Upon heating they do convert, however, into ferrimagnetic phases, and the increase in  $\chi$  near 220°C reflects the conversion of hexagonal into monoclinic pyrrhotite ( $\Delta\chi - hx$ ). The further increase in  $\chi$  is either due to further conversion into ferrimagnetic pyrrhotite phases or the thermal unblocking of ferrimagnetic pyrrhotite as it approaches the final Curie-temperature at  $T_c = 325^\circ\text{C}$  [5,9]. The loss in magnetic susceptibility between the pre-conversion value at  $\sim 220^\circ\text{C}$  and its final Curie-temperature at  $T_c = 325^\circ\text{C}$  is a conservative estimate for the presence of preexisting monoclinic pyrrhotite ( $\Delta\chi - mcl$ ). A more detailed analysis of thermomagnetic curves can therefore yield estimates of both hexagonal and monoclinic pyrrhotite phases.

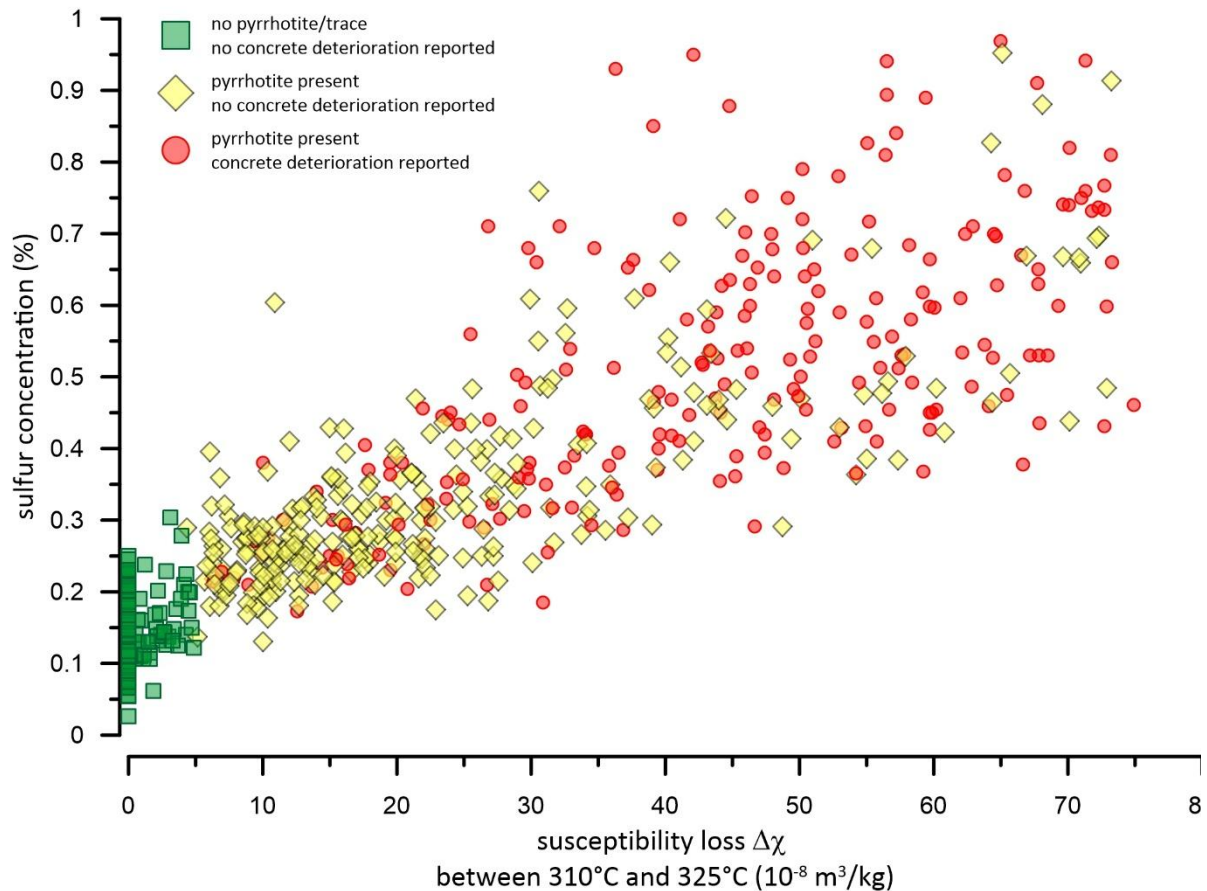
Figure 2 shows the results of our analyses for over 1000 crushed core samples from Connecticut and Massachusetts following the method outlined in Geiss and Gourley [1]. Sulphur concentration has been measured using an Elementar vario Max cube elemental analyser. The amount of pyrrhotite has been estimated from the drop in magnetic susceptibility between 310°C and 325°C, which is indicated in orange in Figure 1b. The status of the investigated structure is also shown: Red circles indicate homes that display map cracking due to the presence of pyrrhotite. Yellow diamonds indicate houses that contain pyrrhotite in their structures but do not show any indication of map cracking. Green squares show homes with only trace levels of pyrrhotite that display no pyrrhotite deterioration. These observations were recorded during sample collection.

Figure 2: Total sulphur concentration (in % S) as a function of pyrrhotite abundance as determined by thermomagnetic analyses for over 1000 homes in Connecticut and Massachusetts. The status of the investigated structure is also indicated.

Both Figures 2 and 3 show a strong control of pyrrhotite abundance on concrete deterioration (independent of pyrrhotite phase) we multiplied hx/mcl ratios by the total loss of susceptibility between 310°C and 325°C ( $\chi_{po3}$ ) and repeated our analysis. The results are shown in Figure 4b. Here, the likelihood of concrete deterioration increases rapidly for low values of hx/mcl\*po3, dips slightly and reaches a plateau for the highest values of hx/mcl\*po3.

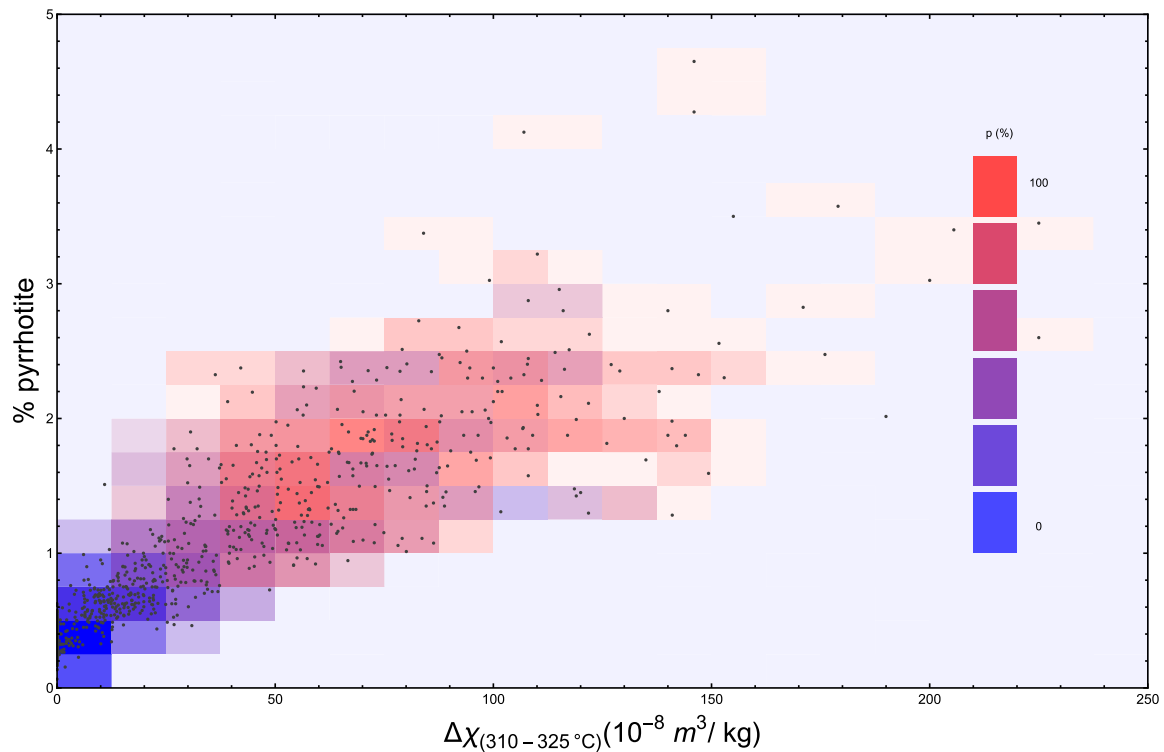
Figure 3 takes the same dataset and calculates the percentage of houses that show signs of concrete deterioration due to pyrrhotite (map cracking). Pyrrhotite concentrations have been estimated from the sulphur content after subtracting the average S-concentration for pyrrhotite-free samples (~0.15%). As seen in Figure 3, the amount of pyrrhotite strongly controls the likelihood of concrete deterioration but there is no clear cutoff that would indicate a “safe level” of pyrrhotite abundance in concrete.

Figure 3: Likelihood of concrete deterioration. Total % pyrrhotite estimated from sulphur concentrations, change in susceptibility as shown in Figure 1b. Hue indicates likelihood of failure (red = 100%, blue = 0%), lightness of hue indicates number of structures that were used to calculate failure rate.

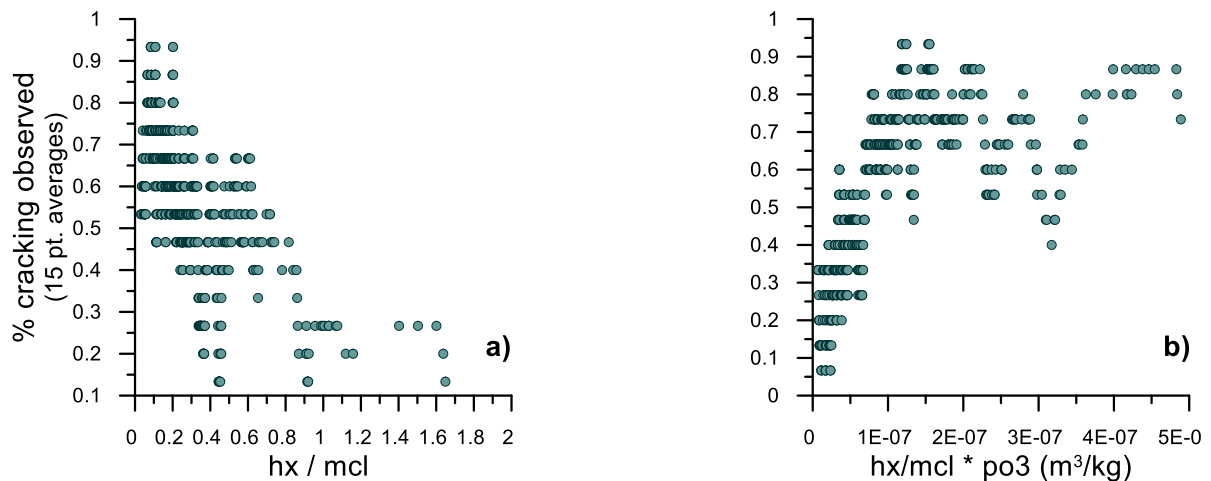
We estimated the abundance of hexagonal (hx) and monoclinic (mcl) pyrrhotite from thermomagnetic curves as outlined in the introduction (see Figure 1b). Hx/mcl ratios were calculated for 630 structures (the analysis omitted structures that were free of pyrrhotite, hence the lower number of structures analyzed). The status of the analysed structures was classified either as “shows deterioration” = 1 (same as red spheres in Figure 2) or “shows no deterioration” = 0 (all remaining pyrrhotite containing samples in Figure 2). Data were then sorted in order of increasing hx/mcl ratios and a 15 pt. running average of structure status estimated the likelihood of concrete deterioration. Figure 4a shows that samples that contain higher proportions of monoclinic pyrrhotite correlated with an increased concrete deterioration, suggesting that monoclinic pyrrhotite is less stable than hexagonal pyrrhotite.

Figure 4: Likelihood of concrete deterioration as a function of a) hx/mcl and b) hx/mcl\*po3. For more information see text.

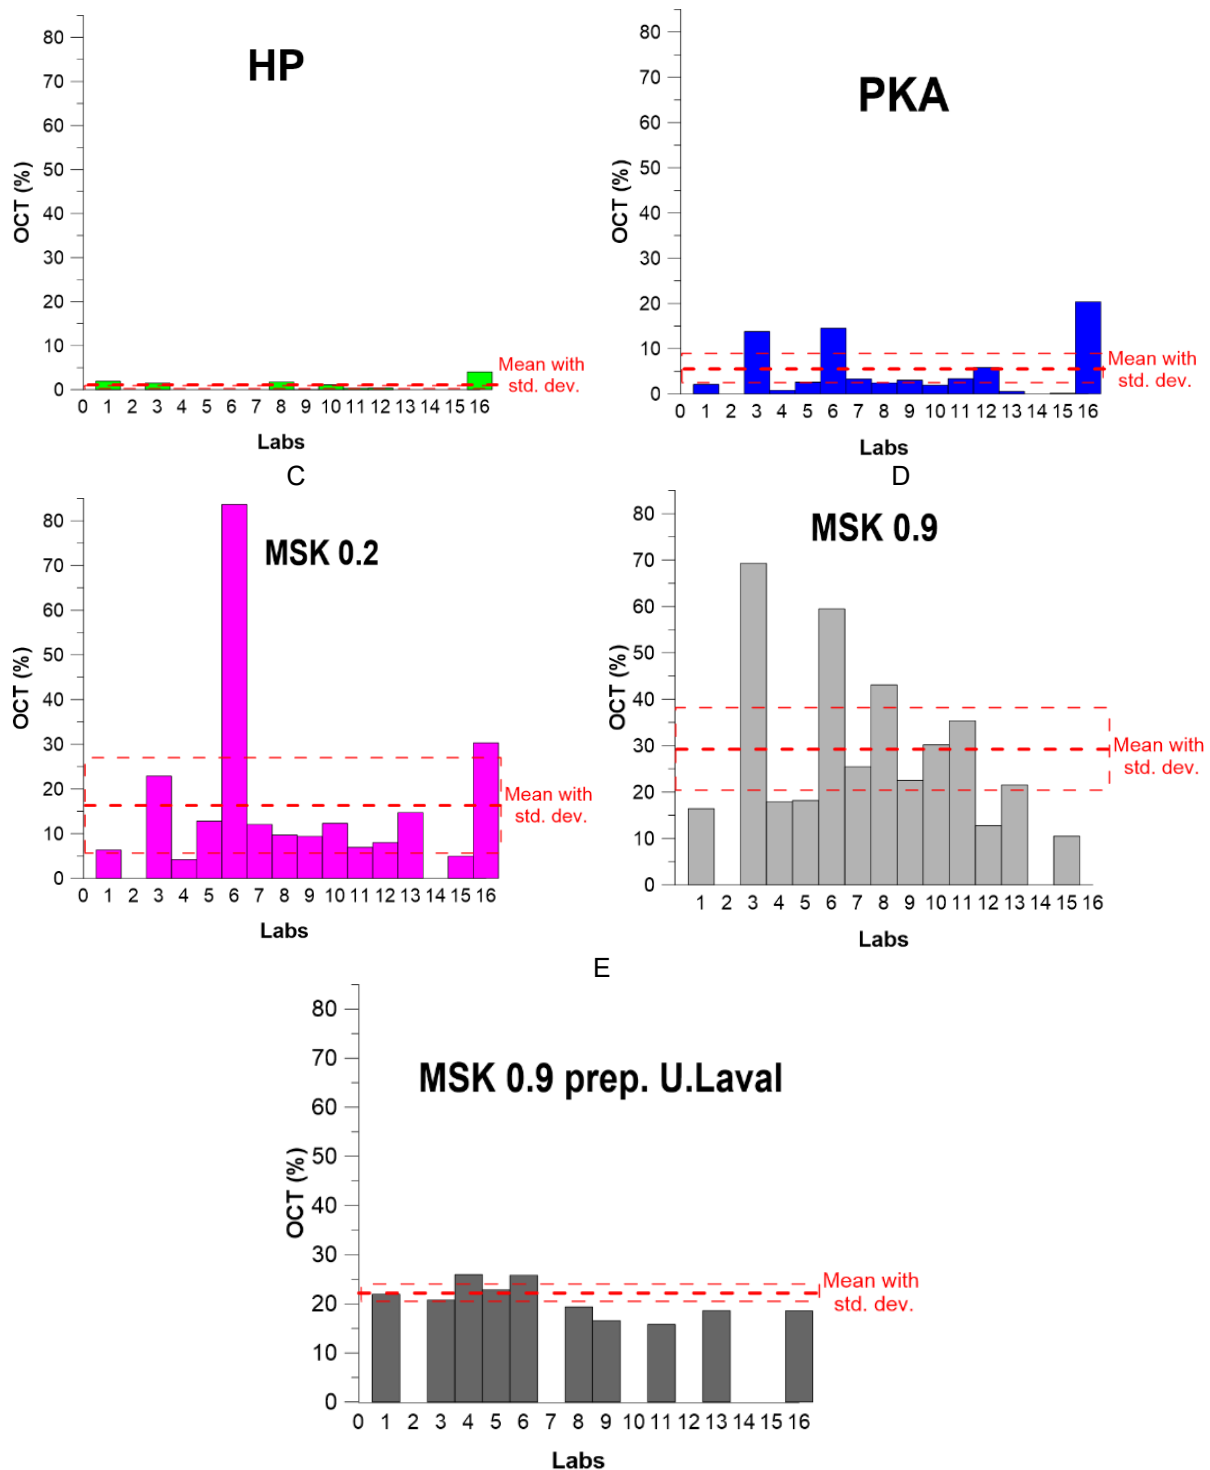
Figure 3.1: Bar charts illustrating the results (means and standard deviations) of OCT interlaboratory study (second trial). A: OCT results for non-reactive HP, B: OCT results for non-reactive PKA, C: OCT results for marginally-reactive MSK 0.2%, D: OCT results for highly-reactive MSK 0.9%, E: OCT results for MSK 0.9% prepared by U. Laval.

The coefficient of variation (CV) ranged from 61.3 to 120.2% for the different specimens prepared and tested by the participating labs (Table 3.1). The highest value of 120.2% was obtained for the marginally reactive MSK 0.2, which was highly influenced by the (very high) result reported by Lab 6 (Figure 3.1C). High CV values were also obtained for non-reactive PKA and HP, which was somewhat expected considering the low OCT values obtained. Interestingly, highly reactive MSK 0.9 CV values are the lowest of the samples prepared and tested by the participants.

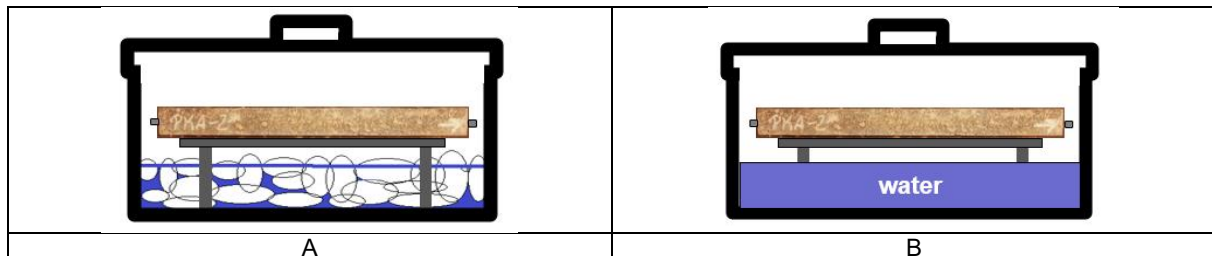
Figure 2.1: Po AMBT phases I and II testing regime schematics. A: Phase I testing regime - mortar bars are supported by ABS pipe sections and plastic grid over supersaturated NaCl solution to maintain 75% R.H. at  $80^\circ\text{C}$ . B: Phase II testing regime – mortar bars are supported by the same setup over tap water to maintain 100% R.H. at  $4^\circ\text{C}$ .

The initial mass and length of each bar are first recorded after 72 ± 2 h. The bars are then totally immersed in 6 vol. % bleach solution in a LocknLock container (provided) for 3 h (± 15 min). The bars are then removed from the solution, towel wiped and rapidly measured for their “zero” mass and length. The bars are then left to dry at room temperature (23 ± 2 °C) under in-service fume hood for 3 h (± 15 min). After the zero reading, the bars are placed in the Phase I testing regime setup (Figure 2.1A). Twice a week, over the 13-weeks of Phase I (e.g., “Day 1” and “Day 4” each week), the containers are removed from the storage condition. The bars are then removed from the container, left to cool for 30 minutes in air at 23 ± 2 °C and then immersed in the bleach solution for 3 h at 23 ± 2 °C. Mass and length changes are recorded once a week and the bleach solution is replaced every two weeks. Between the 3 h immersion periods, the bars are maintained under their Phase I testing conditions. After completion of Phase I, the bars are transferred in the Phase II testing regime setup (Figure 2.1B) for a final 13-week

period (Phase II) (Figure 2.1B). The bars are subjected to the same 2 x 3 h of bleach soaking/drying (at  $23 \pm 2^\circ\text{C}$ ) and same mass/length measurements frequency. At the end of the 26 weeks testing period, final expansion and mass changes (in %) are determined. More details on the test procedure can be found in [7-9,13] or in the interlaboratory study instruction packages [11,12].

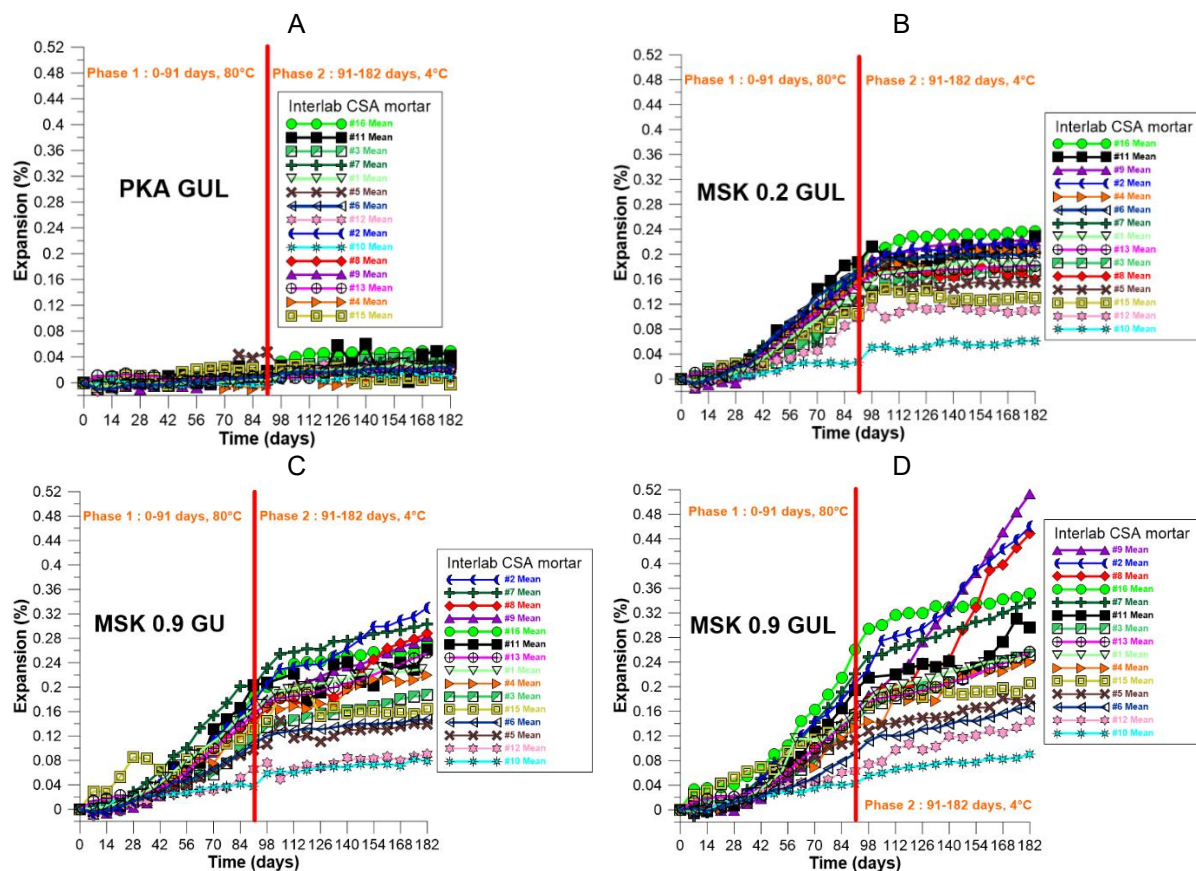
Figure 3.1: Expansion graphs of the results of the Po AMBT interlaboratory study. A: PKA with GUL cement, B: MSK 0.2% with GUL cement, C: MSK 0.9% with GU cement, D: MSK 0.9% with GUL cement.

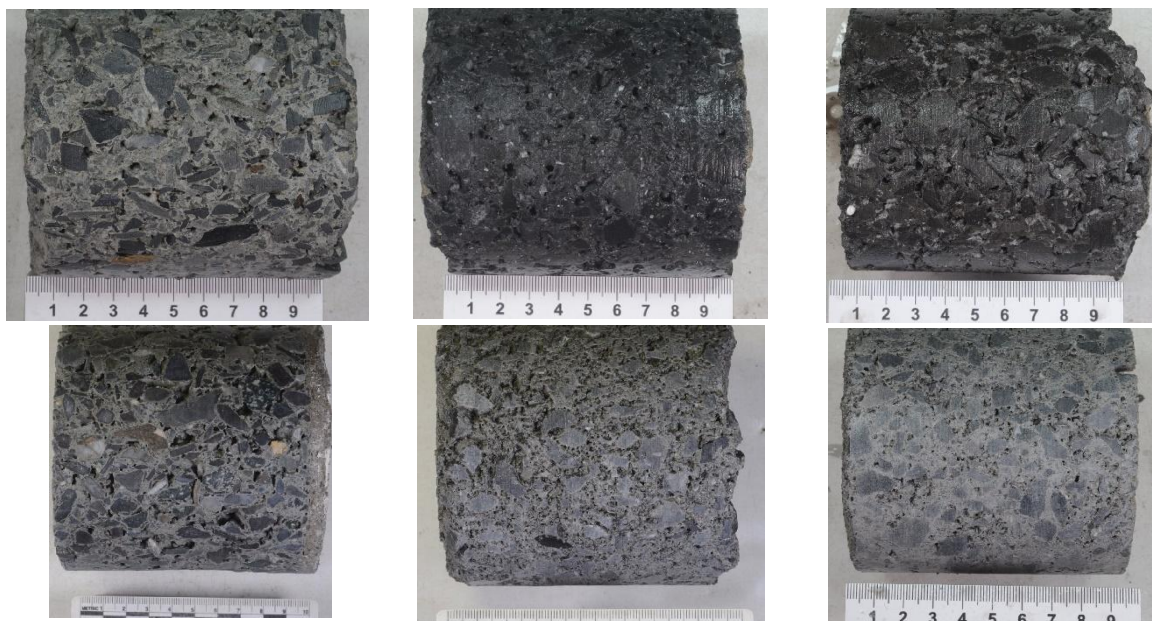
Figure 1.1: Macroscopic photos of several different types of concrete from Ireland. From left to right top row: Donegal phyllite (PHY), Clare BCS, Mayo BLS, bottom row: Donegal HFS, Clare pyritiferous claystone (LPC), Clare bioclastic limestone (GLS). Note similarity in appearance between LPC & GLS.

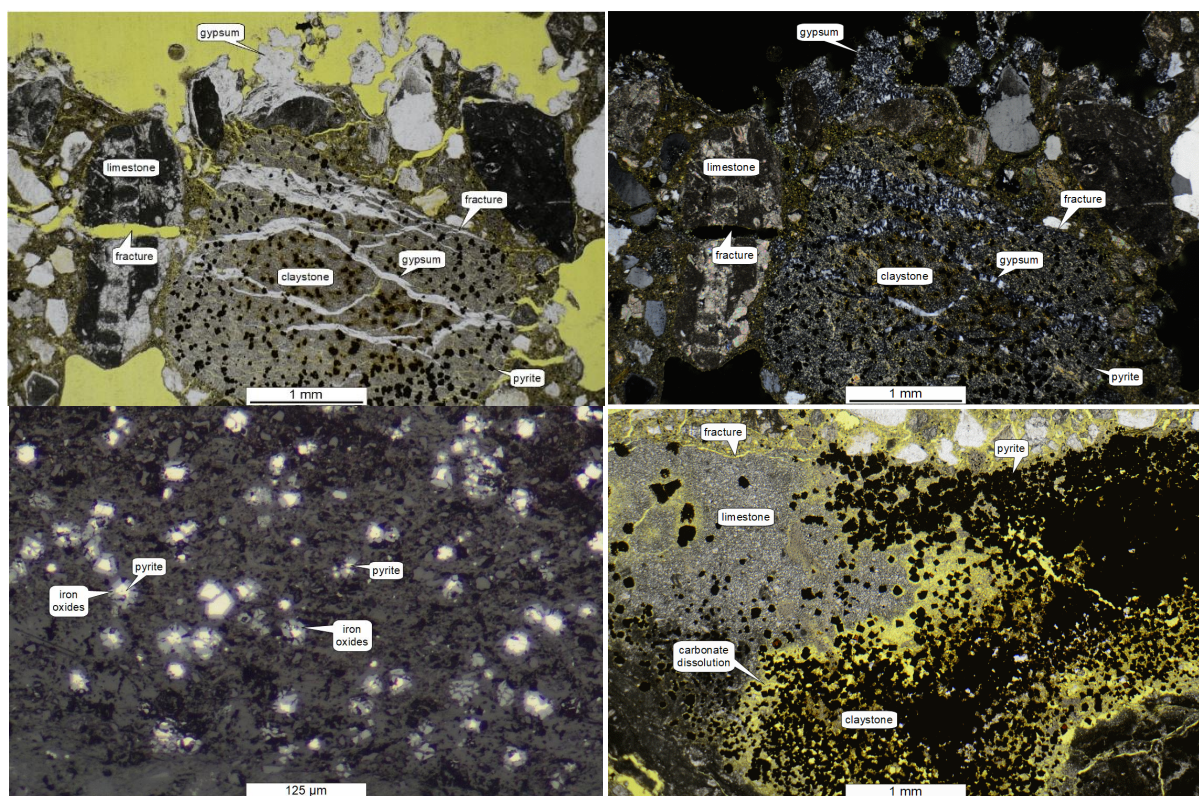
Figure 2.1: Evidence of microscopic deterioration observed associated with the pyritiferous claystone aggregate. Upper row: Expansive ISA with gypsum filled fractures radiating from claystone aggregate (plane & cross polars). Bottom row: Left – reflected light image showing abundant fine pyrite undergoing oxidation. Right – dissolution of calcite within limestone around the edge of a pyritiferous claystone lens.

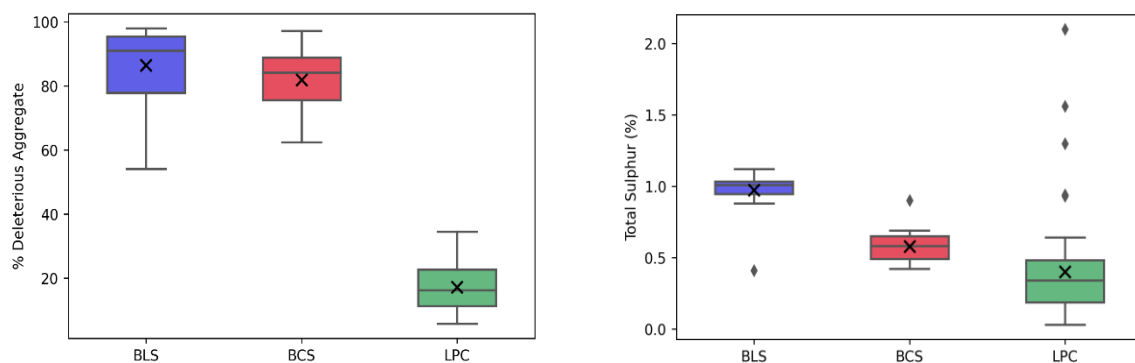
Figure 2.2: Comparative charts showing the difference in deleterious aggregate proportions (left) and total sulphur content – EN 1744, Clause 11.2 HTC (right) between the two main deleterious “mudrock” aggregates and the claystone. Due to the small sample size for LPC ( $n=23$ ), similar numbers of tested samples were selected for BLS and BCS ( $n=21$ ). TS values have a 0.1% “correction” subtracted as an assumption of the cement contribution as per I.S. 465.

Secondly, the reactive aggregate is generally present in low proportions, with the dominant visible aggregate being a “clean” grey limestone, and consequently with a somewhat lower TS value than typical calcareous “mudrocks”. While the hardcore aggregate standards suggest there should be a cutoff of 10% calcareous “mudrock” for the aggregate to be considered unsuitable for use in fill [6], and the RICS Mundic Guidance allows up to 30% deleterious aggregate in block before a house is considered unmortgageable within the South West of England (Cornwall and West Devon) [7], in several blocks showing evidence of expansion, the abundance of claystone lies between 5 and 8% of the aggregate. When combined with other potentially deleterious components such as pyritiferous limestone and argillaceous limestone, the abundance reaches 10-25%, but never the typical 50-90% seen with calcareous mudrock block (Figure 2.2). The concentration of the claystone into  $<1\ \text{mm}$  fines also means it is extremely difficult to spot macroscopically, being generally suspected rather than confirmed prior to thin section manufacture. Only one core was encountered where the claystone was confidently confirmed macroscopically, and that was an outlier with 19.5% claystone aggregate.

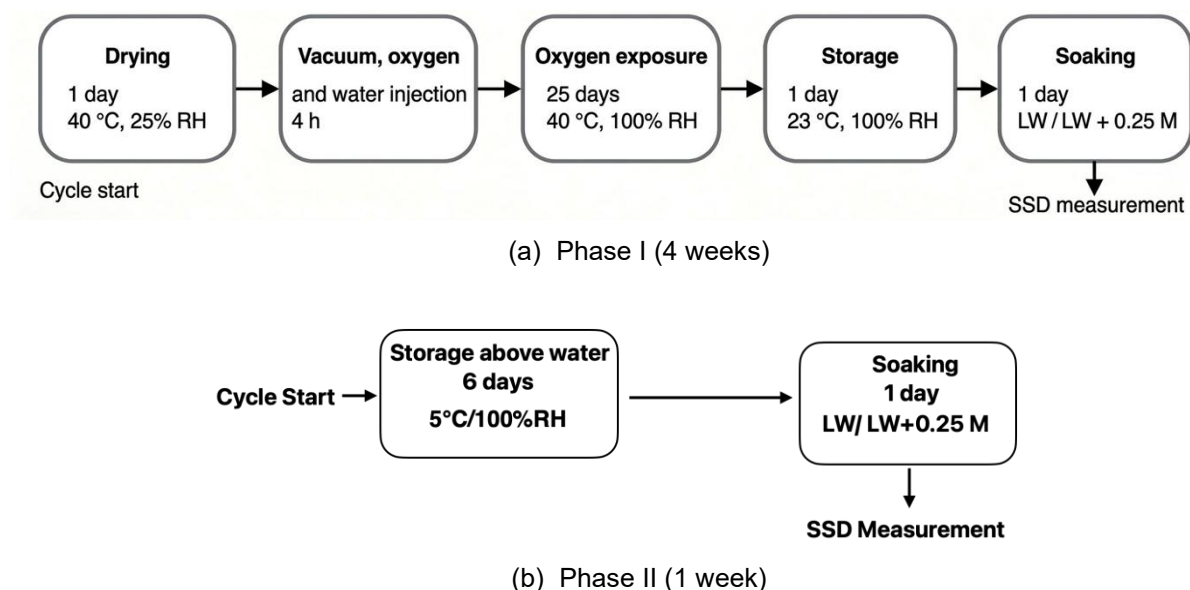
Figure 2-1: Oxygen-rich test cycles: (a) 28 days per cycle for oxidation phase; (b) sulphate attack phase (7 days per cycle).

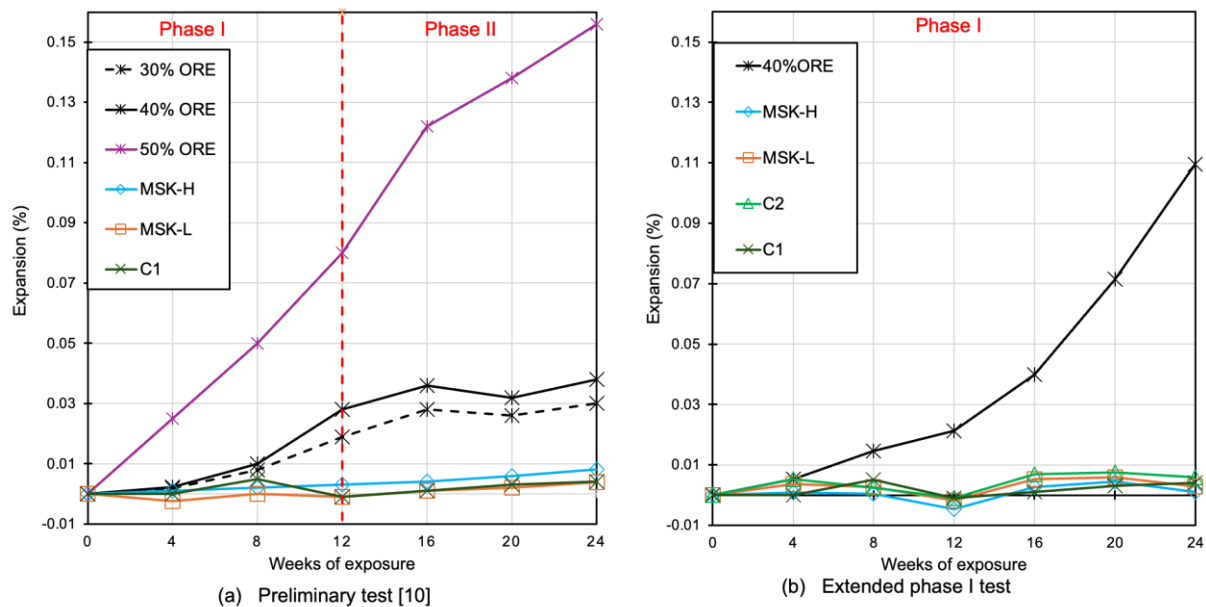
Figure 3-1: Expansion behaviour of SBA under oxygen-rich chamber exposure soaked in saturated limewater: (a) GU cement in phase I & II, each lasting 12 weeks; (b) White GU cement with 1.0%  $\text{Na}_2\text{O}_{\text{eq}}$  in phase I only lasting 24 weeks.

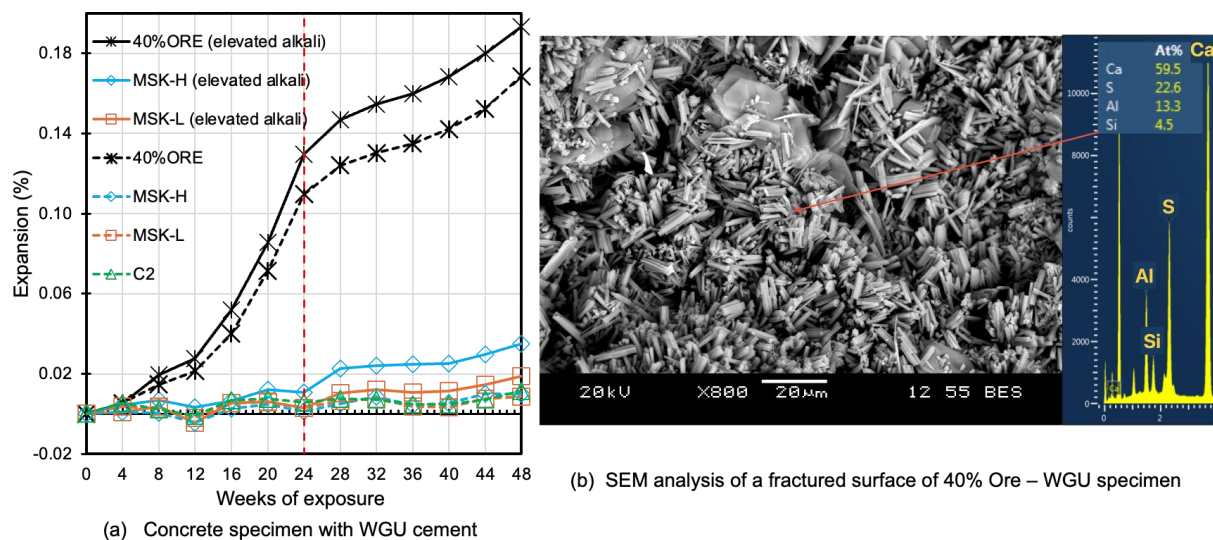
Figure 3-2: Expansion behaviour of concrete specimens containing SBA prepared with WGU (1.0%  $\text{Na}_2\text{O}_{\text{eq}}$ ). **Dashed lines:** saturated limewater soaking conditions. **Solid lines:** saturated limewater with 0.25M NaOH soaking solution. The red dashed line indicates the phase I/II transition at 24 weeks: (b) SEM image of a fractured concrete surface showing ettringite-like needles in the paste adjacent to Ore aggregates, with corresponding EDS spectrum.

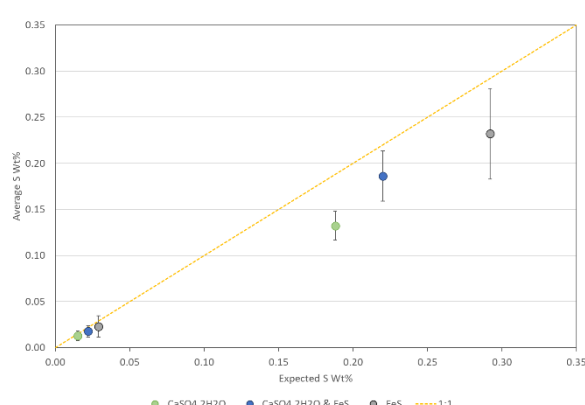
Figure 2.1.2.1: HTC Results of Standards

Results presented in Figures 2.1.2.1 and 2.1.2.2 and Table 2.1.2.1 show that the microwave digestion test method had comparable and even better results with the HTC method. HTC method showed more consistent results with a sample size of 0.5 g, therefore that was used for the next phase of testing.

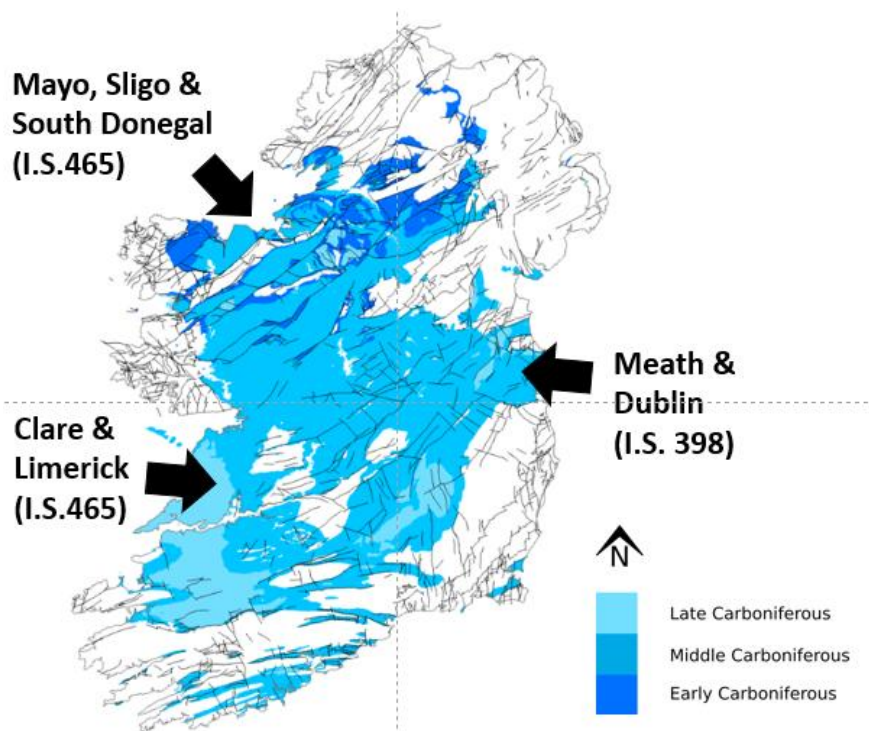
Figure 3.1: The three main areas of the Carboniferous from which poor quality calcareous mudrock aggregates have been quarried and used in construction products. The area highlighted in blue is the full extent of the Carboniferous across the island of Ireland.

For the other impacted counties of the Republic of Ireland the deleterious aggregate is largely derived from the deeply deposited Carboniferous units [3], and from three main areas (Figure 3.1), namely the Shannon Basin around Clare and Limerick, the Dublin basin around Dublin and surrounding counties and the deeper early deposits of the Carboniferous around Mayo, Sligo and South Donegal.

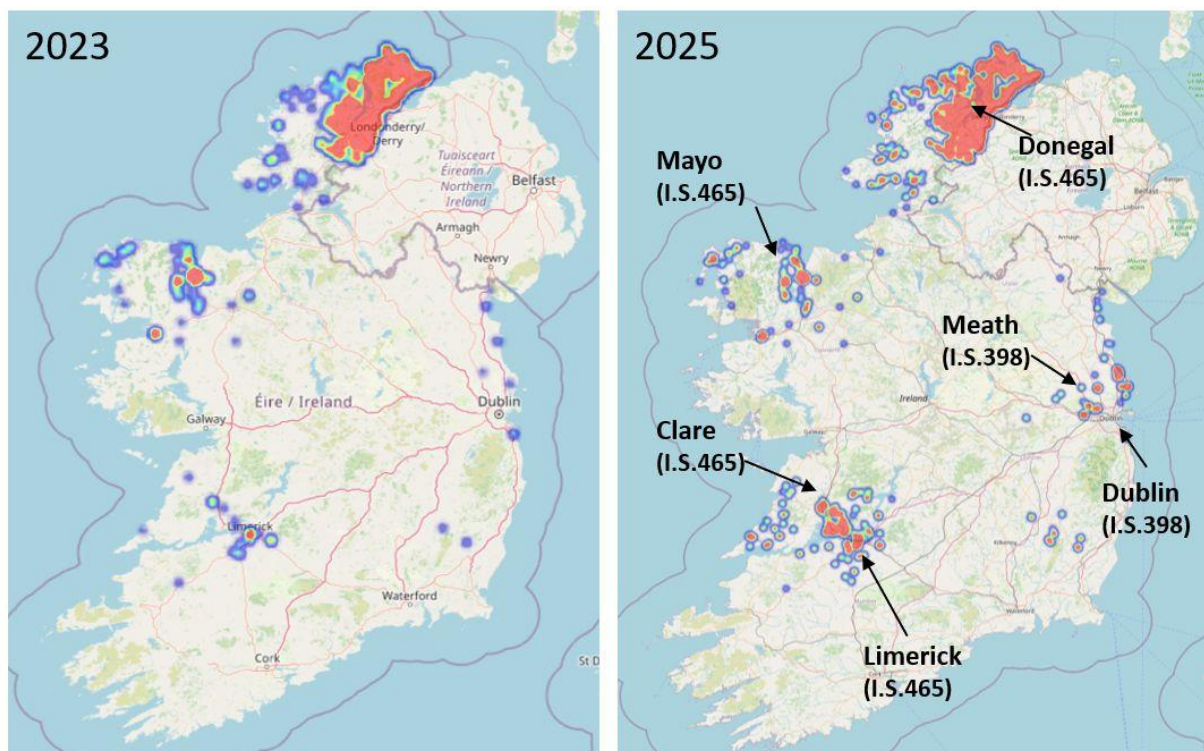
Figure 3.2: A comparison across 2 years of collecting data (2023 (see [2]) vs 2025), showing the growth of properties affected by deleterious blockwork (I.S. 465) around Clare and Limerick, as well as some other areas of Ireland. Data from recent areas of hardcore issues (I.S. 398) are also included.

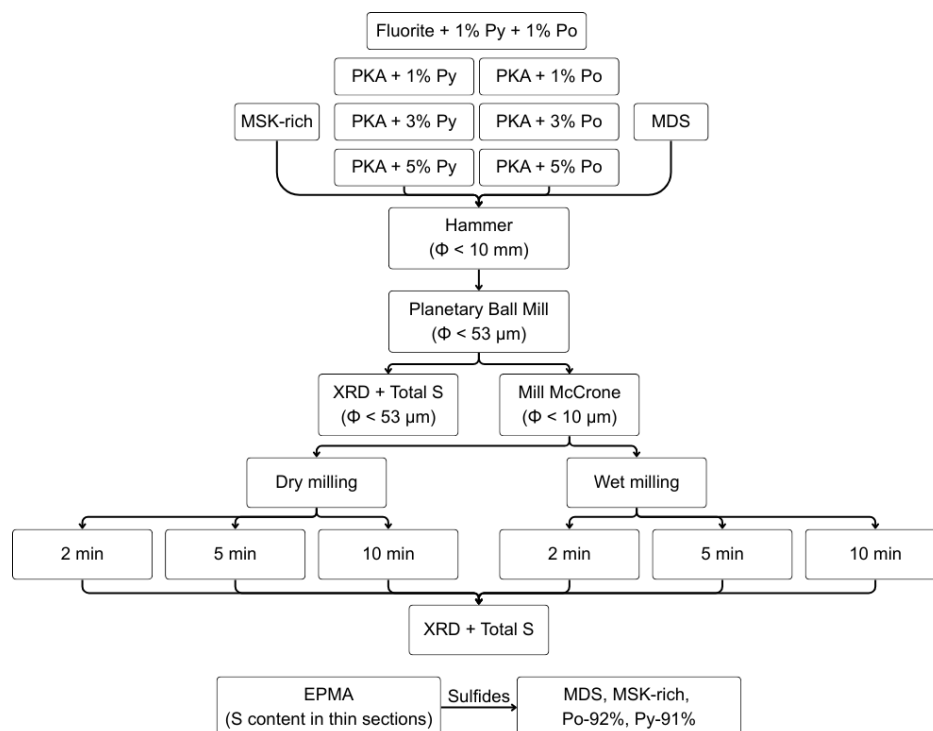
Figure 2.1. Flowchart of sample preparation and analysis of MSK-rich, MDS, PKA, and Fluorite. PKA and Fluorite were mixed with different contents of Pyh and Py. Percentages are in weight %.

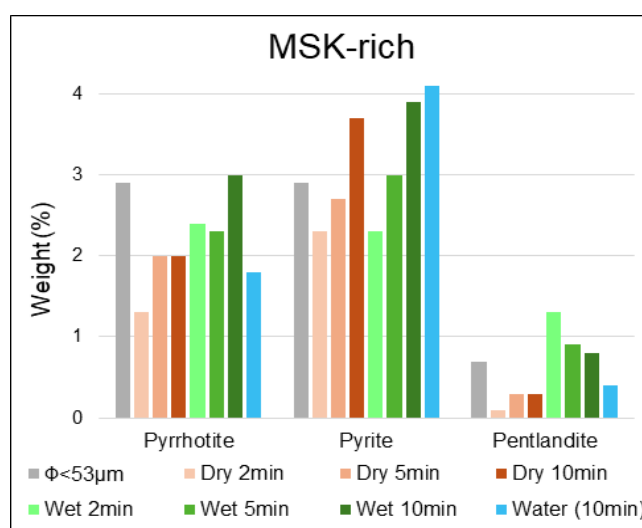
Figure 3.1. Variation in sulfide content in MSK-rich aggregate according to the sample preparation method. Results determined by Rietveld refinement (XRD).

In the MSK-rich aggregate, a clear distinction was observed between preparation methods (Figure 3.1). Wet milling (ethanol) yielded higher concentrations of Pyh (2.3 - 3.0 wt%) and Pn (0.8 - 1.3 wt%) compared to dry milling (Pyh: 1.3 - 2.0 wt%; Pn: 0.1 - 0.3 wt%). In contrast, the Py content was more affected by the milling time, exhibiting similar behavior for both dry and wet milling. After milling with water, the Pyh and Pn concentrations decreased, while the Py content exhibited a relative increase.

These results suggest two primary controlling factors. Firstly, the choice of milling solvent is critical [8]. The suppression of Pyh and Pn during dry milling and, more drastically, when using water, strongly suggests the occurrence of oxidation during sample preparation (Figure 3.1). The metastable nature of Pyh [5] makes it particularly vulnerable, and its oxidation likely leads to an underestimation of its true content. Secondly, the results seem to be influenced by grinding duration and rock microtexture [2]. Prolonged wet grinding with ethanol produces more accurate and reproducible sulfide quantification, especially for Pyh (Figure 3.3). The difference between the coarse-grained MSK-rich and fine-grained MDS aggregates suggests that microtexture plays a key role in sulfides quantification by XRD. In MSK-rich, sulfide grains may be more exposed to damage, whereas the fine-grained matrix of the MDS aggregate could potentially shield the sulfides, which explains its lower sensitivity to the preparation method.

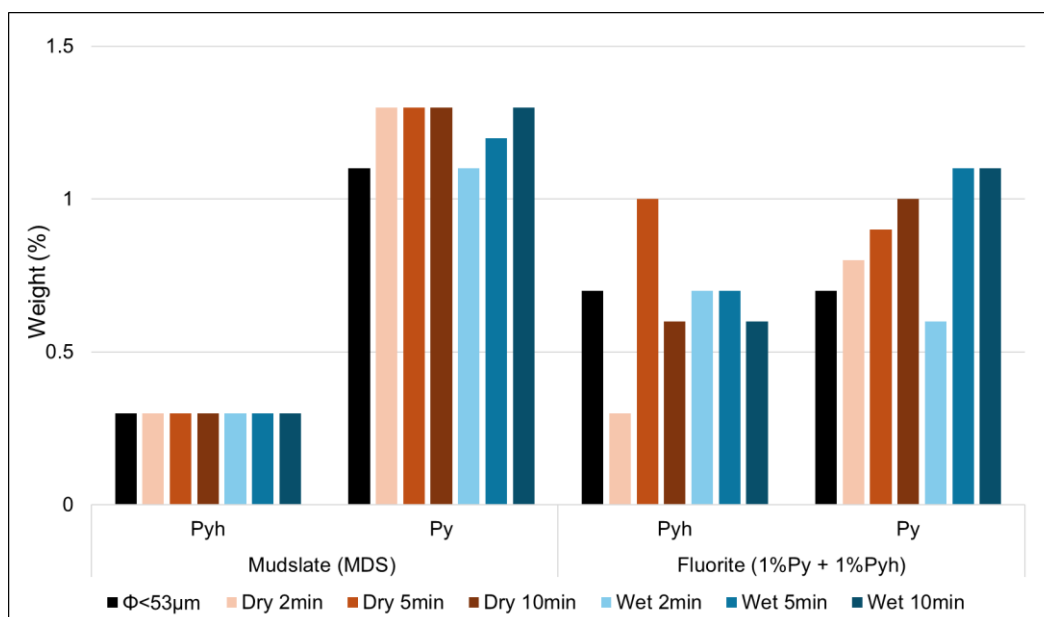
Figure 3.2. Sulfide variation in MDS (natural aggregate) and Fl+1% Py+1% Pyh (synthetic mixtures).

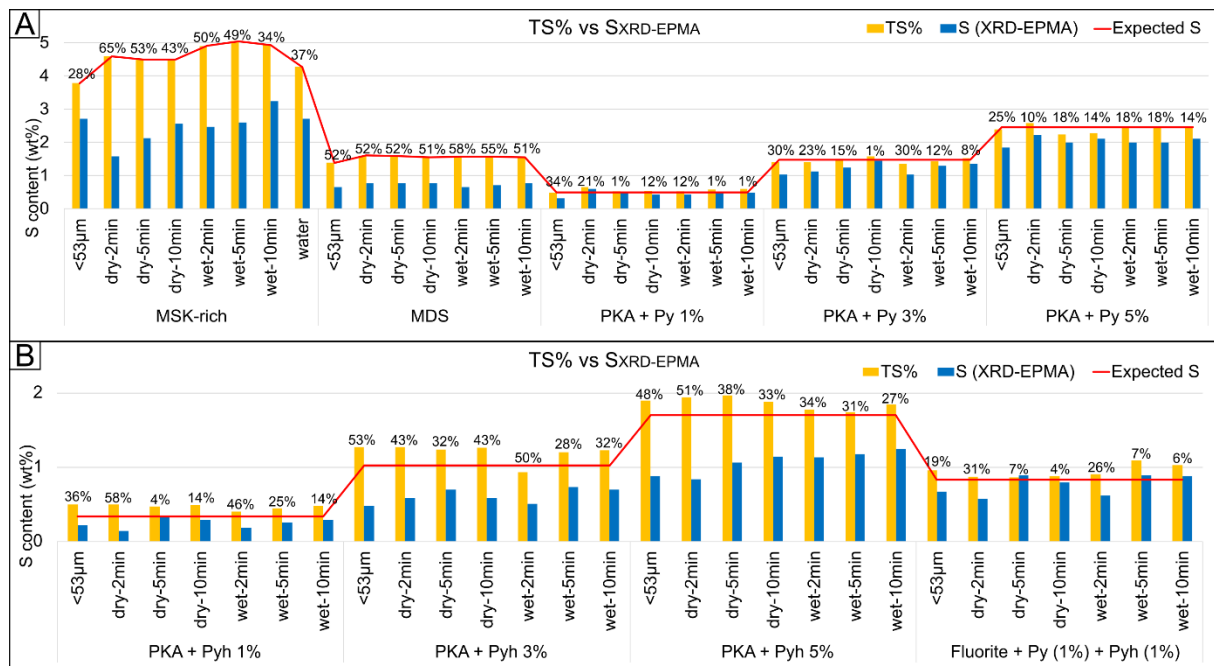
Figure 3.4. Variation between the measured sulfur from TS% vs mineralogy-derived sulfur ( $S_{\text{XRD-EPMA}}$ ). Percentage values above the bars indicate the relative error between the two techniques.

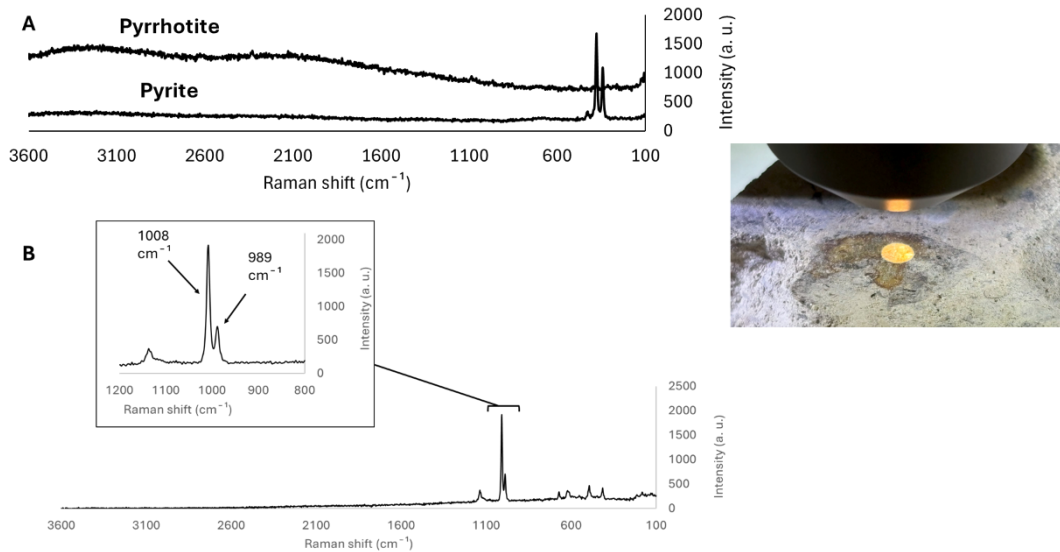
Figure 3.1: Raman spectra with 10x objective for A) concrete sample using 532 nm excitation (6.25 mW) and B) ettringite and gypsum pure compound mixture using 732 excitation (10 mW).

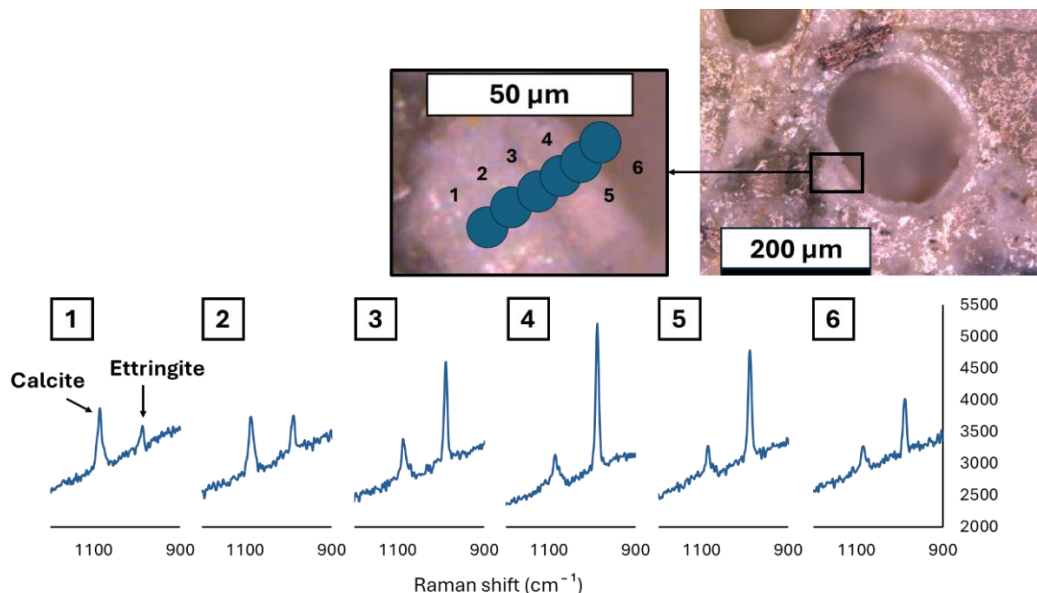
Figure 3.2: Raman spectra for concrete air void with ettringite formation using 785 nm excitation (10 mW) with 10x objective.

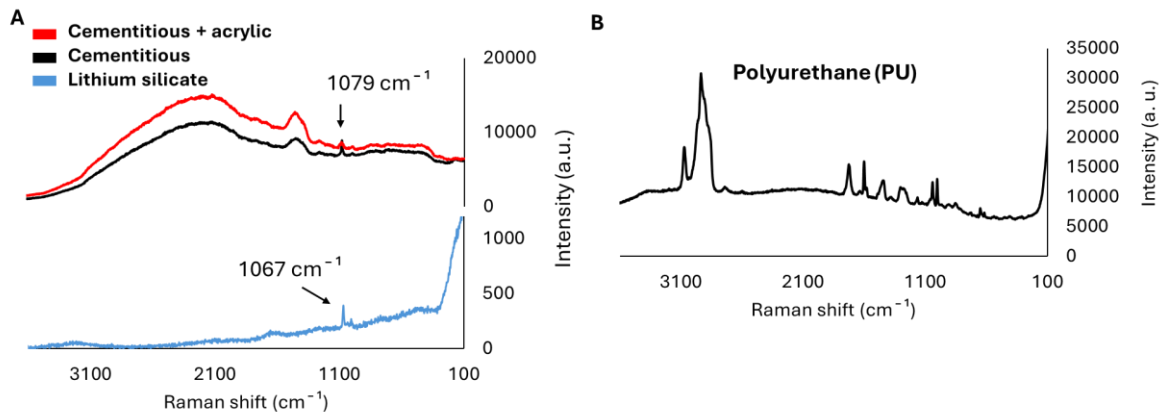
Figure 3.3: Raman spectra for concrete sealants A) cementitious types using 785 nm excitation (25mW) and B) polyurethane using 532 nm excitation (6.25 mW).

Concrete sealant compounds, both cementitious and polymeric, were also examined. Figure 3.3 show spectra for pure cementitious and polymeric sealant types. Preliminary results from cross sections of sealant-applied concrete show that the porous nature of the concrete dilutes the Raman signal from the sealant and the complex composition of the concrete makes it difficult to detect each specific sealant. More work is needed to optimize instrument parameters to better identify the sealant layer and subsequent sealant gradient.

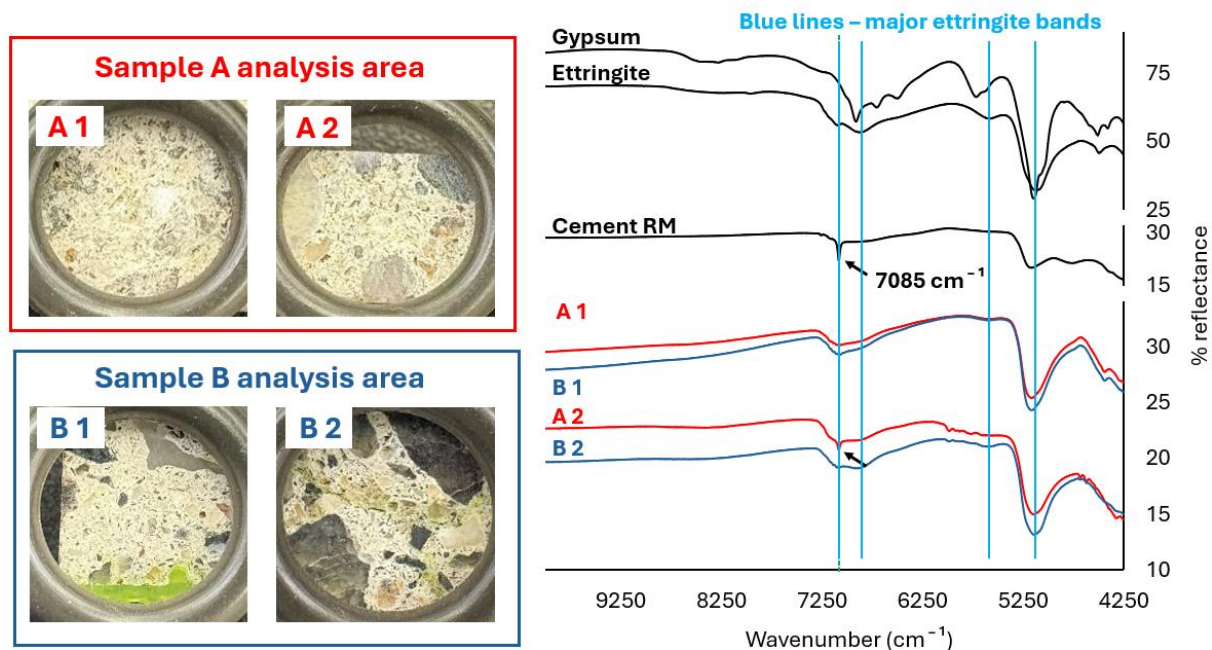
Figure 3.4: NIR spectra for gypsum, ettringite and cement compared to locations on concrete samples, sample areas (9 mm diameter) A and B.
