# 2ND INTERNATIONAL CONFERENCE ON IRON-SULFIDE REACTIONS IN CONCRETE

## Proceedings

The 2nd International Conference on Iron-Sulfide Reactions in Concrete — ICISR 2026 — was hosted by the University of Connecticut in Mystic, Connecticut, USA, from May 12 to 14, 2026. Building on the foundation established by the first ICISR, held at Université Laval in Quebec City, Canada, in 2024, ICISR 2026 continued this international exchange by bringing together researchers, practitioners, public agencies, industry partners, homeowners, and policy stakeholders.

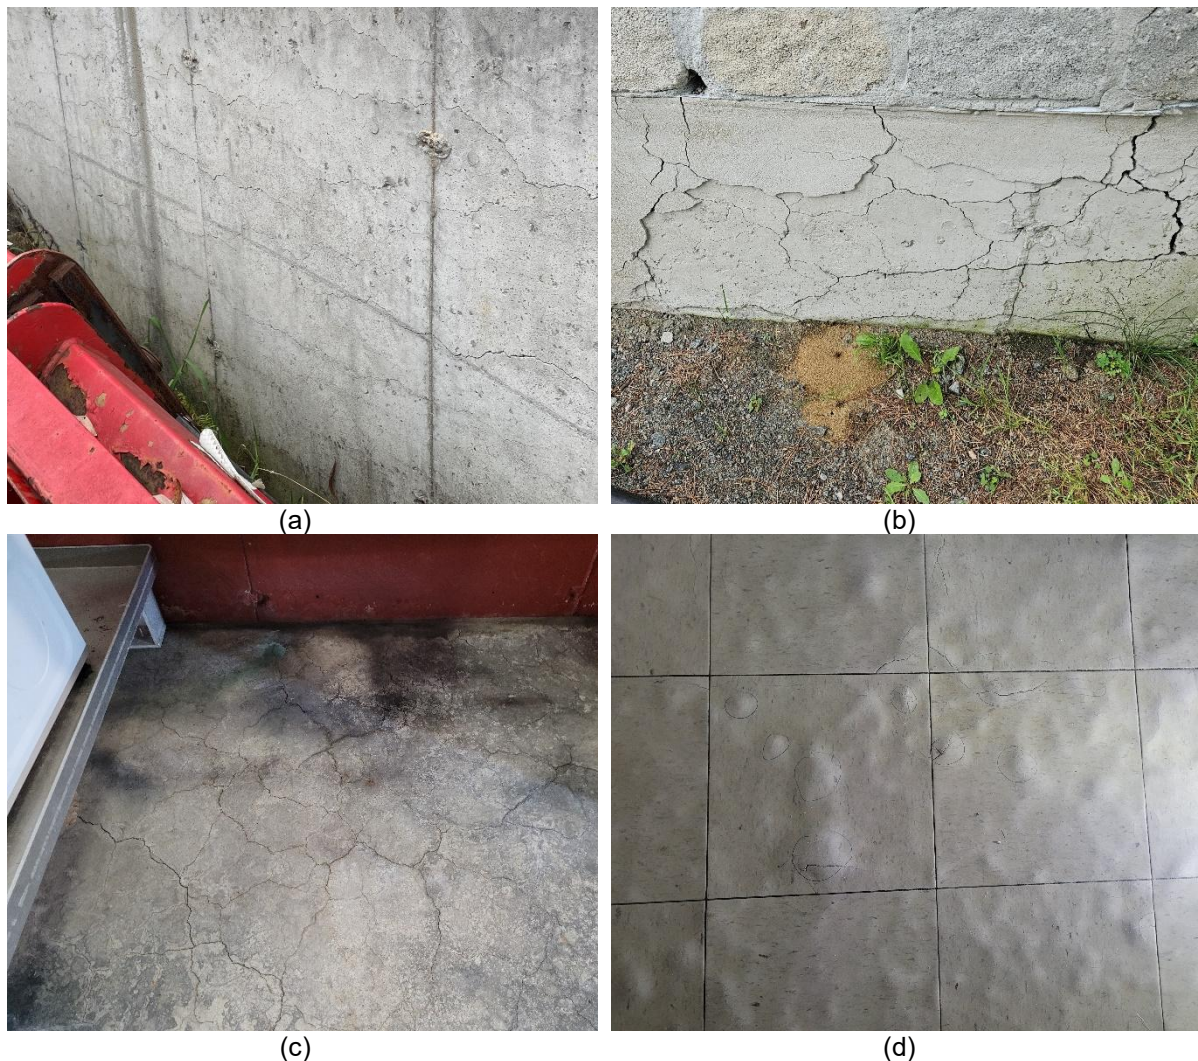
Figure 2.1: (a) Beginning of map-cracking on foundation wall; (b) Severe map-cracking on foundation wall; (c) Severe map-cracking on floor slab; (d) Blisters under vinyl covering.

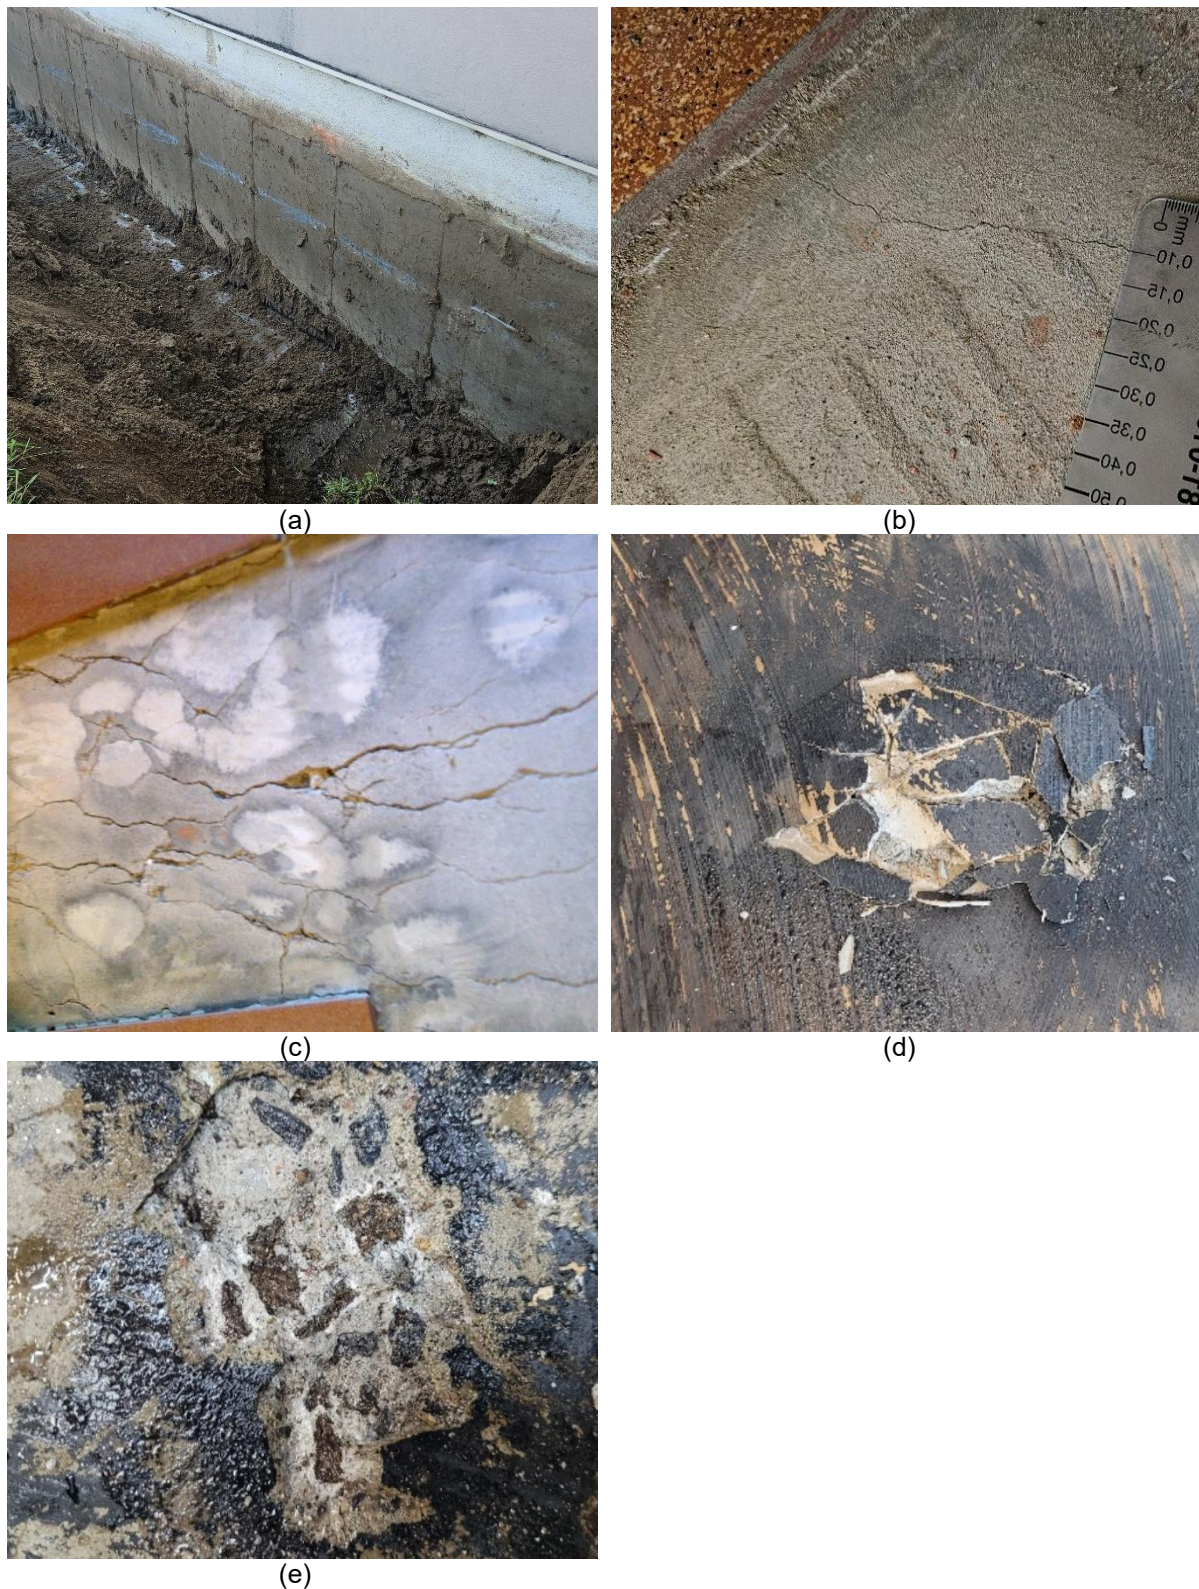
Figure 2.2: (a) Excavated foundation wall; (b) Cracking beneath ceramic tiles (internal stairwell); (c) map-cracking beneath ceramic tiles (building entrance); (d) Deformation and localized disintegration beneath vinyl covering (blister); (e) Whitish products surrounding the aggregates beneath vinyl covering (blister)

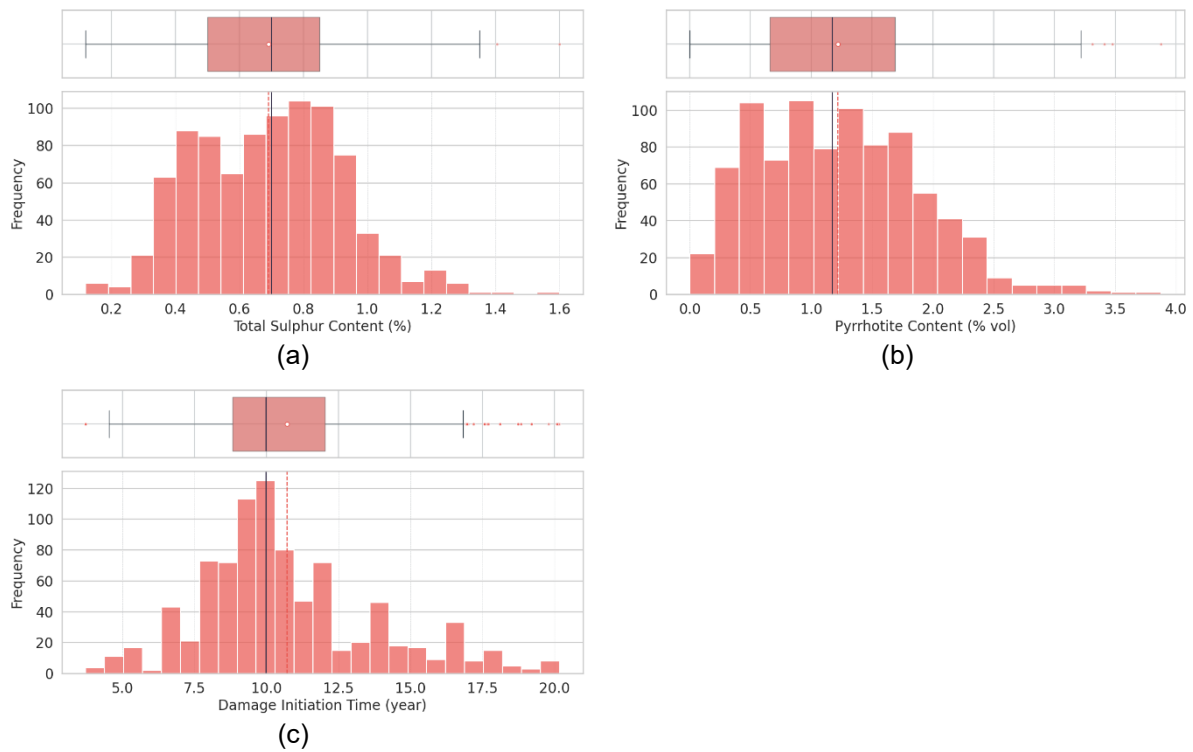
Figure 5.1: Distribution of damaged concrete in function of (a) total sulphur content, (b) pyrrhotite content and (c) damage initiation time

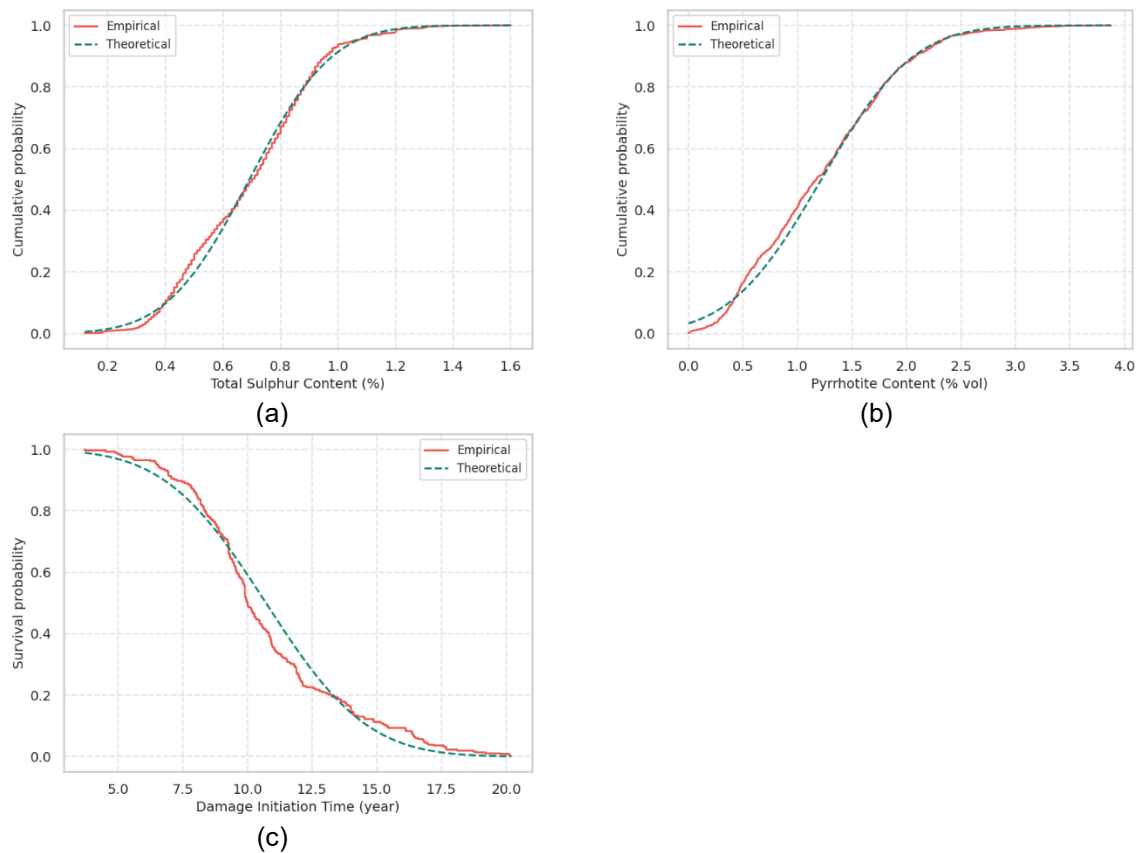
Figure 5.2: Theoretical and empirical cumulative probabilities of damaged concrete elements for (a) total sulphur content; (b) pyrrhotite content and (c) damage initiation time

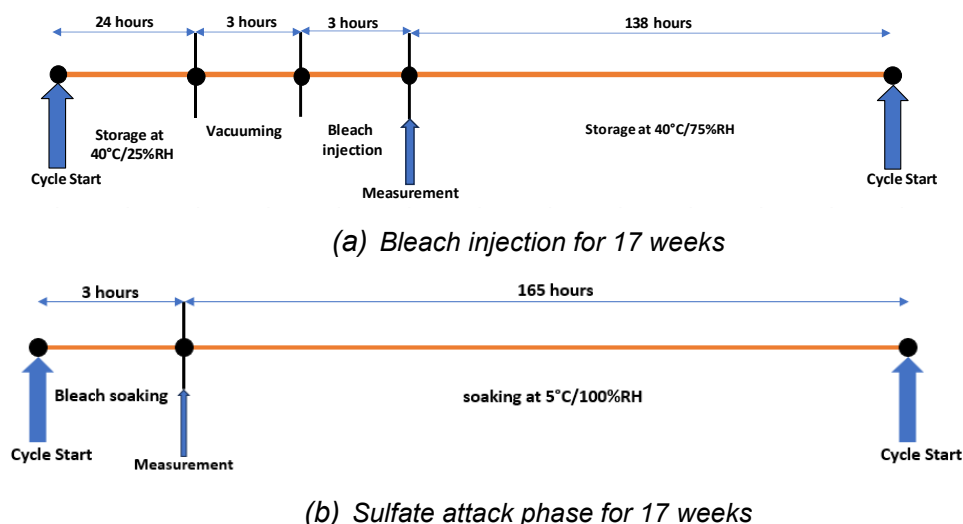
Figure 3.1: VBIT conditioning schematic details

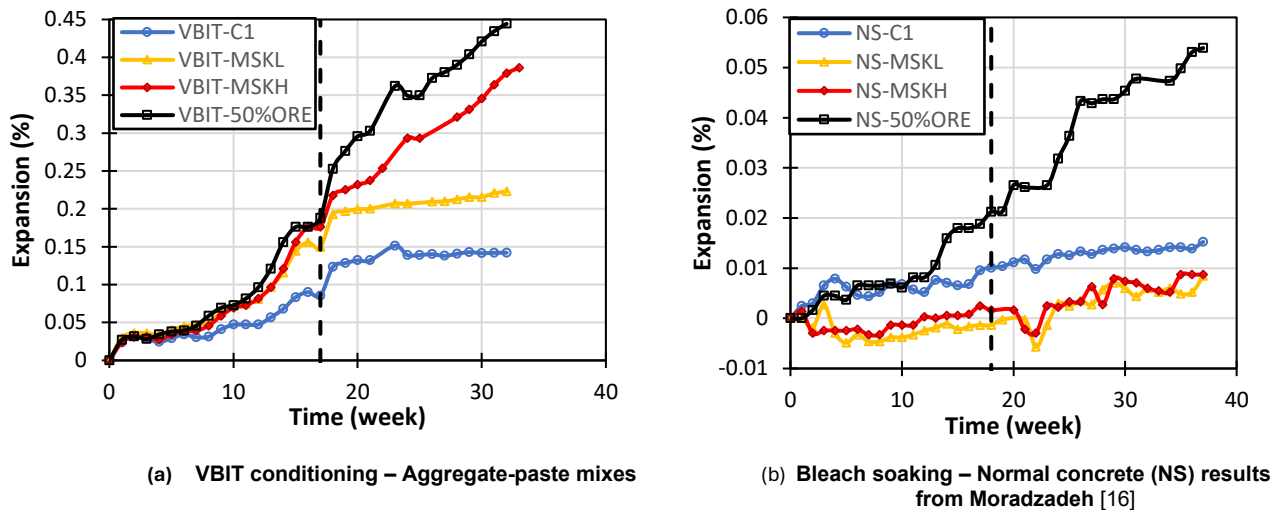
Figure 4.1: VBIT and Normal Bleach Soaking expansion results – Different scale of the Y-axes

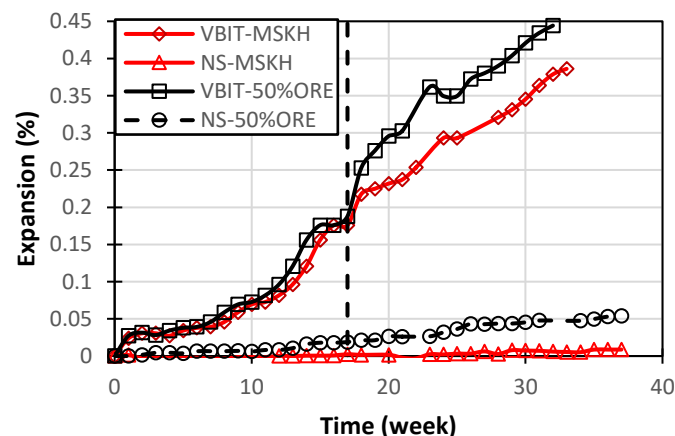
Figure 4.2: Comparison of VBIT with Normal Bleach Soaking conditionings

control aggregate (C1). The comparison indicates that just 3 hours of weekly bleach injection in aggregate-paste mixes is more effective than 16 hours of conventional bleach soaking in normal concrete. The difference is more pronounced in Figure 4.2.

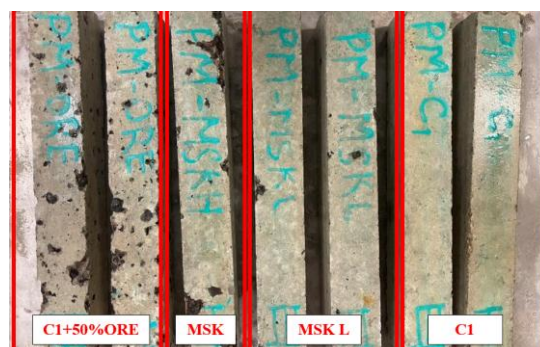
Figure 4.3: The surface of the aggregate-paste mix samples at the end of conditioning

Figure 4.3 shows the surfaces of some of the aggregate-paste mix samples at the end of conditioning. The C1+50% ORE specimens exhibit extensive pop-outs and spalling, with surface deterioration decreasing progressively as the sulfide content decreases (MSK H, MSK L, and C1). During visual inspection, particularly while extracting material for chemical analysis, the highly contaminated samples fractured easily, and the cement paste separated readily from the aggregate.

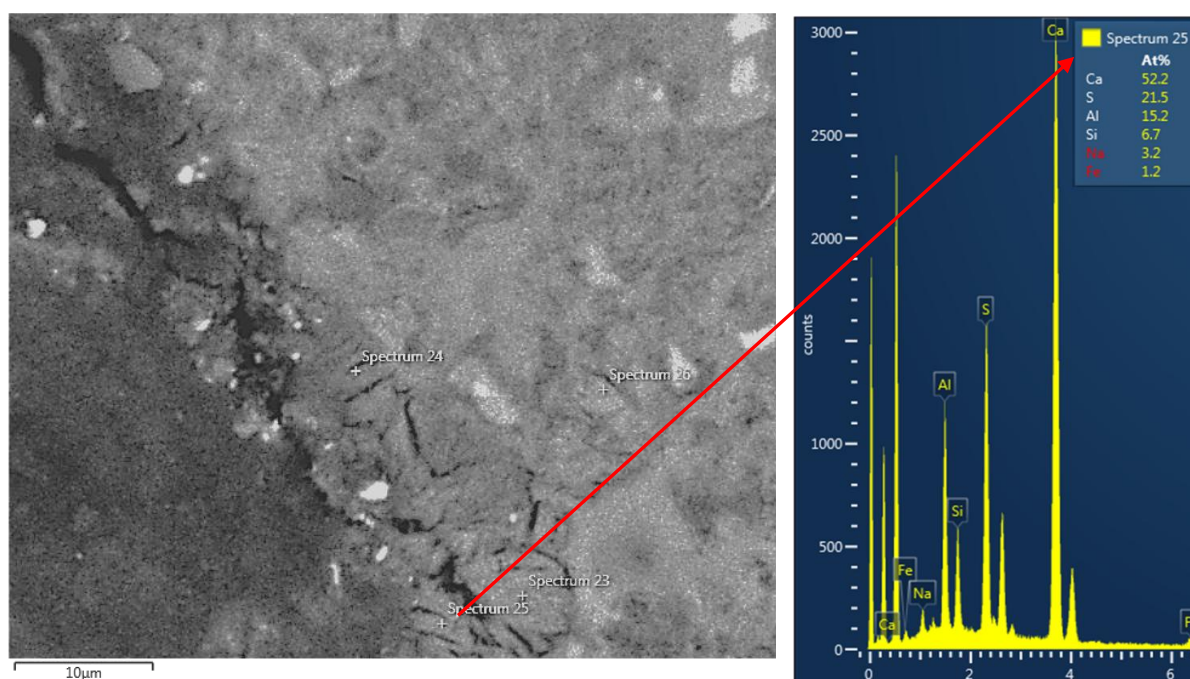
Figure 4.4: Ettringite-thaumasite products in 50%ORE sample

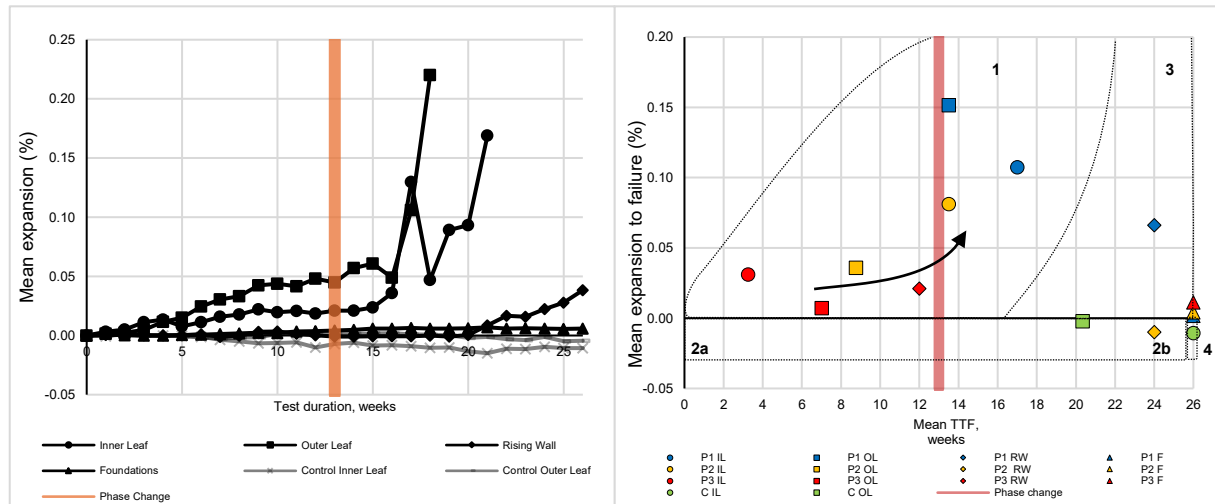
Figure 3.1 (left) Mean expansion of the test properties versus the control property, with the change of storage conditions marked at 13 weeks (red line). Figure 3.2 (right) Mean expansion at failure against time to failure exhibits approximate population areas 1 to 4, interpreted as: 1) expansive failures with greater expansion over time; 2) non-expansive failures related to initial condition or localised sample failures; 3) intact, still-expanding, typically late-stage expansive results; 4) intact samples that did not significantly expand. Note that some plots are obscured behind others. P1, P2, P3 F. A single P1 F 13-week TTF value was taken off test (non-failure for comparative reasons between phases 1 and 2) and is not included in mean TTF calculations. The arrow indicates the generalised progression of core expansion over time seen within population area 1 samples.

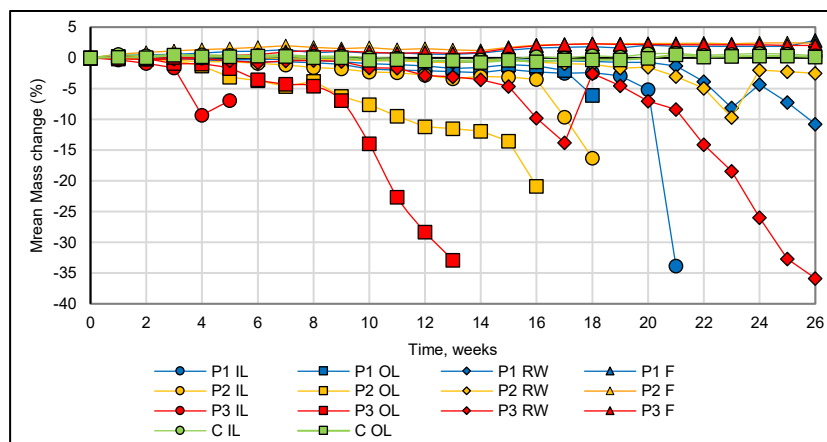
Figure 3.3 Mean mass change of each element from the three test properties and the control property over the duration of the test. Note that the mean values for each element are presented, therefore where a set of readings ends before 26 weeks this represents the failure of the last sub-sample. Where a series

increases in mass sharply, this represents a sub-sample failure that had been losing mass and the mean reverting to the remaining sub-samples.

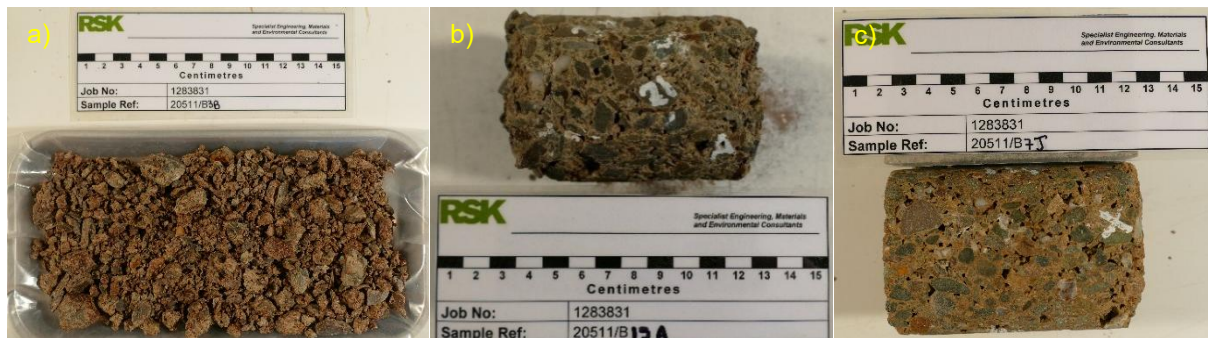
Figure 3.4 Photographs of the different failure morphologies a) complete failure, b) partial failure (heavily cracked, loss of stud(s)), c) Localised failure under measurement studs.

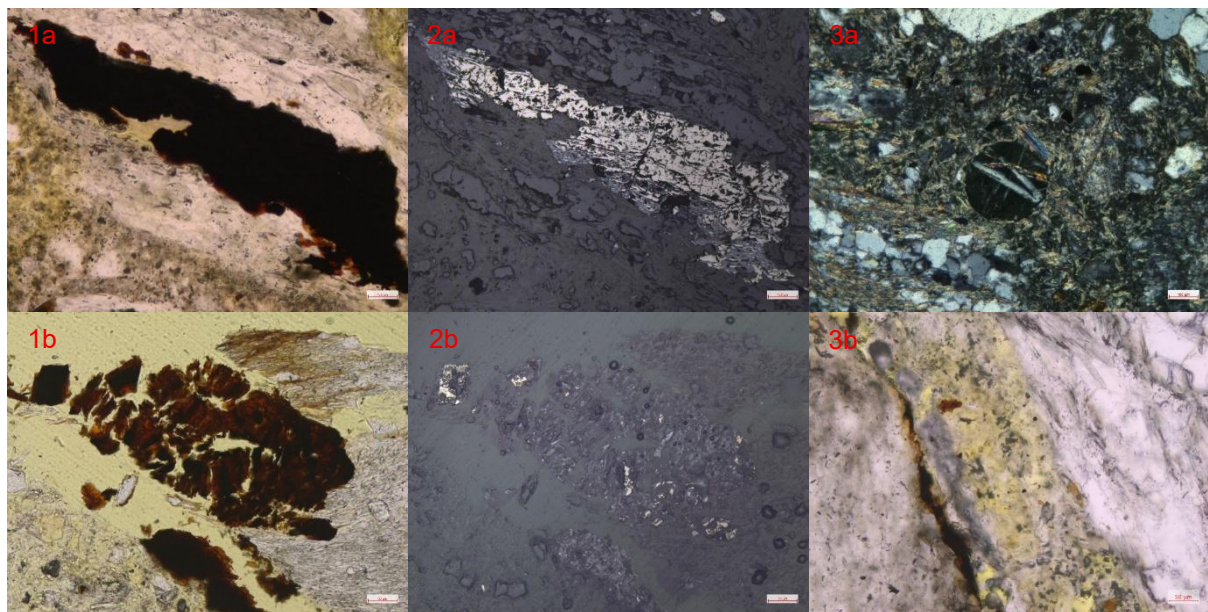
Figure 3.5 Photomicrograph examples of the test properties before (a) and after (b) the ACT showing the oxidation of the pyrrhotite in both plane polarised light (1a and 1b) and reflected light (2a and 2b), and the internal sulfate attack products (3a, gypsum XPL and 3b, ettringite PPL).

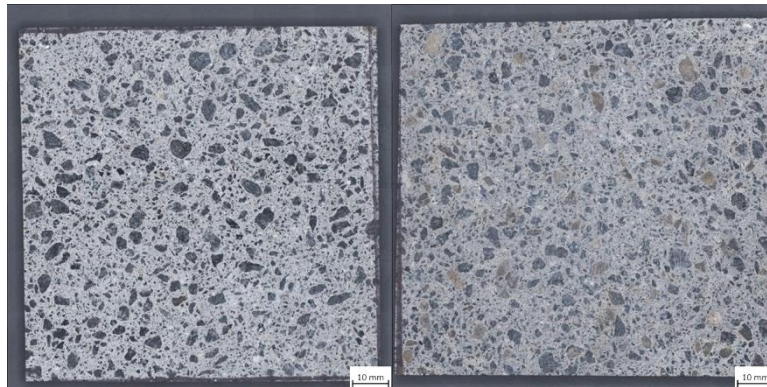
Figure 2.1: Pre-experiment mortar tiles. Left, control sample of diabase and OPC I/II cement. Right, 10 % of diabase sand replaced with natural pyrrhotite.

Mortar samples, both with and without pyrrhotite, were prepared according to ASTM C305. A nominally sulfide-free diabase aggregate, pyrrhotite (Wards Scientific – Galax, Virginia, USA, passing a 4.75 mm (#4), retained on 1.18 mm (#16) sieve), and Type I/II OPC were used. The mortar solids consisted of diabase sand (ASTM C33) in a 2.25 sand-to-cement ratio with 10 % pyrrhotite replacing diabase in pyrrhotite-bearing samples. The water-to-cement ratio was 0.5. Samples were molded in a 152 mm (6") x 152 mm (6") cube mold filled only to an approximate 6 mm depth. Samples were cured initially in a high-humidity chamber for 24 hours, and then for 14 days in a saturated lime-water bath. Samples were trimmed to ~ 100 mm x 100 mm flat "tiles" with one surface polished to 1200 grit to aid inspection (Figure 2.1). Following curing, samples were stored in an evacuated chamber at a pressure of  $8.5 \times 10^{-2}$  MPa until use.

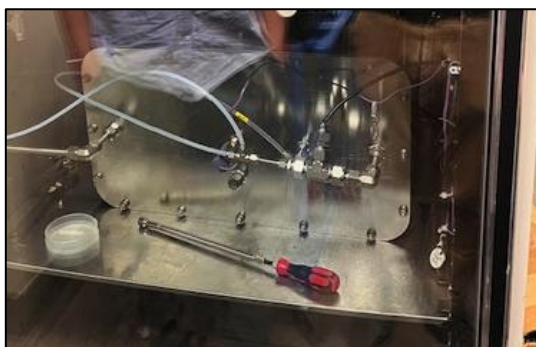
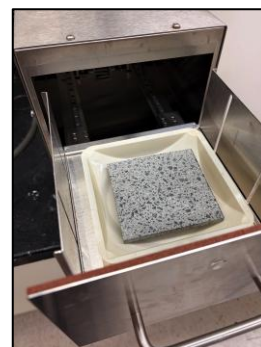
An initial experiment exposed one pyrrhotite and one control tile to ozone under a controlled atmosphere of 500 ppb (ng/kg) ozone in air (40 % humidity) for 14 days (Figure 2.1). During this time, one additional pyrrhotite-bearing tile was exposed to room conditions on a lab bench in case any effects of room air needed to be investigated.

Figure 2.1: Left, 500 ppb set-up. Right, UV/ozone cleaner set-up.

To investigate a more aggressive regimen, a pyrrhotite-bearing tile was placed in a UV/Ozone cleaner (Jelight Model No. 342) suspended over water with 90-minute exposure cycles twice daily for four days, followed by three days without exposure for four weeks (Figure 2.1). The size of this device prevented the use of a pyrrhotite-free control sample. Relative humidity in the chamber was measured at 70 %. The water bath was monitored daily. In this type of device, atmospheric  $O_2$  is exposed to UV radiation from a low-pressure mercury vapor grid lamp and converted to  $O_3$ , while  $H_2O$  in the presence of both UV and  $O_3$  can be converted to  $OH^-$ . This type of device does not target a predetermined ozone concentration. Testing by the manufacturer gives a suggested range for our setup of 40–50 ppm ozone.

The pyrrhotite sample exposed to 500 ppb ozone showed visual signs of oxidation, characterized by a change in the surface color (bronzing) and sheen of the pyrrhotite. There were no ‘rust stains’ or other signs of oxidation at this concentration, for this duration. No change was noted in the control sample.

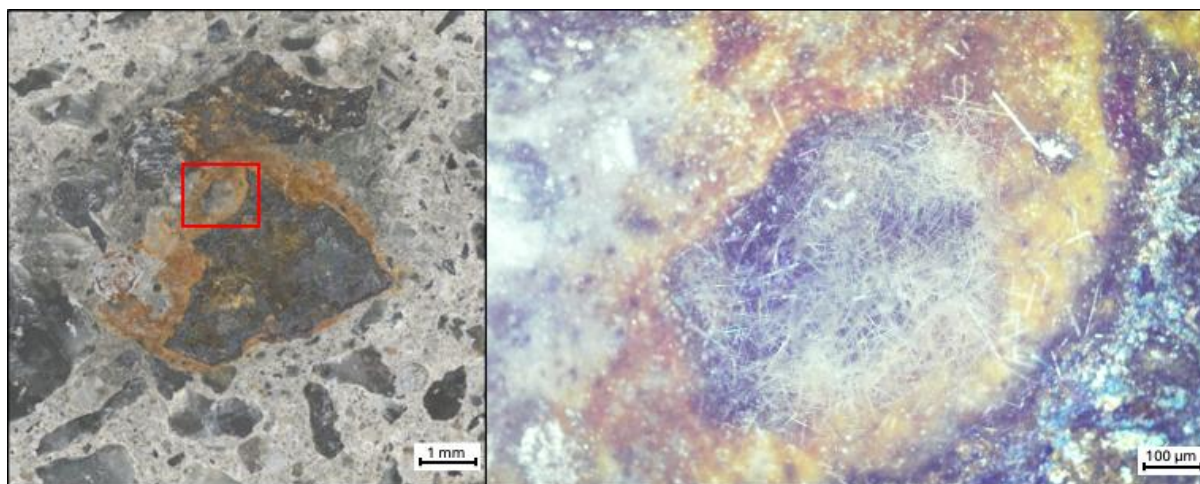
Figure 3.1: Sample P-2 (UV/ozone exposure) after three weeks. Left, staining and white mineral growth. Right, thin white needles can be seen growing into the cavity from the edges.

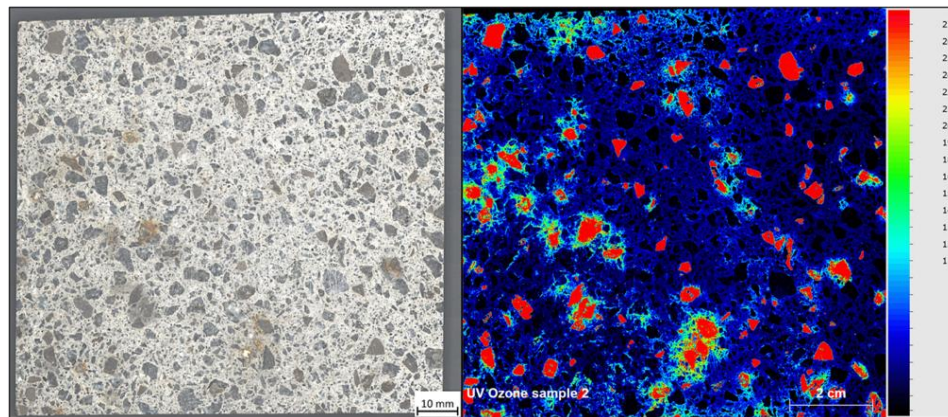
The surface of the UV/Ozone exposure sample was examined by  $\mu$ XRF (Bruker M4 Tornado<sup>plus</sup>).  $\mu$ XRF is a non-invasive technique that does not require sample preparation, allowing the sample to be fully analyzed later by other methods. Mapping sulfur distribution as shown in Figure 3.2 indicated a spread of sulfur from sulfide grains across and potentially into the cement paste.

Figure 3.2:  $\mu$ XRF 'Heat map' of sulfur abundance (EDS) in the UV/Ozone exposure sample showing sulfides (red), non-pyrrhotite aggregate (black), cement paste (blue), and areas of elevated sulfur within or upon the surface of the sample (light-blue, green, orange).

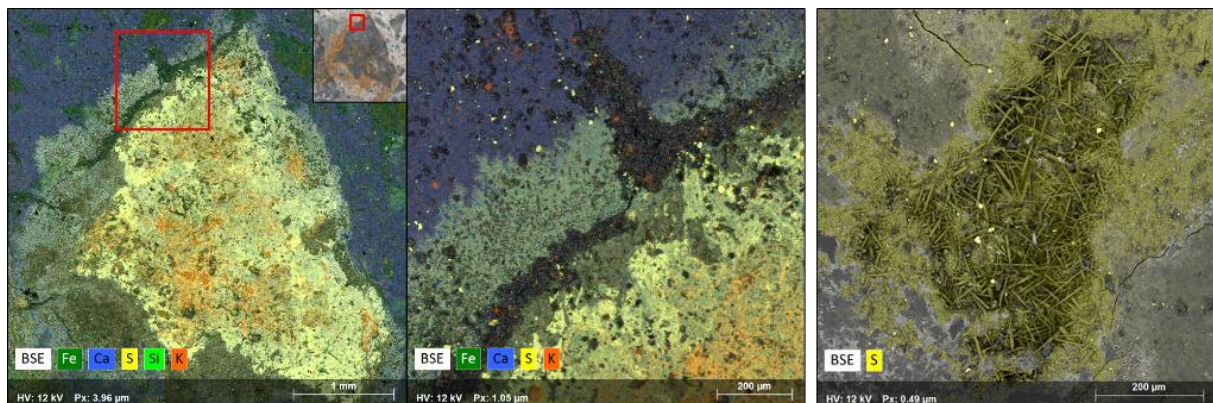
Retained sections of samples P-2 (UV/Ozone) and P-3 (500 ppb) were mounted on aluminum stubs and carbon-coated for analysis by SEM/EDS on a Tescan Mira4 field emission SEM with two Bruker XFlash 70 mm EDS detectors with 12 kV accelerating voltage and 5 nA beam current. Sample P-3 from the 500 ppb exposure experiments was examined and did not show significant mineral growth. Sample P-2, from the UV/Ozone exposure, showed the growth of mineral crusts over aggregate grains. The growths, as seen in Figure 3.3 (left, center), varied in chemistry across the grain, changing broadly in bands from the center, where potassium-calcium sulfates were found, through calcium sulfates amid patches of bare iron sulfide, and out onto the surface of the cement paste. This indicates a reaction between the sulfate ions and the cations in the cement or aggregate minerals. In other areas of P-2, needle-like growths are identified on the surface. They generally contain sulfur and calcium without other cations and are likely gypsum. The needles are surrounded by patches of thin growth on the surface (Figure 3.3, right).

Figure 3.3: Sample surface after UV/ozone exposure. Left/Center, crust formed on an aggregate grain surface and cement paste. Inset, optical image. Others, SEM Backscatter Electron (BSE) image with EDS sulfur map overlay. Right, needle-like growth of minerals in a cavity at another spot.

The pyrrhotite-bearing sample exposed in the UV/Ozone cleaner showed surface evidence of reaction, including “rust” stains around pyrrhotite grains, the appearance of fine white needle-like crystals in an air void exposed at the surface, and white crust spots on the surface. Analysis of needles at three weeks by micro-Raman (Bruker Senterra II) best match spectra collected from gypsum. SEM/EDS confirmed the presence of sulfur and calcium without other cations. (Figure 3.1).

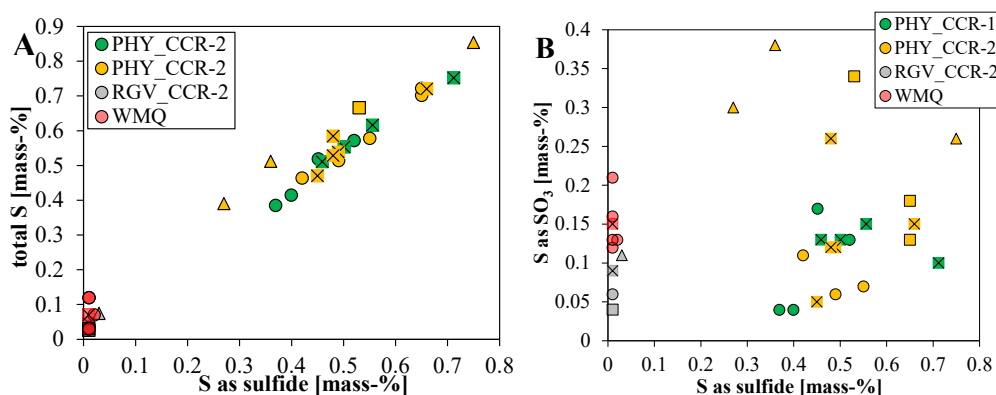
The concrete produced with WMQ aggregates shows a low total sulfur content (Table 3.1, Figure 3.1). The concrete containing PHY aggregates displays the highest total sulfur contents and the concrete containing RGV aggregates from the undamaged reference home [3] the lowest. However, the blocks produced with WMQ and PHY aggregates do not differ in regard to the mean sulfur content present as  $\text{SO}_3$  (present in the hydrates) and water soluble sulfur (present as gypsum).

Figure 3.1: Total sulfur (S) as a function of sulfur (S) as sulfide (A) and sulfur (S) as  $\text{SO}_3$  as a function of sulfur (S) as sulfide (B). CCR-1: data from [2], CCR-2: data from [3]. Symbols in (B): triangle = foundation concrete, square = RB, circle = OL, cross = IL.

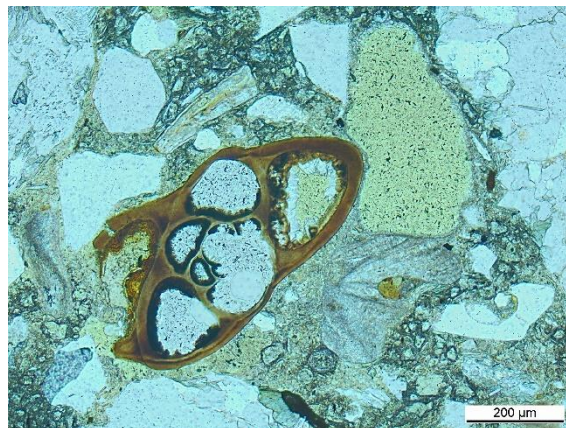
Figure 3.2: Stained shell particle with linings of opaque particles in its interior from an RB sample using polarized light.

The analysis of the thin sections confirmed the assessment in regard to the degree of carbonation already indicated by the phenolphthalein test (see 2.1). The rounded micaceous meta-quartzite and greywacke particles often show the presence of iron oxides/hydroxides. Some opaque minerals indicate the presence of likely oxide or sulfide phases. The content of free sheet-silicate platelets in the cement paste is relatively high. The sand mainly consists of partly rounded quartzite with a high amount of calcareous shell particles. Numerous shell particles are stained by iron oxides/hydroxides and occasionally show small opaque particles (Figure 3.2). Some air voids contain ettringite. More details on the aggregates are given in paragraph 3.4.1. The cement paste is highly porous indicating a high water-to-cement ratio.

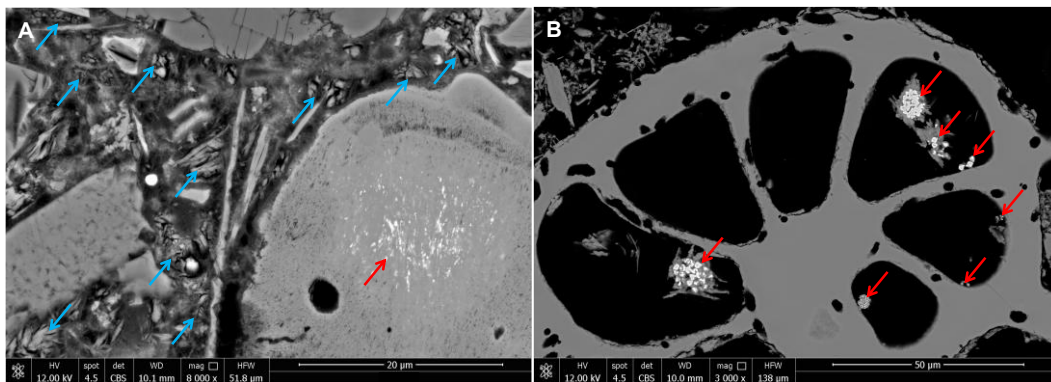
Figure 3.3: A: Partly oxidized pyrrhotite in shell particle (red arrow) and secondary ettringite (blue arrows) formed in the adjacent cement paste (HWF = 51.8  $\mu\text{m}$ ). Outer leaf. B: Partly oxidized framboidal pyrite clusters (red arrows) in shell particle (HWF = 138  $\mu\text{m}$ ). Inner leaf.

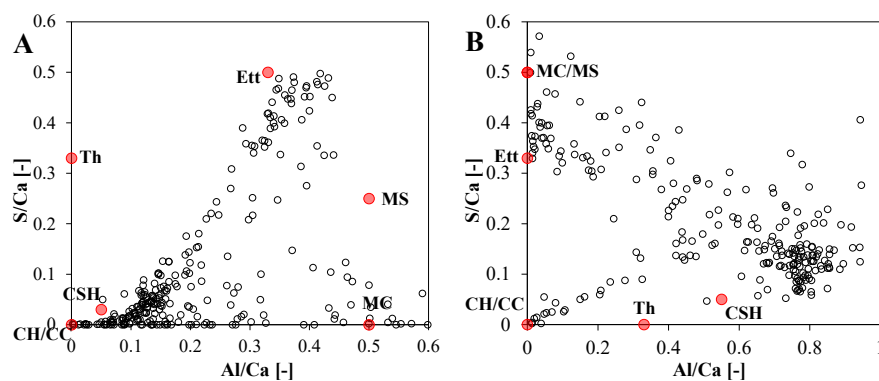
The cement hydrates in the uncarbonated zones of all samples show C-S-H, monocarbonate and portlandite as the main cement hydrates present (Figure 3.4). The amount of monocarbonate is unusually high. In addition, there is a clear shift from C-S-H towards ettringite. The Si/Ca-ratio of the C-S-H is significantly higher than usual. Chloride is present in all samples, mainly in monocarbonate, where it is absorbed in the interlayer [8] shifting the monocarbonate composition towards Friedel's salt ( $\text{Ca}_2\text{Al}(\text{OH})_6(\text{Cl},\text{OH})\cdot 2\text{H}_2\text{O}$ ). There are carbonated zones in all samples of the outer leaf. Sometimes calcium is redistributed forming a layer in the transition of the leached carbonated and the unleached uncarbonated zone. Simultaneously, sulfur is absent in the carbonated zone with a relatively high content in the form of ettringite in the adjacent uncarbonated zone (Figure 3.5). In the fully carbonated inner leaf, the cement hydrates have been completely altered. Calcite and Si-Al-gel are the main phases. Small gypsum particles typically intermixed with calcite occur. There are some indications of thaumasite, but no certain identification was possible. The cement hydrates present in the RB samples are identical to the ones in the uncarbonated OL with a lower but still elevated occurrence of ettringite.

Figure 3.4: S/Ca-ratio as a function of the Al/Ca-ratio (A) and Al/Ca-ratio as a function of the Si/Ca-ratio in an outer leaf sample (B). The red dots indicate the composition of the pure phases: CC = calcite, CH = portlandite, CSH = calcium-silicate-hydrate, Th = thaumasite, MS = monosulfate, MC = monocarbonate.

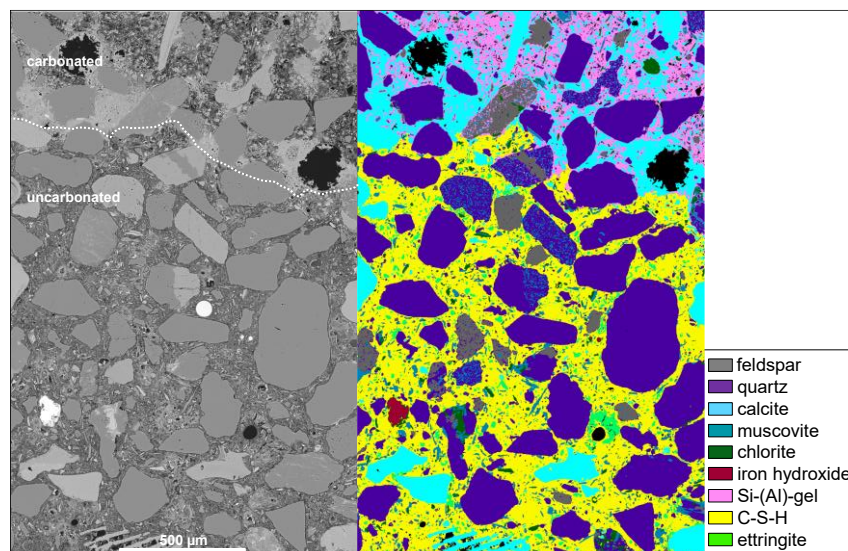
Figure 3.5: BSE-image (A) of the carbonation front (above dashed line) and phases present in the carbonated and uncarbonated cement paste (B). Outer leaf.

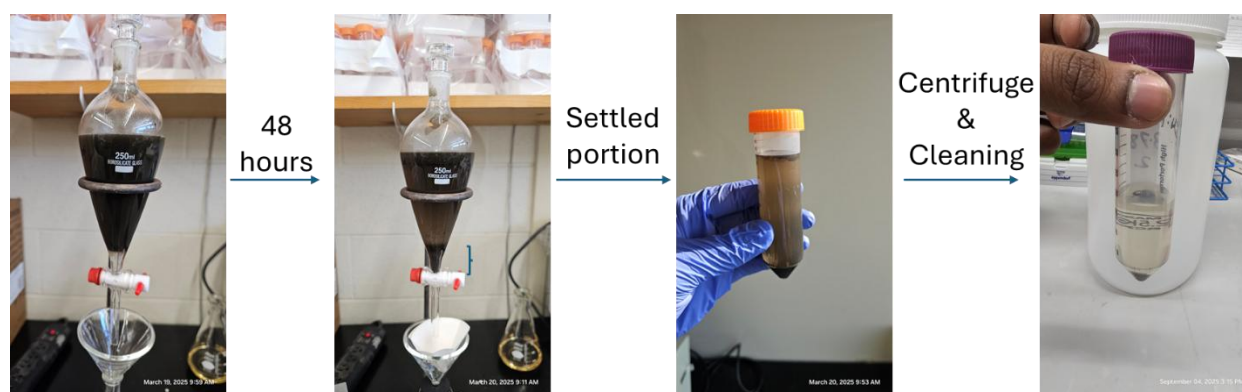
Aggregate samples with varying quantities of iron sulfides were collected from North American quarries. The bulk samples were crushed using a jaw crusher until the particles were fine enough to pass through  $90\text{ }\mu\text{m}$ . 30 g of that crushed sample was then mixed with 200 mL of Lithium Metatungstate (LMT) (density  $2.95\text{ g/cm}^3$ ) in a separatory funnel. The resultant slurry was then left to settle for 24 hours for the heavier particles to settle down. After that the supernatant is remixed and kept stranded for 24 hours. Then the settled portion was collected in a centrifuge tube. A portion of that settled slurry was transferred to another centrifuge tube, topped up with deionized (DI) water and thoroughly mixed. Then the mix was centrifuged for 10 min in 5000 rpm to separate the water and the particles. This cleaning process continued till all the settled slurry was cleaned and the supernatant was cleared. The cleaned particles were dried inside an oven with 25 mmHg vacuum and  $50\text{ }^\circ\text{C}$  to limit the oxidation of the samples. Both the preprocessed and the settled samples were micronized for 15 minutes inside a grinding jar with agate bead (XRD-MILL MCCRONE) in isopropanol for homogenization. The homogenized samples were then dried in similar fashion for further experiments. The floated slurry of the powders and the LMT were also collected by filtering through analytical filter papers and washed with DI water.

Figure 3: The flow of experiments utilized to concentrate the iron sulfides.

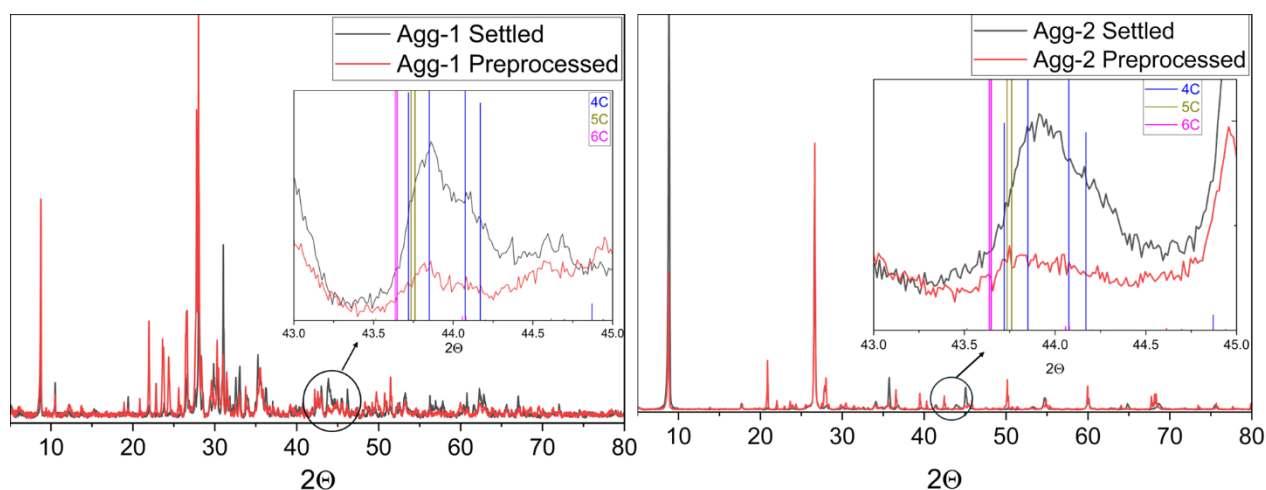
Figure 4: XRD scans of the samples before and after gravity-based separation using LMT.

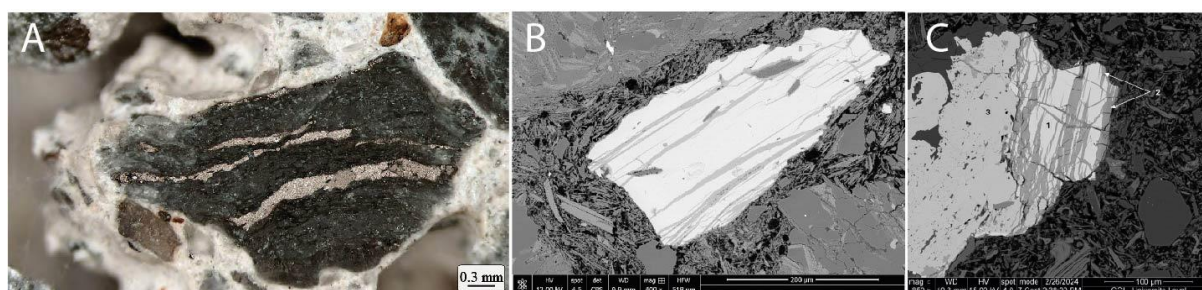
Petrographic examination of the deteriorated concrete samples from all structural locations confirmed that aggregates were derived primarily from phyllitic and micaceous lithologies which commonly contain disseminated iron sulfide minerals. Optical microscopy and point-count analyses showed pyrrhotite to be the predominant sulfide, accounting for the majority of the iron sulfide population, with minor pyrite and trace accessory sulfides (Fig. 1A). Optical microscopy and SEM–EDS analyses consistently identified oxidation occurring within pyrrhotite grains, both within aggregate particles and where individual iron sulfide grains were liberated into the cement paste (Fig. 1B & C). These oxidised zones were commonly associated with secondary sulfate-bearing phases in the surrounding paste, providing direct microstructural evidence of ISA. SEM–EDS microanalysis identified progressive alteration of the cement paste matrix and a transition from normal hydration products toward an ISA-dominated microstructure with secondary ettringite and thaumasite in samples analysed from the three damaged properties. While secondary ettringite formation causes concrete expansion, thaumasite formation leads to a loss of cement paste strength and concrete durability.

Figure 1. A shows pyrrhotite bands clearly identified in concrete aggregates (CRT). B (Empa) C (Laval) SEM images of pyrrhotite with oxidized regions.

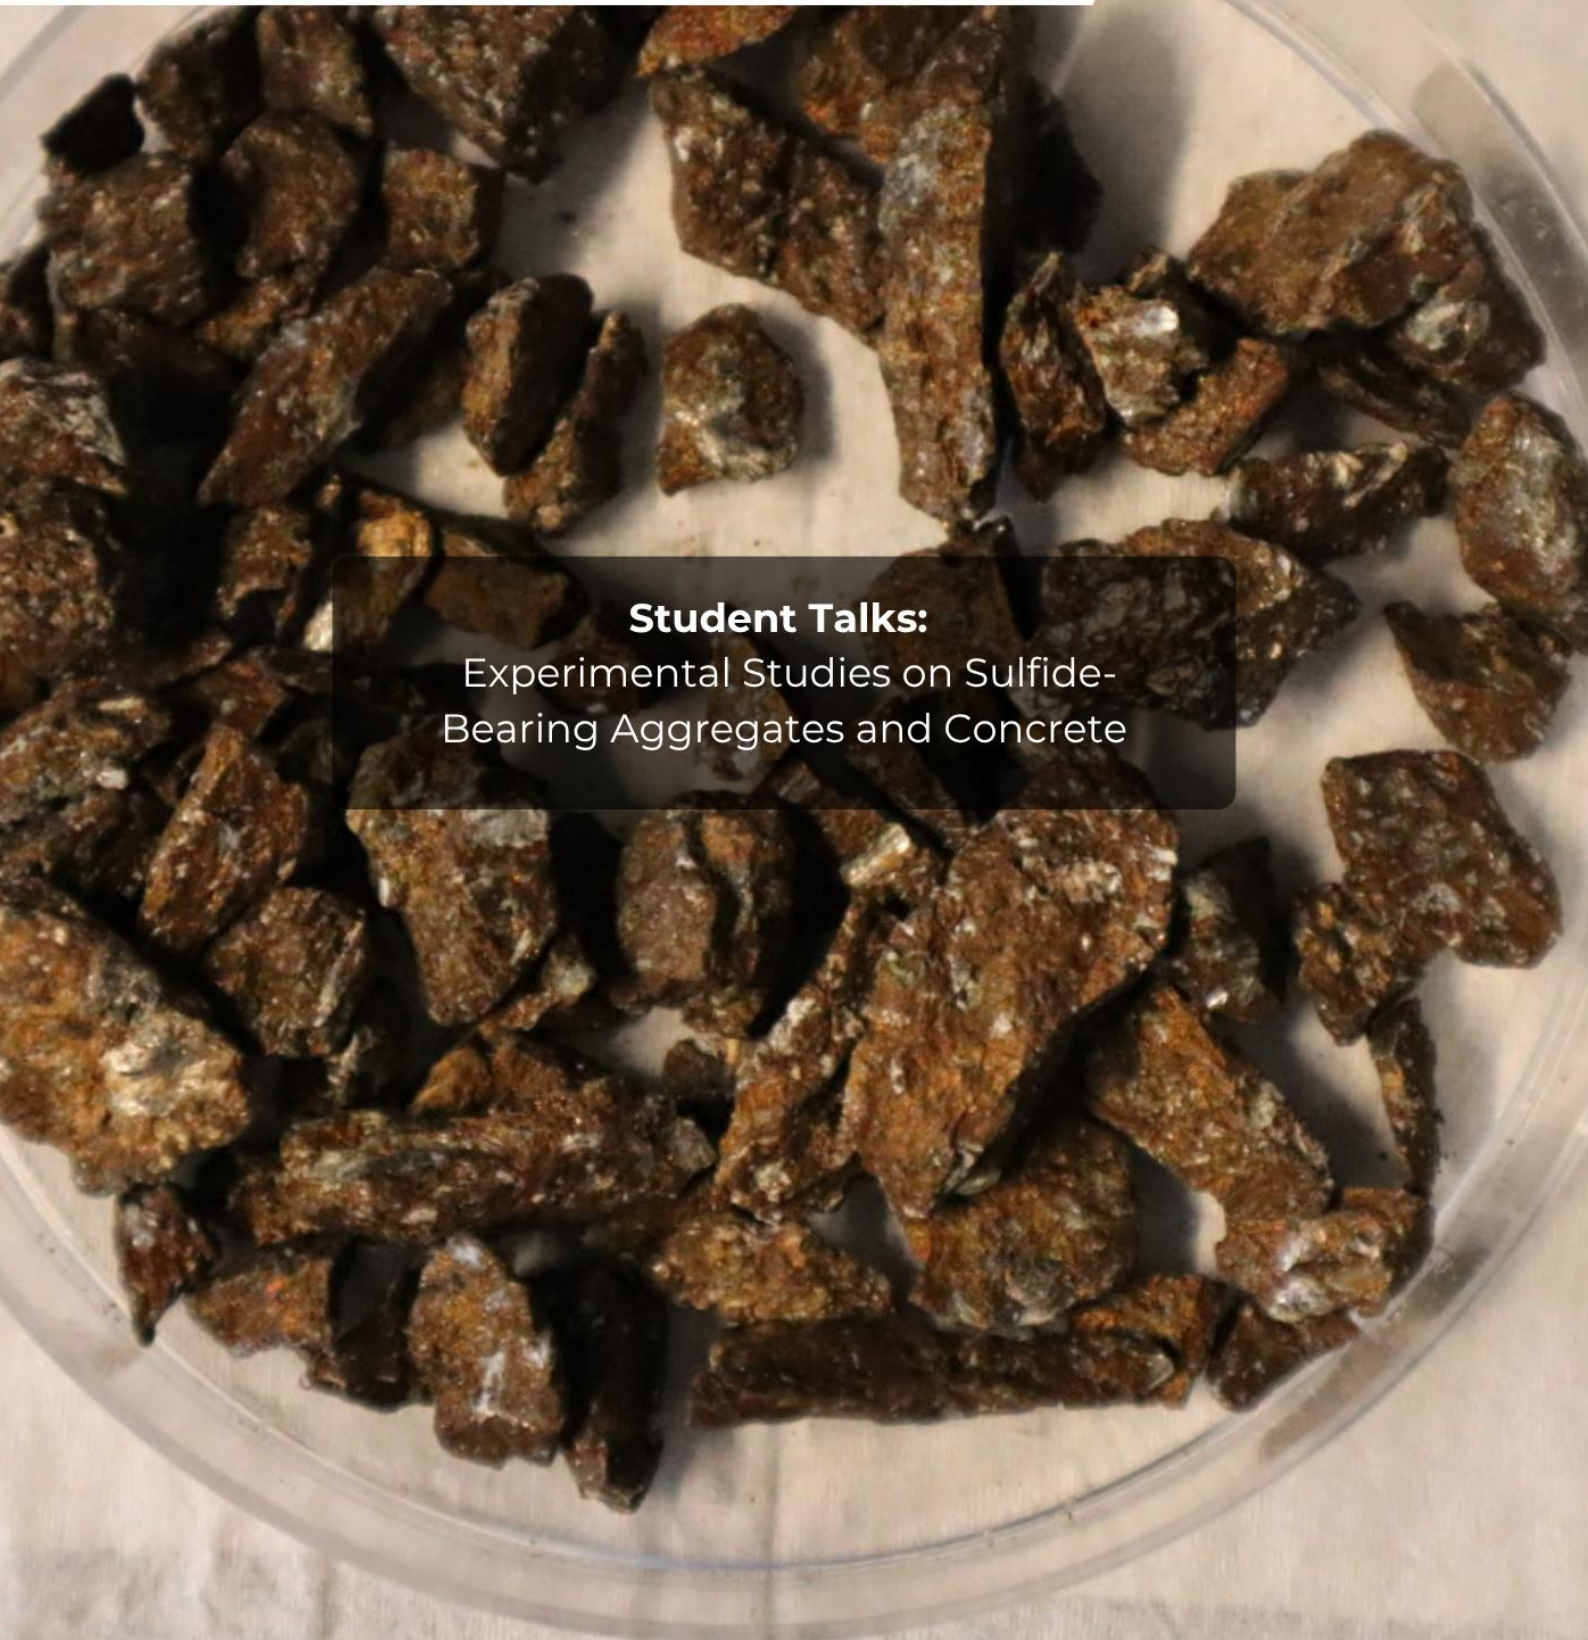
A photograph of a petri dish filled with numerous small, irregular pieces of concrete aggregate. The aggregates are heavily corroded, showing a dark brown, rusted surface with some lighter, white crystalline deposits. The dish is placed on a light-colored, textured surface.
