# 2ND INTERNATIONAL CONFERENCE ON IRON-SULFIDE REACTIONS IN CONCRETE

## Proceedings

The 2nd International Conference on Iron-Sulfide Reactions in Concrete — ICISR 2026 — was hosted by the University of Connecticut in Mystic, Connecticut, USA, from May 12 to 14, 2026. Building on the foundation established by the first ICISR, held at Université Laval in Quebec City, Canada, in 2024, ICISR 2026 continued this international exchange by bringing together researchers, practitioners, public agencies, industry partners, homeowners, and policy stakeholders.

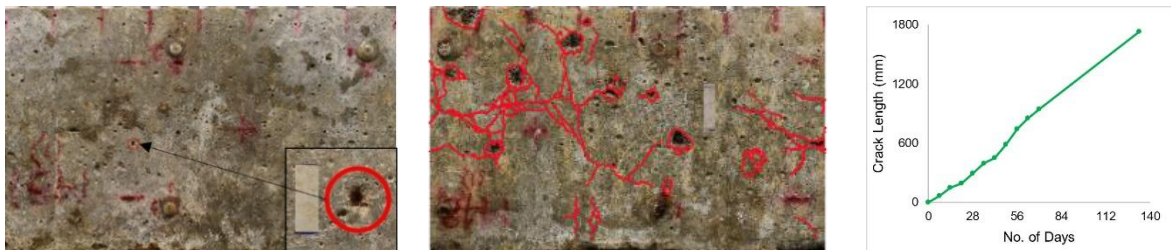
Figure 3.1 shows the visual evidence of deterioration observed in concrete mixtures containing iron sulfide aggregates under EAT. All mixtures with CA1 developed reddish brown staining and localized pop outs associated with oxidized iron sulfide-bearing particles on the end faces and specimen body.

Figure 3.1: Pictures of P-1-CA1 (left) and P-3-CA1 (middle) specimens after 133 days of EAT exposure, and the corresponding crack length increment data for P-3-CA1 (right)

The severity of this damage depended strongly on aggregate size. P-1-CA1, which contained CA1 only in FR1, exhibited discoloration and pop outs, but the extent of deterioration remained limited and no macroscopic cracking was observed at the end of testing. Under similar electrochemical conditions, P-3-CA1, which contained CA1 in FR3, exhibited visible cracking that initiated at oxidized coarse particles and propagated into the surrounding paste. The corresponding crack length data for the specimen shown in Figure 3.1 indicate a steady increase throughout the exposure period, reaching approximately 1730 mm by 133 days.

These results demonstrate that aggregate size governs the severity of electrochemically accelerated deterioration in iron sulfide-containing concrete. Mixtures in which iron sulfide is concentrated in coarse particles exhibit faster crack initiation and more extensive damage than those in which reactive material is restricted to fine fractions with similar overall sulfur levels.

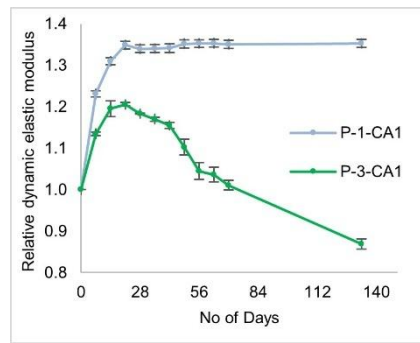
The  $E_{dyn,c}$  results presented in Figure 3.2 further support the strong influence of aggregate size on deterioration. In P-1-CA1,  $E_{dyn,c}$  increased during early exposure due to continued hydration and then remained relatively stable, consistent with the absence of macroscopic cracking. In contrast, mixtures with CA1 in coarse fractions exhibited clear reductions in  $E_{dyn,c}$  after a short initial gain. In P-3-CA1,  $E_{dyn,c}$  increased during early curing but then declined steadily, reflecting progressive stiffness loss associated with cracking.

Figure 3.2: Relative  $E_{dyn,c}$  plots for P-1-CA1 and P-3-CA1 specimens during EAT

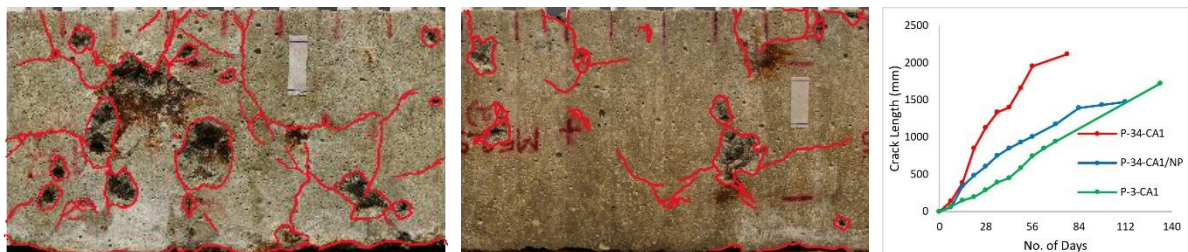
Figure 3.3 presents representative images of the two mixtures as well as the corresponding crack length increments. Although both mixtures displayed surface discoloration and pop outs typical of iron sulfide oxidation, their deterioration progressed at noticeably different rates. P-34-CA1, which contained higher sulfide concentration, developed visible cracking within the first few weeks of exposure and reached a total crack length of approximately 2120 mm by 77 days. In contrast, P-34-CA1/NP exhibited a slower deterioration response. Cracking initiated later, and its rate of propagation was substantially lower, reaching about 1470 mm at 112 days.

Figure 3.3: Pictures of P-34-CA1 (left) and P-34-CA1/NP (middle) specimens after 77 and 112 days of EAT exposure, respectively, and the corresponding crack length increment data (right)

A comparison to P-3-CA1 highlights that P-34-CA1 exhibited substantially greater deterioration, but this increase cannot be attributed to sulfide content alone because the mixture also introduced reactive CA1 into an additional coarse fraction. The combined change in both aggregate size distribution and sulfide level means that P-34-CA1 did not fully isolate the role of sulfide content. In contrast, P-34-CA1/NP retained the same coarse aggregate sizes as P-34-CA1 while reducing the sulfide content through partial NP replacement. This allowed the specific influence of sulfide level to be observed more clearly. P-34-CA1/NP showed a slower and less severe deterioration pattern, despite a longer exposure period.

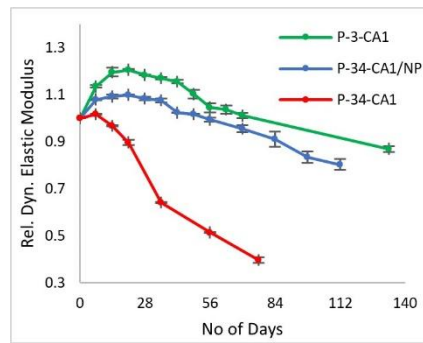
The  $E_{dyn,c}$  results shown in Figure 3.4 further support this trend. P-34-CA1 experienced a rapid decline in  $E_{dyn,c}$ , losing about 60 percent of its initial stiffness by day 77. This decline was larger and occurred earlier than in P-3-CA1, which exhibited a more gradual reduction in stiffness. In contrast, P-34-CA1/NP showed only a moderate decline of about 20 percent at 112 days, which is approximately one third of the loss measured in P-34-CA1 even though it remained under exposure for 35 additional days.

Figure 3.4: Relative  $E_{dyn,c}$  plots for P-34-CA1 and P-34-CA1/NP specimens (P-3-CA1 included)

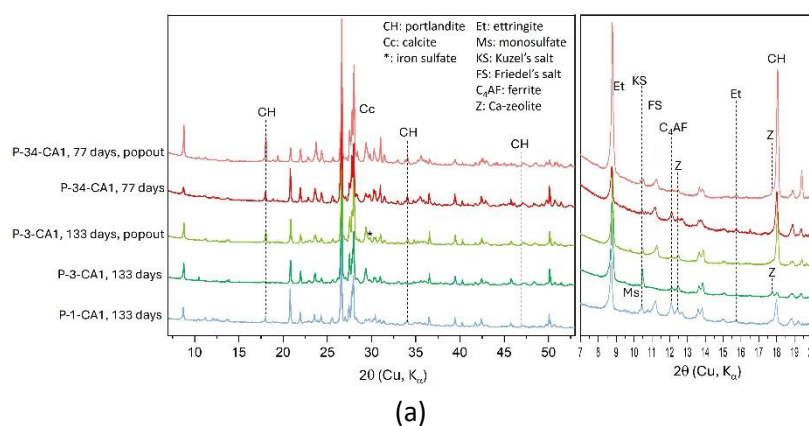
(b)

Microstructural and phase analysis support the trends observed in cracking and stiffness loss. Figure 3.5 (a) presents overlaid X-ray diffraction patterns for P-1-CA1, P-3-CA1, and P-34-CA1 after electrochemical exposure. P-1-CA1, which contained CA1 only in the fine fraction, showed stable hydration phases such as portlandite, ettringite, monosulfate, and Ca-rich zeolite, together with Friedel's and Kuzel's salts formed during chloride exposure [12]. This limited phase evolution aligns with the absence of visible cracking and the stable  $E_{dyn,c}$  observed for this mixture.

In contrast, mixtures containing coarse CA1 exhibited clearer signatures of advanced chemical alteration. Both P-3-CA1 and P-34-CA1 showed higher calcite peak intensities and slight shifts in the Ca-rich zeolite peak, a change that has been associated with the formation of Na,Ca solid solution zeolites such as gismondine in alkaline environments [13]. In this study, the same shift was observed in mixtures that experienced greater deterioration, suggesting that the altered zeolite peak position may serve as an additional indicator of damage. Because cracking typically initiates where mineral transformation is most advanced, further XRD analyses were performed on selected popouts. These fragments contained iron sulfate phases such as ferroxahydrate and romerite, confirming localized oxidation and sulfate-related reactions absent in P-1-CA1.

Figure 3.5: Overlaid X-ray diffraction patterns for P-1-CA1, P-3-CA1, and P-34-CA1 after EAT, showing stable hydration phases in P-1-CA1 and increased calcite and altered Ca-rich zeolite peaks in mixtures containing coarse CA1 (a); SEM images of P-3-CA1 showing the transition from ettringite primarily within pores to a disrupted matrix filled with expansion products after 133 days (b-c); P-34-CA1 showing coarse aggregates surrounded by fibrous expansion phases and microcracking

SEM observations support the XRD results. Figure 3.5 (b-d) shows images of P-3-CA1 and P-34-CA1 after EAT. For P-3-CA1, needle-like ettringite that was initially confined within pores became widespread after 133 days, with expansion products filling the matrix and disrupting the surrounding paste. For P-34-CA1, coarse aggregates were bordered by fibrous reaction products extending into the matrix and nearby pores, and microcracks were frequently observed around these regions. These microstructural features correspond directly to the higher crack lengths and greater stiffness loss measured in mixtures containing coarse CA1, in contrast to the minimal deterioration observed in mixtures with only fine CA1.

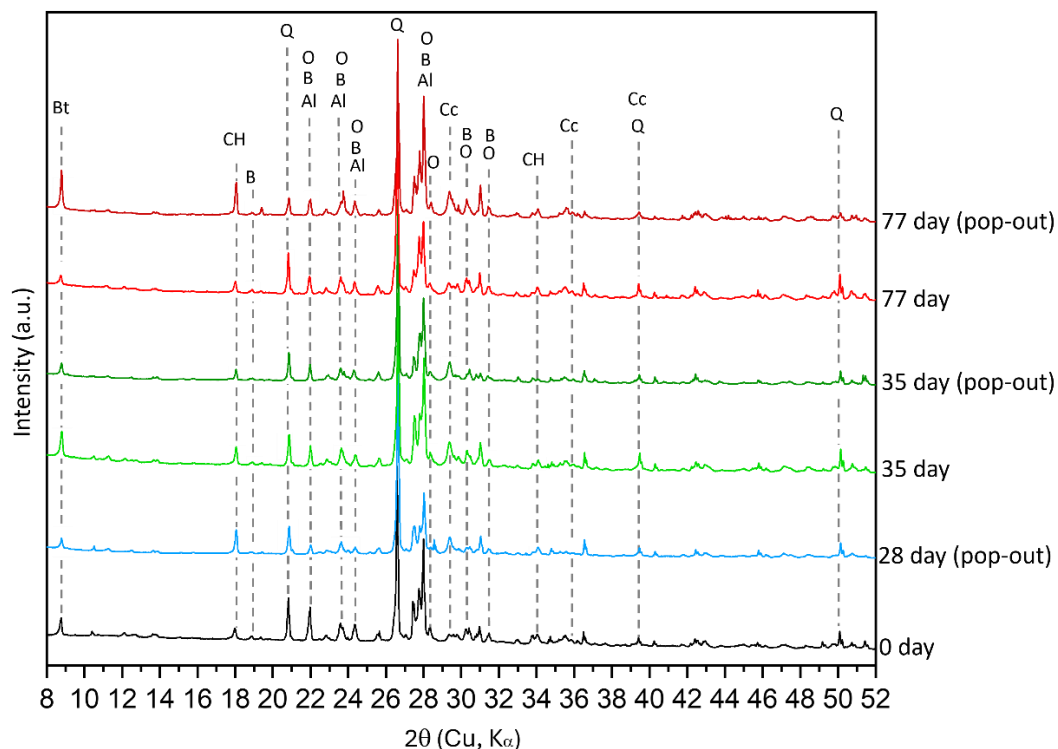
Figure 3.1: XRD pattern of P-34-CA1 samples of different oxidation and carbonation phases (Bt-biotite (9002307), CH-portlandite (9000113), Q-quartz (5000035), Al-albite (9000526), B-bytownite (9011200), O-oligoclase (9011423), Cc-calcite (45024421)).

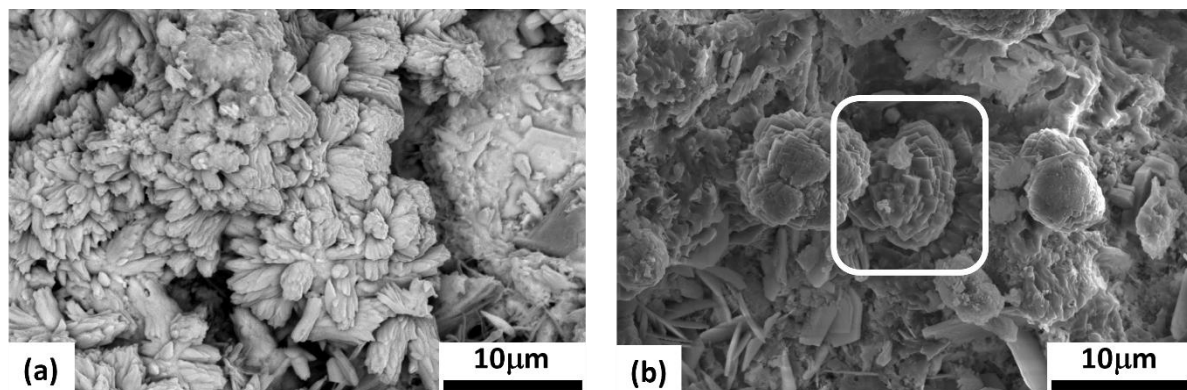
Figure 6.2: SEM of 28 day pop-out of P-34-CA1 sample showing presence of (a) scalenohedral calcite, through-the-lens BSE image, 10 kV and (b) rhombohedral calcite, ETD-SE image, 10 kV.

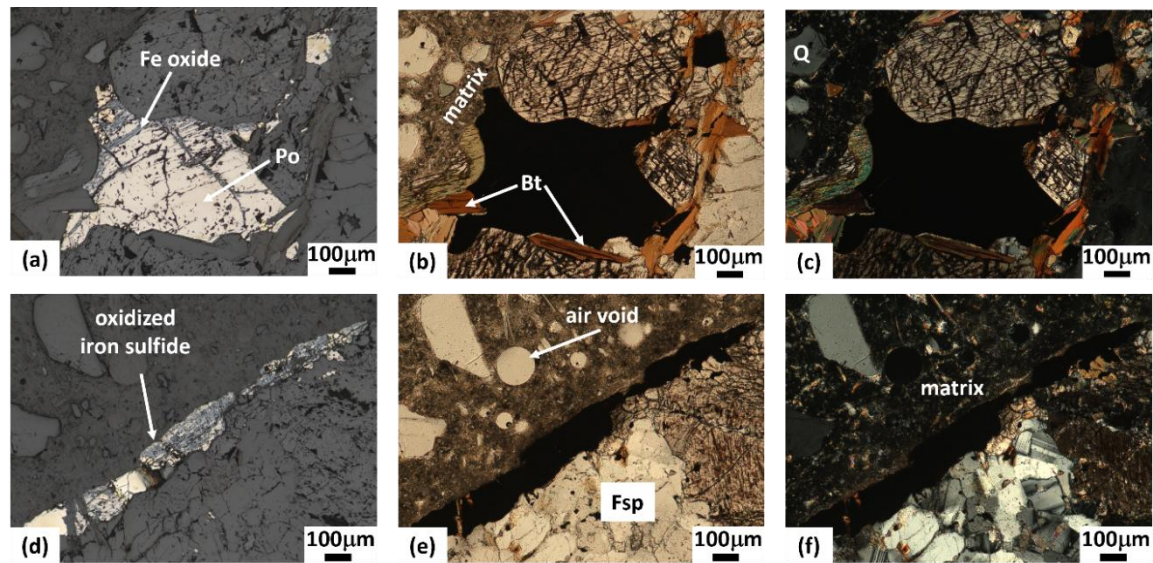
Figure 3.3: Thin section petrographic images of untested P-34-CA1 sample with particular focus on oxidized iron sulfides and its surroundings; (a) and (d) reflected light images, (b) and (e) plane polarized transmitted light images, (c) and (f) cross polarized transmitted light images.  
Key: Po (Pyrrhotite), Bt (Biotite), Fsp (Feldspar), Q (Quartz)

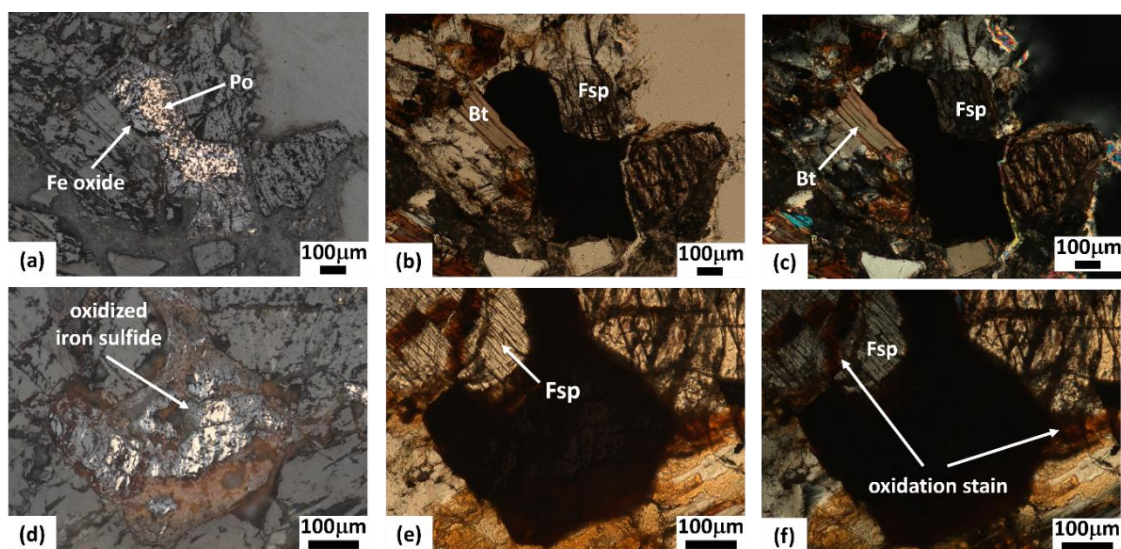
Figure 3.4: Thin section petrographic images of 77 day tested P-34-CA1 sample with particular focus on oxidized iron sulfides with and without adjacent biotite; (a) and (d) reflected light images, (b) and (e) plane polarized transmitted light images, (c) and (f) cross polarized transmitted light images.  
Key: Po (Pyrrhotite), Bt (Biotite), Fsp (Feldspar)

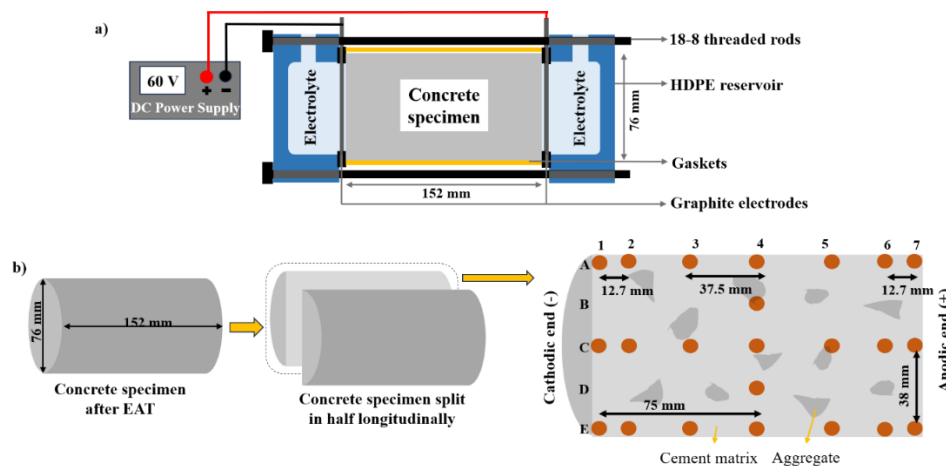
Figure 2.1: (a) Schematic representation of the EAT setup (b) Location and spacing of the spots considered for compositional analysis.

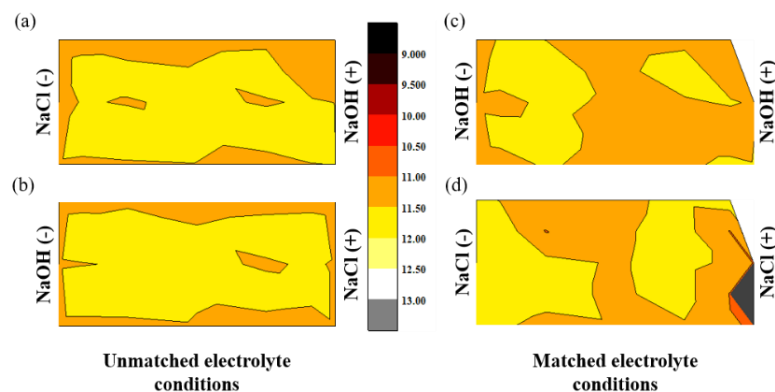
For the four exposed samples, the pH at multiple locations across each specimen (Fig. 3.1) was measured to assess uniform electrolyte transport during testing. In the NaCl/NaOH and NaOH/NaCl (unmatched) exposure conditions, the pH is consistently lower around the electrolyte-facing ends and along the edges (Fig. 3.1: a, b), ranging between 11.0-11.5, whereas pH varies between 11.5-12 in the middle interior matrix. Although the absolute variations were minimal, their spatial concentration at the specimen perimeter suggests non-uniform ionic movement in these configurations. In contrast, specimens subjected to NaOH/NaOH and NaCl/NaCl (matched) exposure showed limited and more localized pH fluctuations (Fig. 3.1: c, d), indicating relatively uniform chemical interaction. These results imply that unmatched electrolyte exposure may influence ionic migration, leading to different chemical alteration in the concrete specimen.

Figure 3.1: Spatial variation of pH measurements in concrete specimens after EAT under four electrolyte configurations: (a) NaCl/NaOH, (b) NaOH/NaCl, (c) NaOH/NaOH, and (d) NaCl/NaCl.

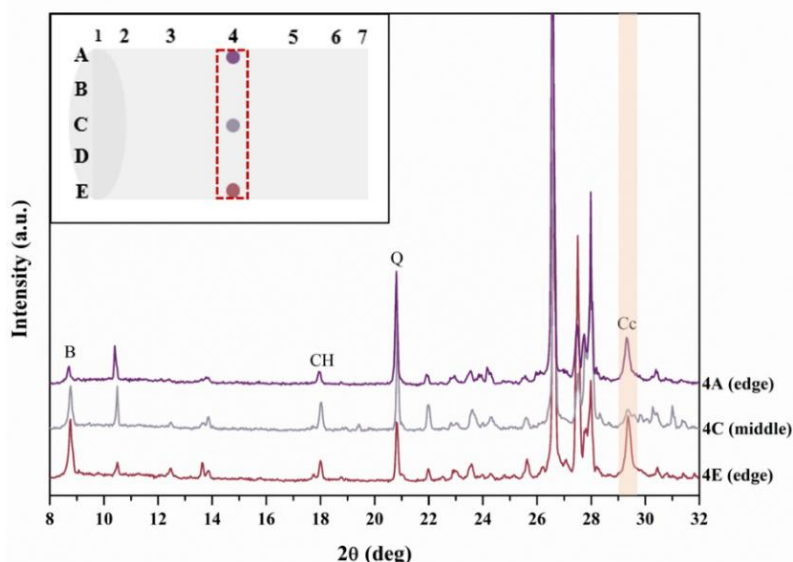
Figure 3.2. XRD pattern of non-accelerated (NA) concrete, showing calcite enrichment near surfaces and limited presence within the matrix. Phase labels: B-Biotite, CH-Portlandite, Q-Quartz, Cc-Calcite

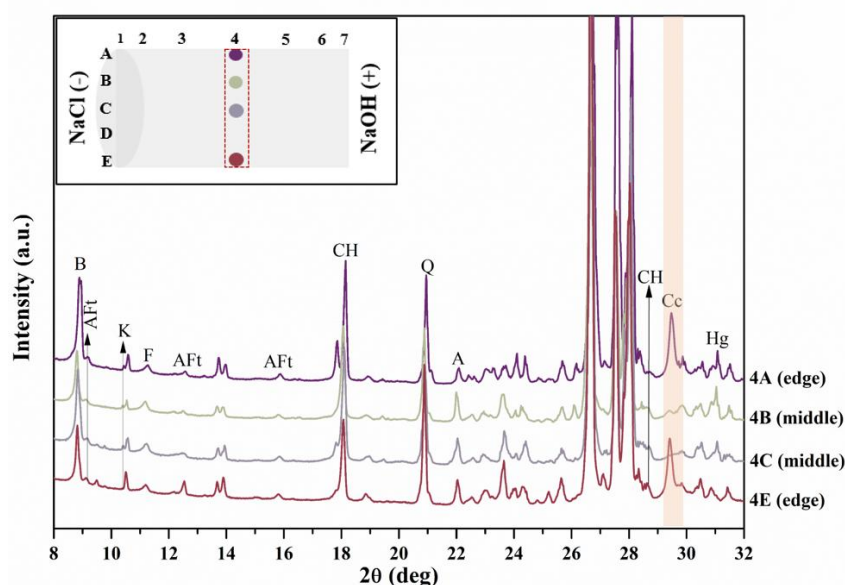
Figure 3.3: XRD profiles comparing interior and peripheral regions of specimens subjected to NaCl/NaOH exposure. Phase labels: Aft-Ettringite & Thaumasite, K-Kuzel salt, F-Friedel salt, A-Albite, and Hg-Hydrogarnet.

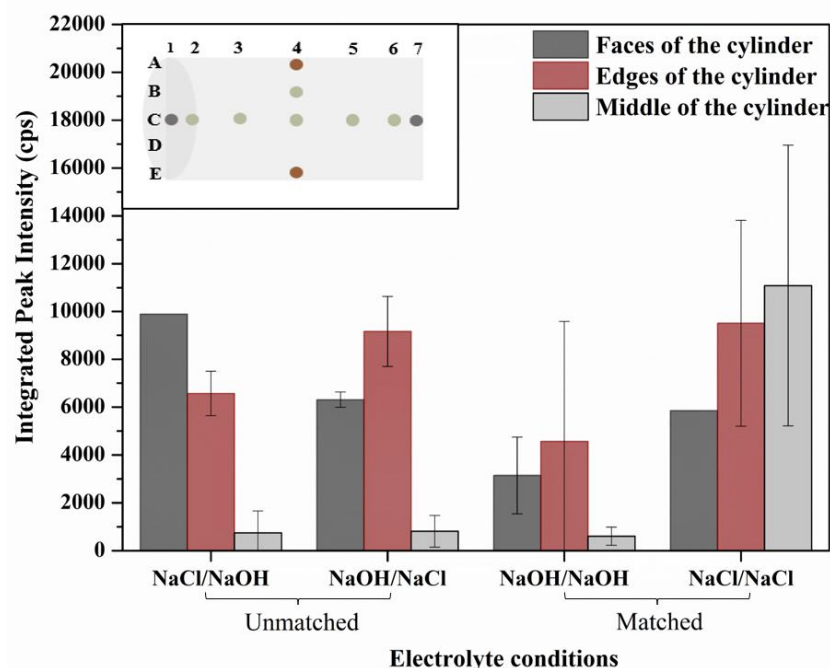
Figure 3.4: Comparison of calcite integrated peak intensities from XRD analysis across matched and unmatched electrolyte exposure configurations, highlighting variations in carbonation progression.

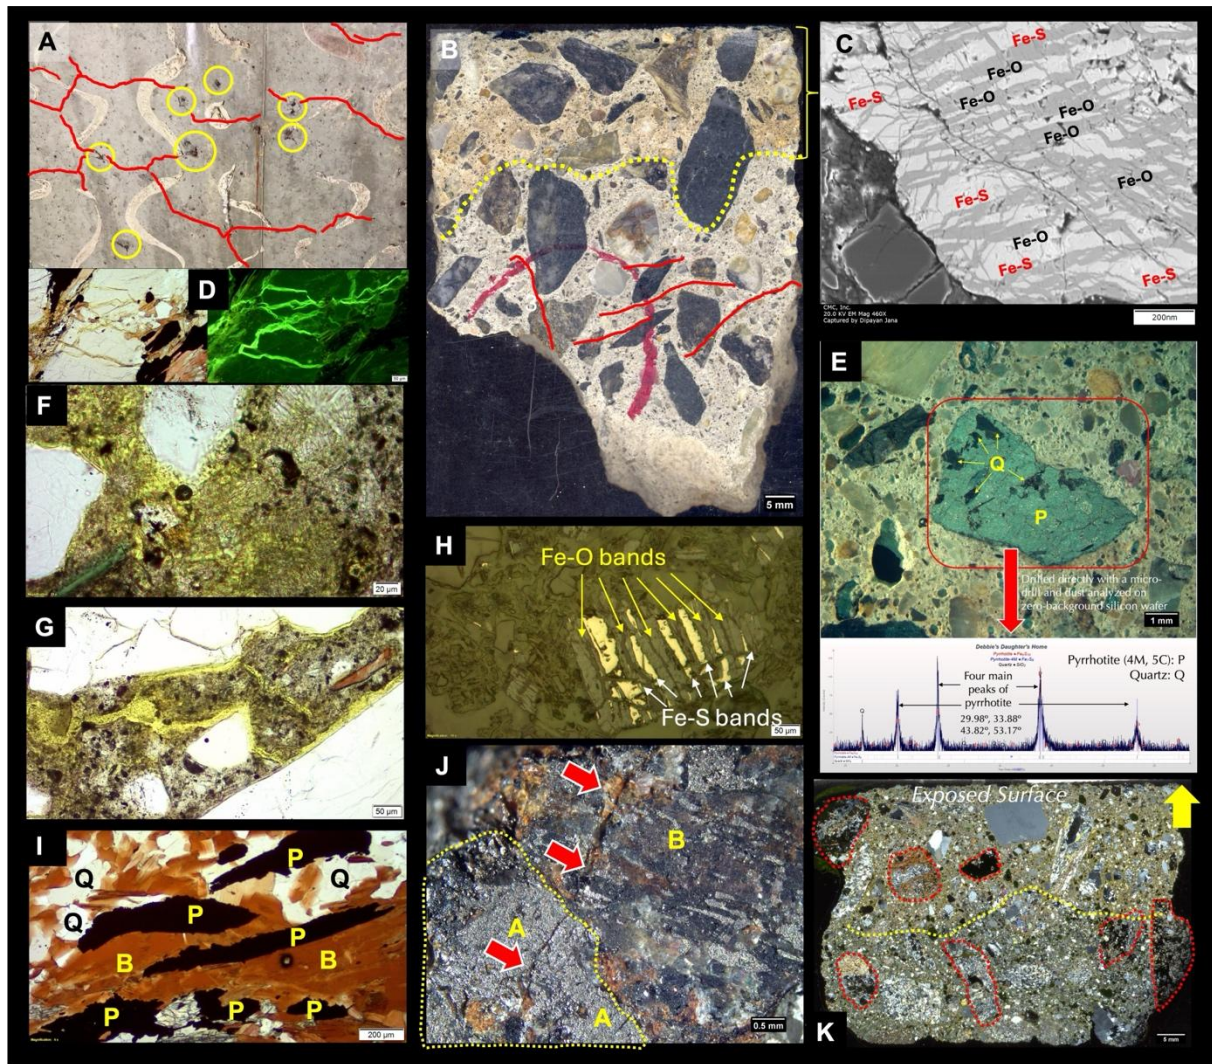
Figure 5: The Vernon, CT home. A: Extensive cracking (red lines) and popouts of oxidized pyrrhotite grains (circled) in the foundation wall. B: A polished concrete fragment showing beige discoloration at the exposed surface end of wall from atmospheric carbonation (depth of carbonation is 30-mm, which is marked by yellow dotted line as the carbonation front); visible cracks are marked with red lines. C: Backscatter electron image of a polished section of extensively cracked oxidized pyrrhotite grain showing alternate darker gray Fe-O and brighter Fe-S bands. D: Micrograph of thin section of an extensively cracked pyrrhotite-bearing coarse aggregate where cracks are highlighted by fluorescent dye in the corresponding image taken in the UV light. E: A sand-size 'chunk' of pyrrhotite with minor quartz inclusions, which has shown a spectacular four-peak diffraction pattern of 4M pyrrhotite. F: Micrograph of thin section showing extensive contamination and mixing of fibrous, acicular ettringite in cement paste, i.e., beyond the usual filling of voids and cracks by secondary ettringite, such ettringite-infested paste is the telltale evidence of ISA in paste. Ettringite-related ISA occurs only in the interior non-carbonated concrete since ettringite is unstable in the carbonated surface region of foundation, G: Cracks extending from unsound aggregates to interstitial paste, which are often filled with ettringite. H: Micrograph of polished section of oxidized pyrrhotite in the reflected-light mode of a petrographic microscope showing alternate Fe-O and Fe-S bands. I: Thin section micrograph showing close association of elongated pyrrhotite grains with biotite flakes in aggregate, where such juxtaposition pyrrhotite within biotite has facilitated easy access of oxygen and moisture for oxidation through the biotite flakes. J: A pyrrhotite 'chunk' in a gneiss coarse aggregate showing one half of less oxidized (marked as 'A') and other half of extensively oxidized pyrrhotite, latter with parallel Fe-S bands (marked as 'B'), and a crack traversing the grain (red arrows) developed from oxidation. K: Large-area (50 × 75 mm) thin section scanned on a flatbed transparent scanner showing pyrrhotite-bearing aggregates (marked by red dotted lines) where thin section was sandwiched between two perpendicular polarizing filters to recreate cross-polarized light view of a petrographic microscope.

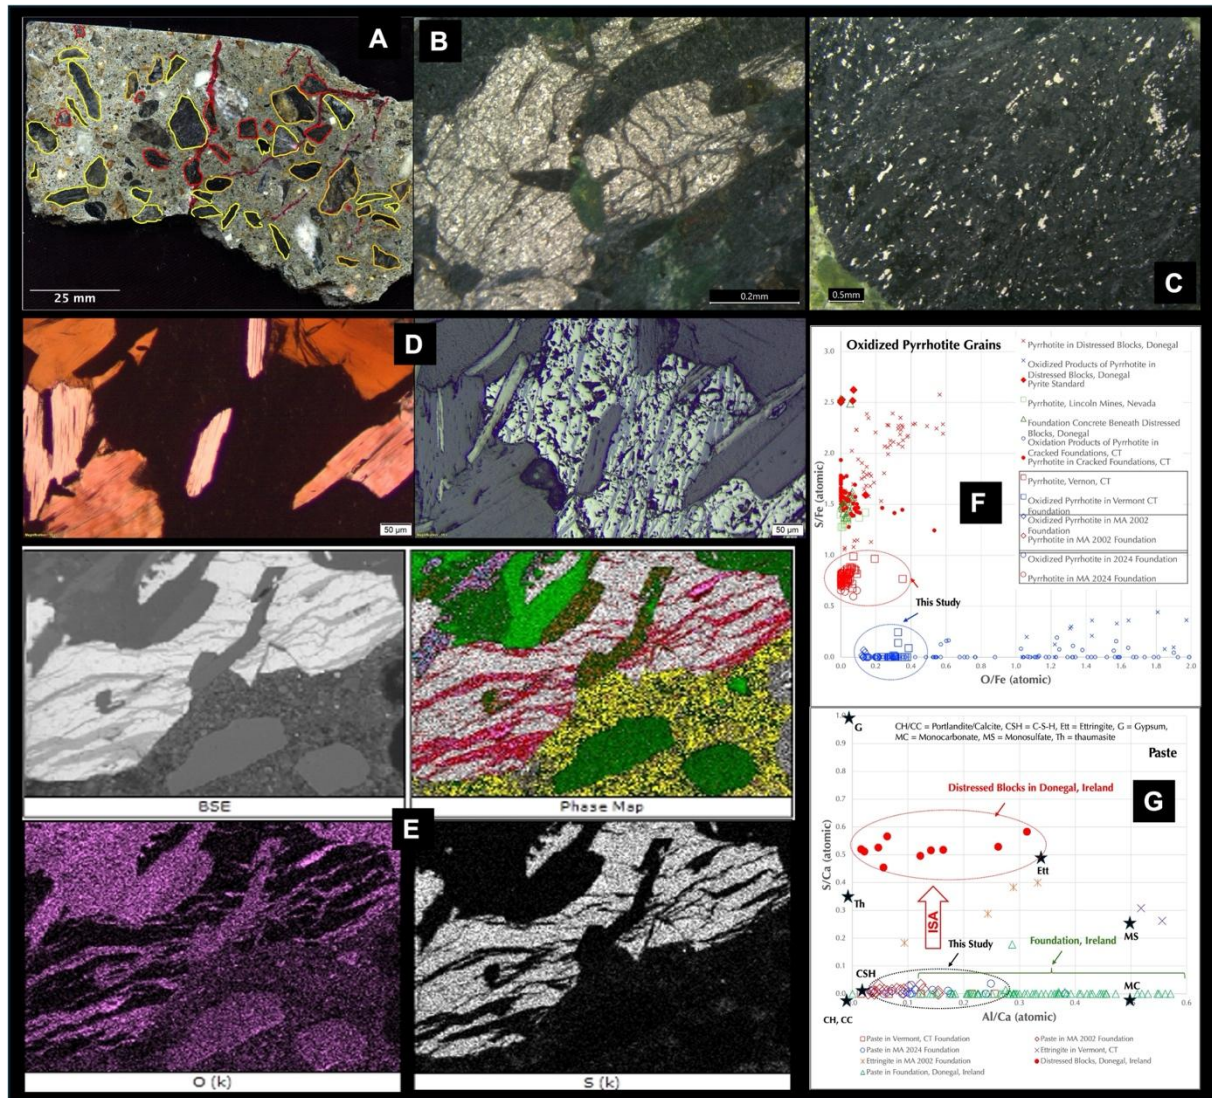
Figure 6: The Rutland, MA foundations. A: Polished cross section of a fragment where extensively and moderately pyrrhotite-bearing schist aggregates are marked by peripheral red and yellow lines, respectively, whereas non-pyrrhotite quartzite aggregates are marked in beige lines; a crack is marked in red line. B: Coarsely crystalline, subhedral to anhedral oxidized pyrrhotite grains showing characteristic striations. C: Finely disseminated forms of pyrrhotite either in random scattered grains or aligned along the weak planes of schistosity. D: Close association of pyrrhotite and biotite often one engulfed into another. E (four images): Backscatter electron image and phase map of an oxidized pyrrhotite from the elemental maps of oxygen (in pink) and sulfur (in white), omitting calcium for paste (in yellow) showing oxidized iron striations in iron sulfide matrix. F: SEM-EDS studies of iron oxide bands in oxidized pyrrhotite grains plotted in S/Fe vs. O/Fe atomic ratios from this study, other crumbled foundations from the eastern CT, and a few distressed concrete blocks and foundations from County Donegal, Ireland. G: SEM-EDS studies of paste showing the absence of elevated sulfate in the paste of dense concrete foundations from the eastern US or in some foundations in County Donegal, Ireland compared to the elevated sulfate levels (S/Ca<sub>atomic</sub> 0.4-0.6) from ISA in the distressed blocks of Ireland. Absence of elevated sulfate in the dense paste of foundations, however, does not necessarily indicate the absence of ISA when all available sulfate in the pore solutions are being used up in formation of ettringite in the confined spaces in paste to cause additional expansion and damage beyond the oxidative damage.

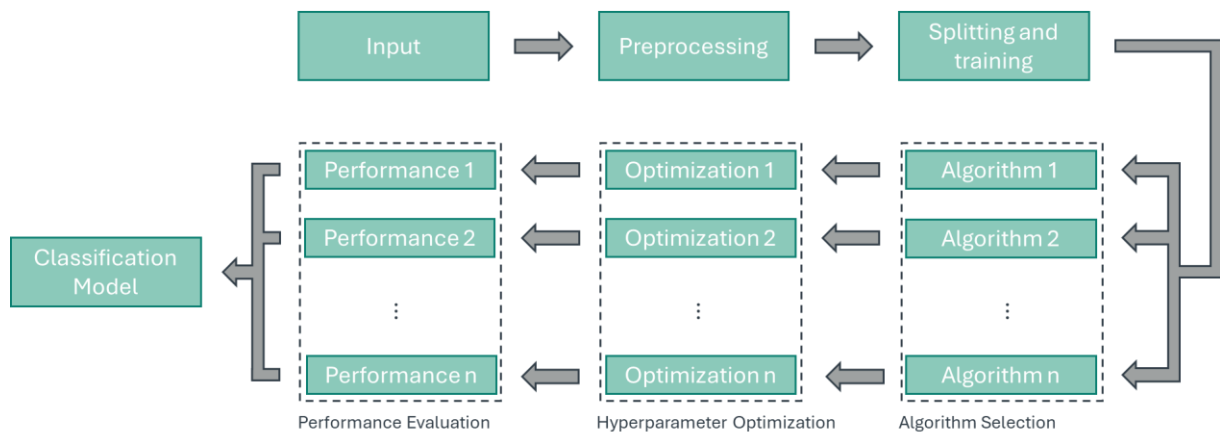
The methodology employed to develop the classification model aims to predict the damage state of concrete elements based on the data collected in this case study. The model is founded on a rigorous approach combining data preprocessing, dataset splitting and training, selection of appropriate algorithms, hyperparameter tuning and performance evaluation using established statistical metrics. Finally, a comprehensive model is proposed, integrating multiple algorithms to enhance predictive robustness. Figure 3.1 illustrates the overall methodological process.

Figure 3.1: Methodological process

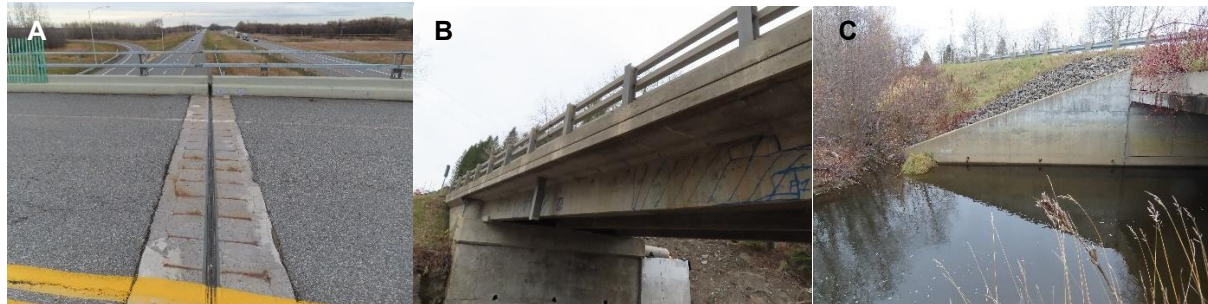
The first structure identified is an overpass constructed in 1979 for which expansion joints were replaced in 2004-2005. Thin concrete repairs were also made on curbs near to the joints (figure 2.1A). The second structure is a bridge constructed in 1957 for which the exterior sides of the deck were rebuilt in 2005 (figure 2.1B). The third structure is a retaining wall built in 2007 at the exit of a culvert (figure 2.1C). Table 2.1 presents the theoretical concrete mix designs used in each project.

Figure 2.1: Structures with concrete containing sulfide-bearing aggregates. A) Structure 1, B) structure 2 and C) structure 3.

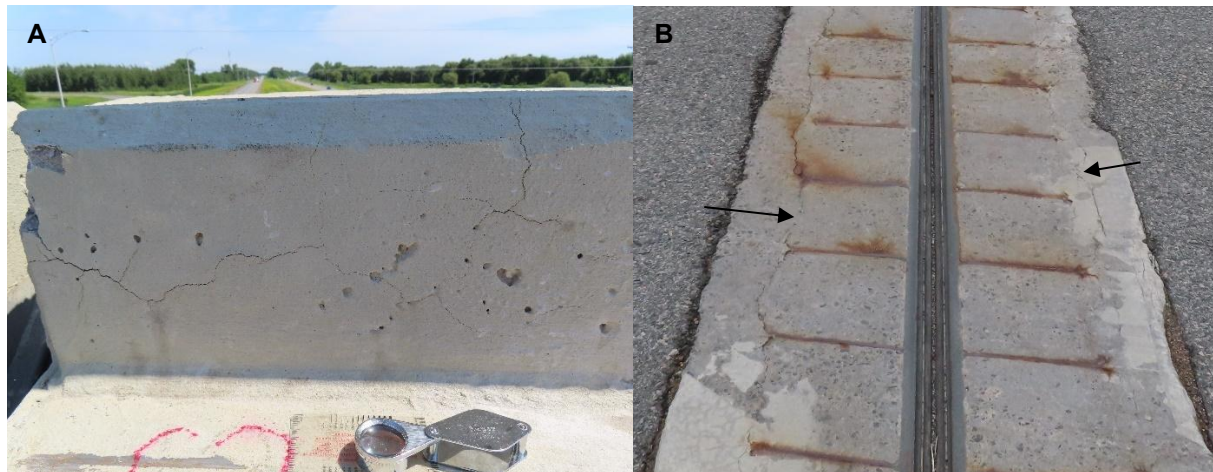
Figure 4.1: A) Polygonal cracking pattern on thin repairs on the curb. B) Large crack at the end of the steel plates of the expansion joint.

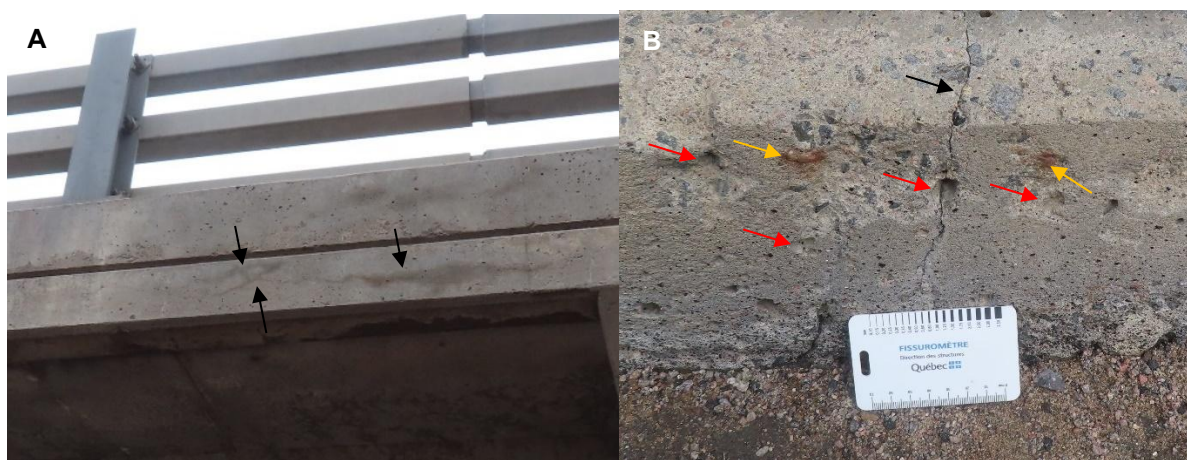
Figure 4.2: A) Longitudinal cracks on the exterior side of the deck. B) Vertical crack (black arrow), rust stains (orange arrows) and pop-outs (red arrows) on the curb.

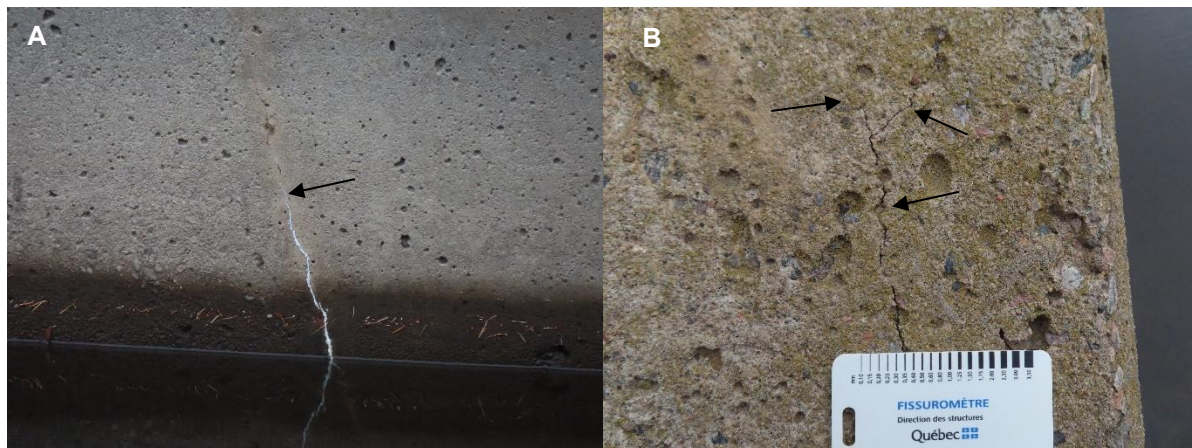
Figure 4.3: A) Vertical crack with efflorescence product. B) Longitudinal crack on the top of the wall.

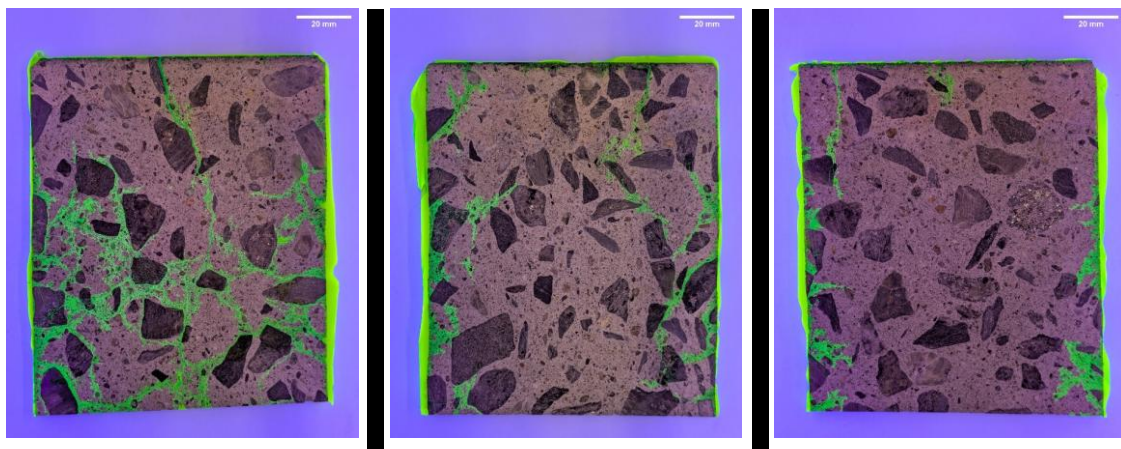
Figure 4.7: Photographs of the core sections of 705-F1, 709-F1, and 707-F1 from left to right under UV light. Interior slices are above with the interior wall edge at the top, and exterior slices are below with the exterior wall edge at the bottom. The field of view for every image above is 129 mm x 158 mm

In Figure 4.7, it is clear there is damage in all core sections, and cracks appear over the entire thickness as found by Jana [1, 2]. Cores 705-F1 and 709-F1 exhibit considerably more damage than 707-F1, which is furthest from a wall corner and has the lowest damage area fraction, 3.5 % (2.7 %, 4.0 %). 705-F1 is the closest to a wall corner and has the largest damage area fraction, 14.3 % (10.5 %, 16.7 %). The sections of 709-F1 are the only pair of the three that shows a larger than 1 % difference of the average between the interior and exterior slice, with the exterior slice damage area fraction nearly double that of the interior. In general, damage area fractions of the two faces of the same section are quite comparable, with maximum absolute differences near 1 % for all measures. In 709-F1, the analysis over the wall thickness (length of the core) on the interior section gives damage area fractions that are not drastically spatially separated. The minimum damage area fraction of the 20 mm length subsections is 4.2 % (2.8 %, 5.0 %) centered at roughly 30 mm from the wall interior, while the maximum of 9.8 % (6.9 %, 11.7 %) is centered roughly at 50 mm from the wall interior. The analysis of the exterior section on the other hand, shows considerable differences. The subsections over the 60 mm closer to the wall exterior all show substantially lower damage area fractions. The minimum damage area fraction of 1.1 % (0.6 %, 1.4 %) is centered at roughly 10 mm from the exterior edge, while the maximum of 24.8 % (17.6 %, 29.1 %) is centered at 90 mm from the exterior edge. Qualitatively, the photographs of the other two cores also suggest more damage over the middle. The lower damage, in the vicinity of the wall interior edge, may be a result of carbonation in this area.

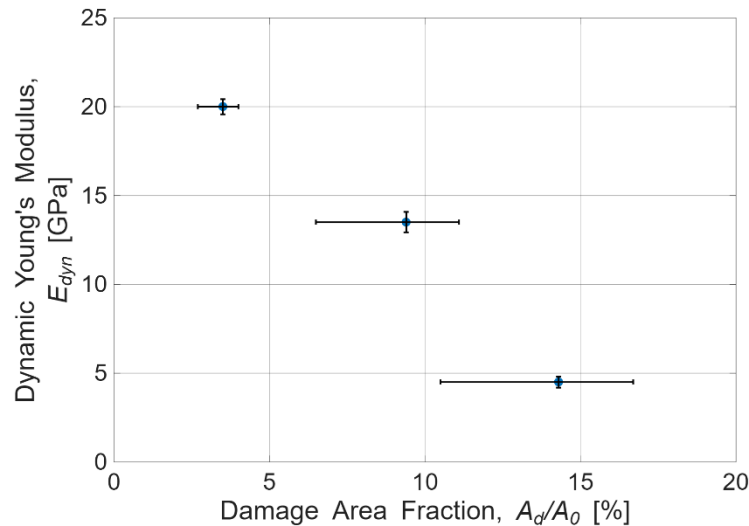
Figure 4.8 plots the longitudinal mode dynamic Young's modulus,  $E_{dyn}$ , against the damage area fraction,  $(A_d/A_0)$ . The vertical error bars are the standard deviation of the three RFT measurements,

while the horizontal bars show the minimum (mode as the lower brightness threshold) and maximum (zero as the lower brightness threshold). The trend is as expected, with the dynamic Young's modulus decreasing as the damage area fraction increases. Additionally, in Figure 4.8 the thresholding methods differ more greatly as the damage area fraction increases.

Figure 4.8: The dynamic Young's modulus (longitudinal mode) against the damage area fraction. Vertical error bars are plus/minus the standard deviation of the three, while horizontal error bars show the minimum and maximum of the damage area fraction from the four methods.

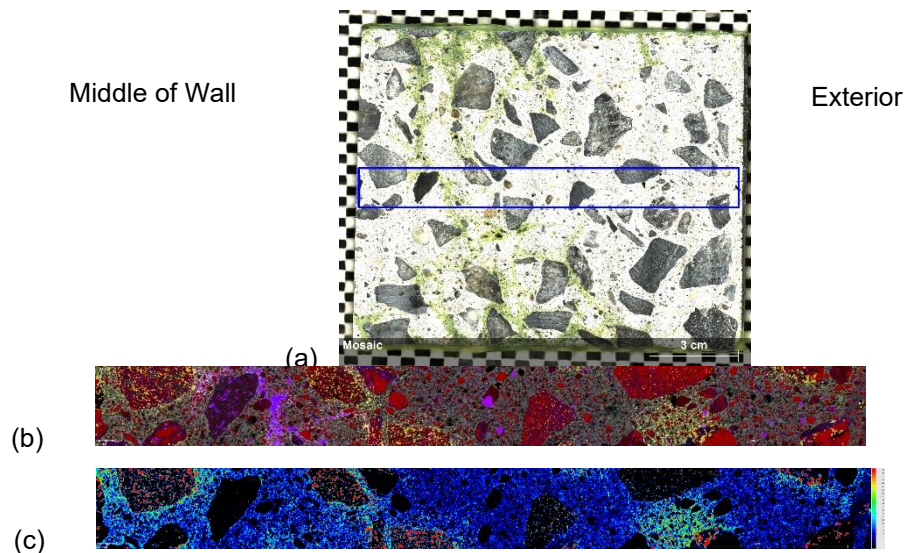
Figure 4.3: (a) The imaged subsection of the 709-F1 exterior slice; the middle of the wall is on the left and the exterior wall edge is on the right; this is consistent in subsequent images (field of view: 139 mm x 120 mm). (b) A  $\mu$ XRF chemical map of the subsection (Ca – green, Si – brown, S – yellow, Cl – purple; field of view: 128 mm x 13 mm). (c) The heat map of sulfur concentration from the  $\mu$ XRF; red is high and black is low (field of view: 128 mm x 13 mm)

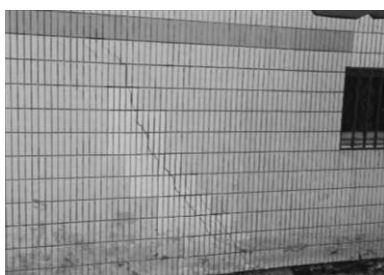
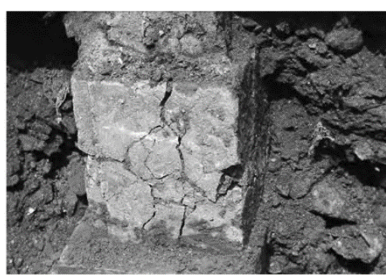
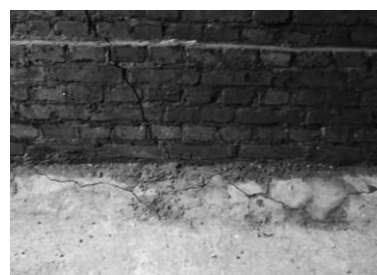
Figure 2.1: Deterioration characteristics of masonry residential building 1 [2]

Shortly after the building was put into use, cracking occurred in some ground-floor walls. In 2015, an inspection was conducted by a qualified agency, which revealed that wall cracks were mainly concentrated on the first floor, most of which were diagonal cracks (Figure 2.1a). The crack widths ranged approximately from 1 to 10 mm, and no distinct pattern was observed in the orientations of the diagonal cracks. The inspection concluded that the wall cracking resulted from differential foundation settlement. In 2016, a company was hired to strengthen the foundation. However, during the strengthening process, after excavation of the foundation, it was discovered that the foundation exhibited extensive map cracking, with local crack widths reaching 5–10 mm. At all locations where severe foundation cracking was present, the overlying walls also exhibited severe diagonal cracking (Figure 2.1b and c).

(a) Diagonal cracking of walls

(b) Cracks at the base of the tie column

(c) Cracking in the foundation

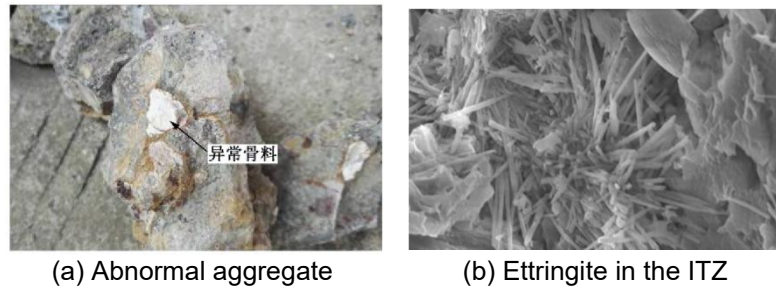
After chiseling open the foundation concrete at several cracked locations, it was found that the concrete aggregates contained abnormal aggregates (Figure 2.2a). Portions of the abnormal aggregates were extracted, ground into fine powder, and subjected to X-ray diffraction (XRD) analysis. The results indicated that the main crystalline phases of the abnormal aggregates were alunite and quartz. Samples containing the interface between the white aggregate and the cementitious matrix were examined by scanning electron microscopy (SEM). A large number of needle-like ettringite crystals could be clearly observed at the interface between the white aggregate and the cementitious matrix (Figure 2.2b). It was concluded that the premature deterioration was primarily attributable to delayed ettringite formation resulting from alunite-bearing coarse aggregates.

Figure 2.2: Abnormal aggregate from building 1 and ettringite in ITZ [2]

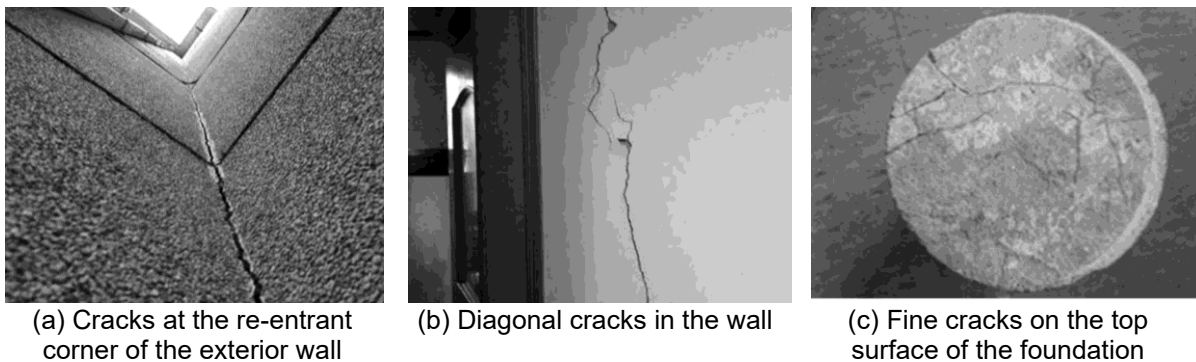
In 2006, foundation strengthening was carried out. However, within several years after the foundation strengthening, cracks in the upper-structure walls developed rapidly. By 2012, severe vertical cracks were observed at the intersections of longitudinal and transverse walls near the central part of the north façade, as well as at similar wall intersections in the central interior of the building (Figure 2.3a). The crack widths were relatively large in the lower stories, generally ranging from 3 to 8 mm, and extended upward to the fourth and fifth floors. In addition, vertical cracks were also present in most exterior longitudinal walls and at window corners, with more severe cracking at the lower floors (typically 2–8 mm in width) and relatively minor cracking at the fourth and fifth floors (Figure 2.3b).

Figure 2.3: Deterioration characteristics of masonry residential building 2 [2]

To clarify the cause, partial excavation of the foundation was carried out. It was found that multiple irregular fine cracks were present on the exposed foundation surface, as shown in Figure 2.3c. Grayish-white abnormal aggregates were identified within the concrete aggregates (Figure 2.4a). X-ray diffraction (XRD) results indicated that the abnormal aggregates were mainly composed of alunite. Scanning electron microscopy (SEM) analysis of the gray material surrounding the alunite revealed that these gray phases were primarily composed of ettringite.

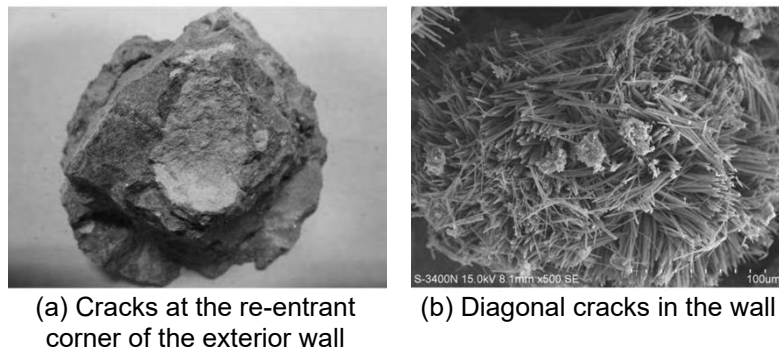
Figure 2.4: Abnormal aggregate from building 2 and ettringite in ITZ [2]

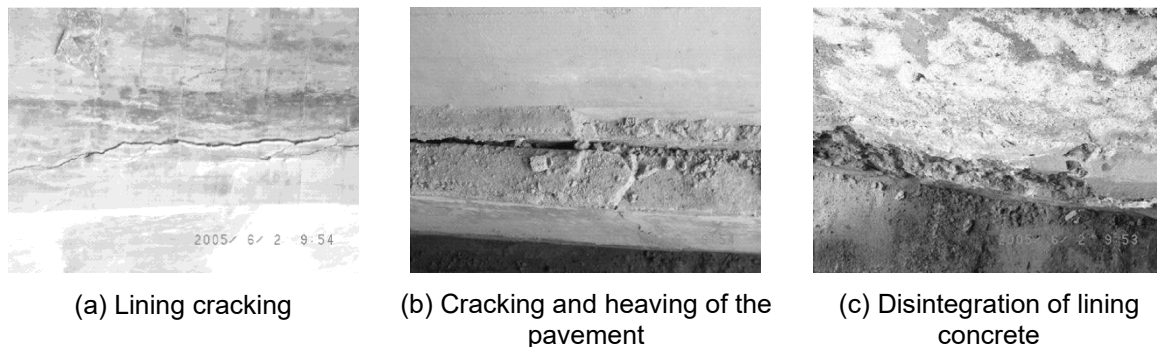
The Shiziya Tunnel is a key control project of the Taixi section of National Highway G209, located in Badong County, Hubei Province, China. The tunnel has a total length of 453 m. Construction commenced on October 12, 2002, and full breakthrough was achieved by late May 2003, after which the tunnel entered the trial operation stage. However, severe deterioration was observed within one year after it was opened to traffic. Typical characteristics of deterioration are shown in Figure 3.1. The tunnel lining cracked and was accompanied by seepage, dripping, and formation of white deposits (Figure 3.1a). The maximum pavement heave reached 124 mm and the crack opening width has reached 20~40 mm (Figure 3.1b). Under locally humid conditions, the deterioration of the tunnel lining concrete was significantly accelerated, leading to disintegration of lining concrete (Figure 3.1c).

Figure 3.1: Typical deterioration characteristics of Shiziya Tunnel [3]

The excavation of the Shiziya Tunnel significantly disturbed the original groundwater recharge, runoff, and drainage regime, turning the tunnel base into a groundwater discharge surface and flow-concentration corridor. The resulting groundwater accumulation played a critical role in inducing the tunnel deterioration. Subsequent inspections revealed that the aggregates used in the tunnel structure and pavement concrete are gypsum-bearing dolomite aggregate [4]. Under wet or humid conditions as in this case, ettringite and thaumasite were formed in the ITZ, leading to a severe reduction in concrete strength. Consequently, localized concrete exhibited black discoloration, cracking, and spalling.
