# 2ND INTERNATIONAL CONFERENCE ON IRON-SULFIDE REACTIONS IN CONCRETE

## Proceedings

The 2nd International Conference on Iron-Sulfide Reactions in Concrete — ICISR 2026 — was hosted by the University of Connecticut in Mystic, Connecticut, USA, from May 12 to 14, 2026. Building on the foundation established by the first ICISR, held at Université Laval in Quebec City, Canada, in 2024, ICISR 2026 continued this international exchange by bringing together researchers, practitioners, public agencies, industry partners, homeowners, and policy stakeholders.

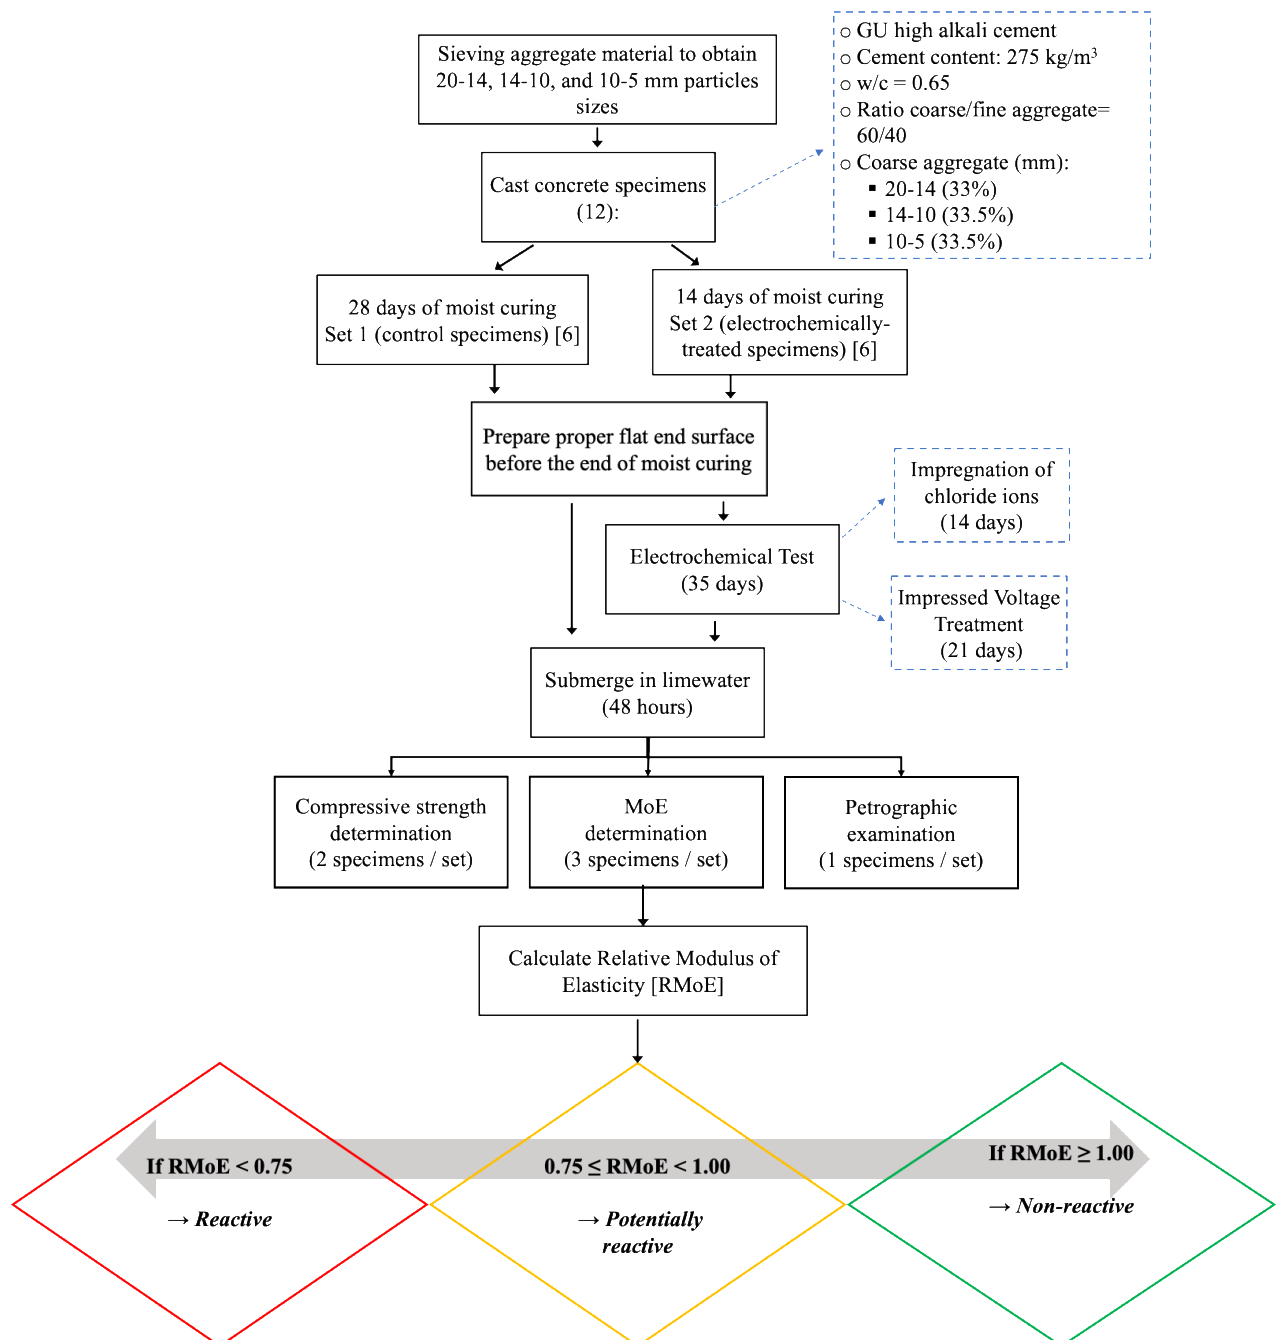
Figure 3.1: Electrochemical testing scheme proposed by Castillo Araiza et al. [5].

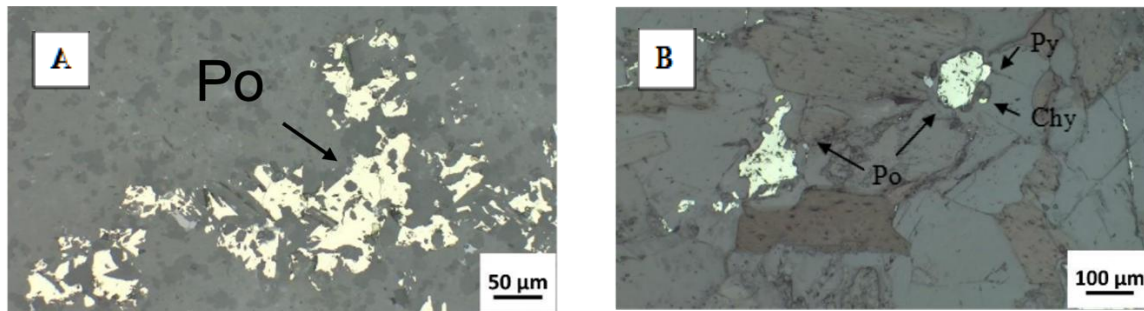
The findings from the petrographic examination and chemical analysis of each aggregate are summarized in Table 4.1. Reflected light petrography confirmed the presence of iron sulphide minerals in almost all of the investigated aggregates (Figure 4.1). The sulphide mineral phases identified in the samples include pyrite (Py), pyrrhotite (Po), chalcopyrite (Cpp) and pentlandite (Pn).

Figure 4.1: Reflected light micrographs. Po: Pyrrhotite Py: Pyrite; Chy: Chalcopyrite. [A] Epidote hornfels (C). [B] Coarse-grained garnet gneiss (M).

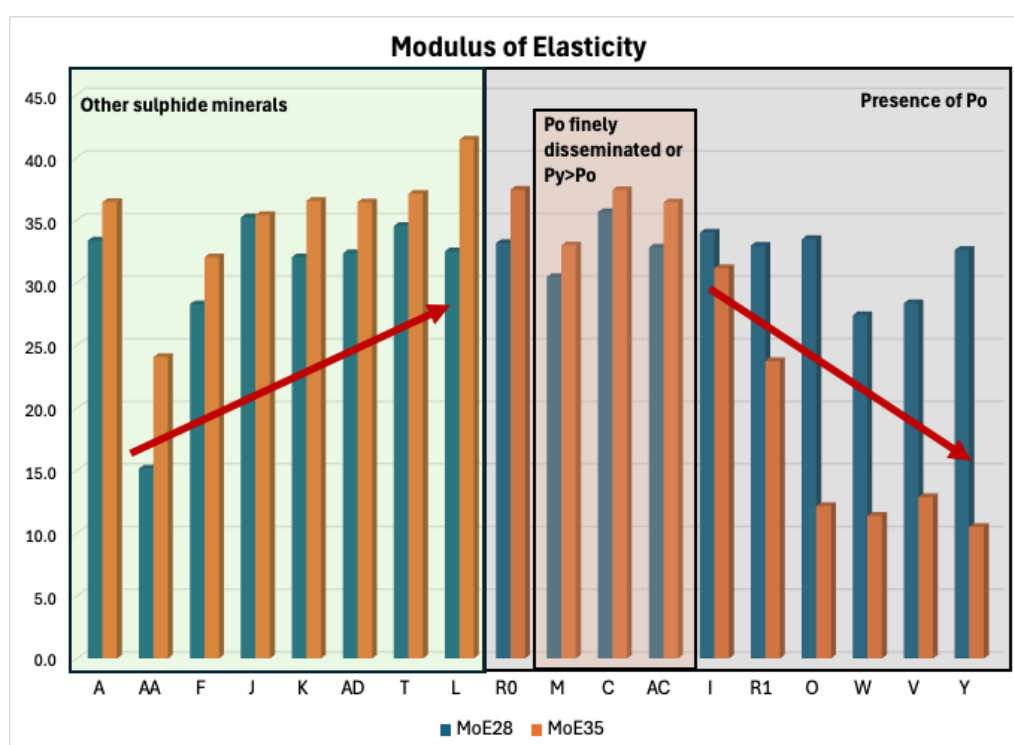
The results of modulus of elasticity (MoE) determination are presented in Figure 4.2. The MoE values of the control concrete specimens vary from 15.2 to 35.6 GPa due to the specific mechanical and mineralogical characteristics of the aggregate sources. Interestingly, the MoE of concrete specimens incorporating aggregates without Po and those with small amount (R0) or finely disseminated Po increased following the electrochemical treatment (by 6% to 58%). This resulted in RMoE values of 1.0 or higher (Table 4.2) suggesting limited damage in the test specimens,

On the other hand, the MoE associated with high  $T_s$  and pyrrhotite-bearing aggregates decreased significantly following the electrochemical treatment (by -28% to -68% in the worst case) (Figure 4.2). They thus displayed RMoE values ranging from 0.72 to 0.32 (Table 4.2).

Figure 4.2: MoE values of control concrete specimens (blue bars) vs concrete specimens subjected to electrochemical testing (orange bars).

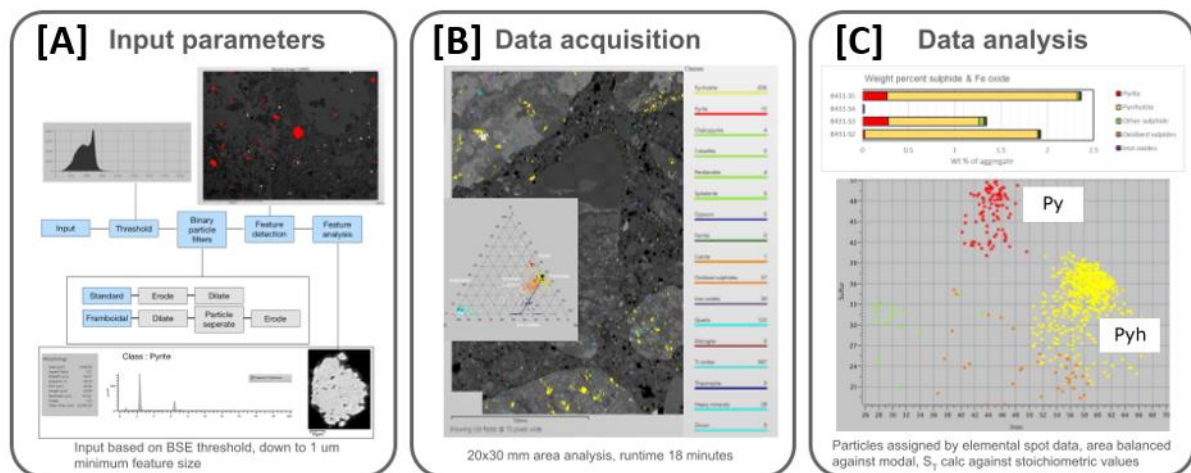
Figure 3.1: [A] Summary of TPS input parameters including binary filter stacks [B] TPS scan of Connecticut foundations highlighting pyh [C] Py & Pyh elemental splits for a PHY sample

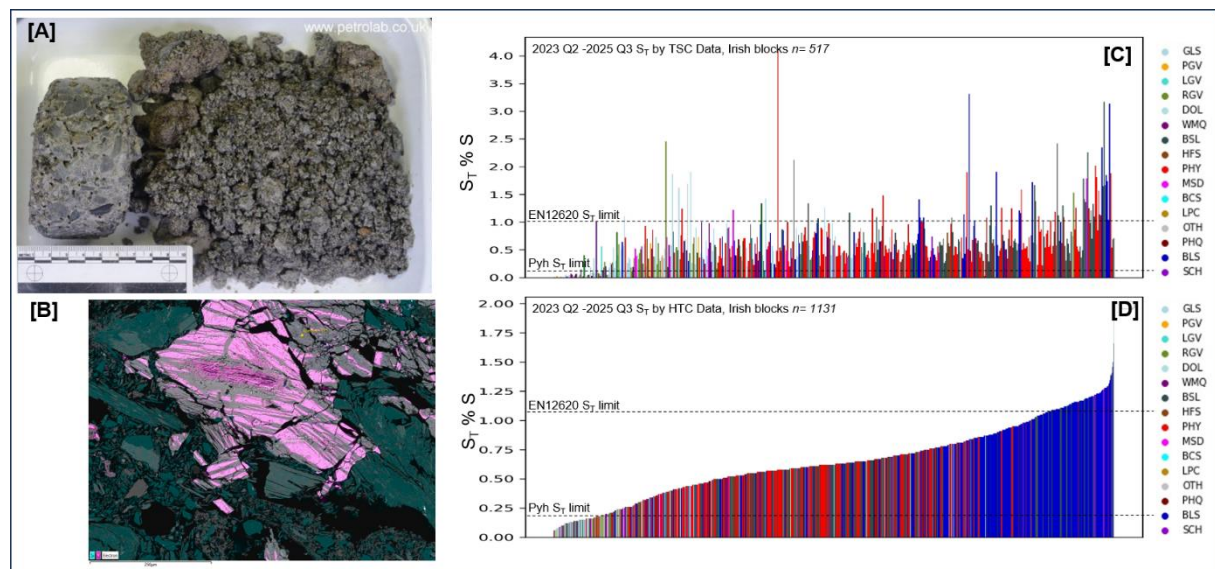
An overview of the SEM determined  $S_T$ % equivalent values and HTC chemistry results (adjusted for 0.1% S contribution from cement) by lithology code is given in Figure 4.1, In total n=517 samples with both EN 1744 HTC sample results and TSC SEM results have been considered, with TSC analysis undertaken by Petrolab, and EN1744 HTC analysis undertaken by two accredited laboratories.

Figure 4.1: [A] Example PHY core [B] oxidised pyh in PHY aggregate [C] TSC determined  $S_T$  results coloured by lithology code and arranged by ascending HTC S% [D] HTC determined  $S_T$  results coloured by lithology code arranged by ascending HTC S%.

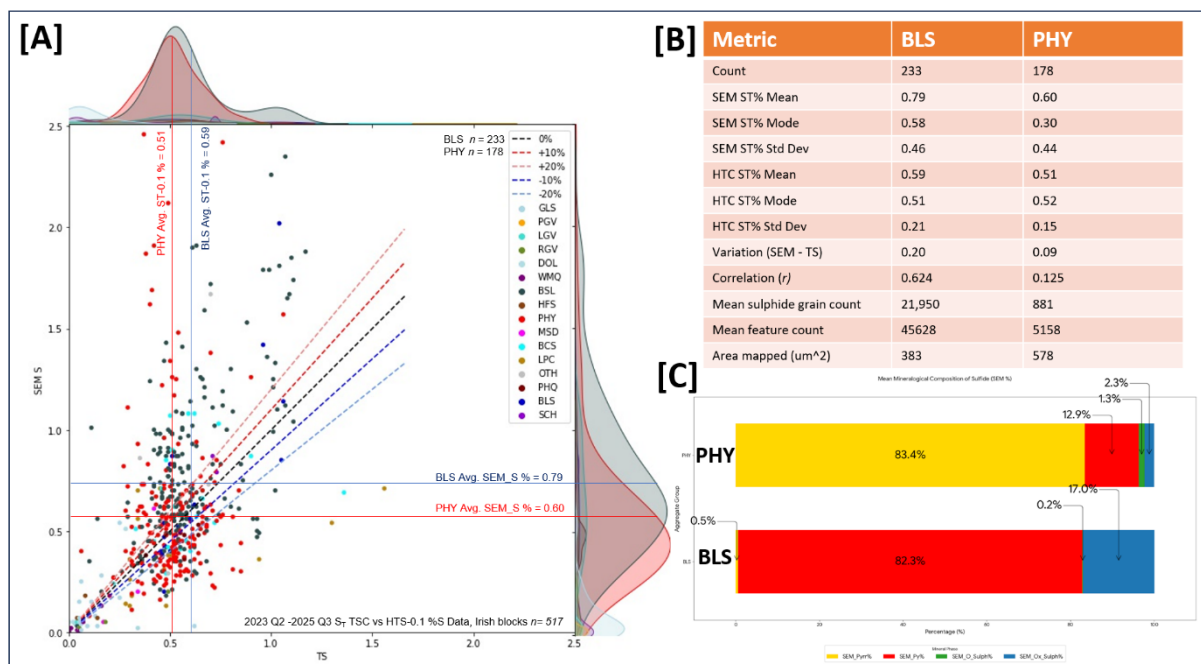
Figure 4.2 exploring the results for all lithologies with a focus on the PHY and BLS lithologies, including key statistical values and metrics across the dataset. As overall determined values are not known for the material in question and considering the findings of the repeatability and reproducibility study, comparison against the mean HTC value is deemed the most appropriate comparison, noting that both values are imperfect metrics in different ways. Correlation figures (*Pearson* coefficient -  $r$ ) between the two suggests a stronger correlation of results for BLS analysis than for PHY analysis. Standard deviation values are fairly consistent between the lithologies by technique, with the SEM determined values giving a higher standard deviation result.

As part of the mineral classification scheme several criteria were used to differentiate compositionally similar sulphide species, a mean of the returned dataset is given in Figure 4.2 C. Differentiation of pyrite and pyrrhotite was achieved using an Fe range classification (e.g. Figure 3.1 C), with further proportional checks to ensure Fe always exceeds S within a pyrrhotite classification, in addition to management of py and pyh positions within the mineral list hierarchy. Within the pyh dominated PHY classification a 6C monoclinic structure close to troilite is predominant. The large variation in Fe to S elemental proportion allows for reliable distinction between the two phases with proportions being consistent with those identified in reflected light for the PHY lithology. Within the BLS lithology py classifications are dominant, however pyh is seen associated with some County Mayo BLS material where a crosscutting cpy-py-pyh bearing dolerite dyke intersects the quarry. Interestingly rare samples are identified with major very fine anhedral and framboidal pyh. Whilst initially considered to be a classification error, pyh was confirmed by detailed EDX point analysis and reflected light analysis, contextually representing alteration of original framboidal py within a high temperature de-sulphidation “skarn-style” alteration [9] halo around the dolerite dyke. As such, the TPS is considered to provide reliable rapid speciation of py and pyh in the context of the examined Irish samples. Oberhardt et al [10] note unsatisfactory splitting of py and pyh solely on Fe concentration during analysis of Maskimo material. In this case the pyh composition is much closer in Fe content to the py than in the Irish samples, and phases are also notably more intergrown, necessitating an additional backscatter electron grey-level filter at thresholding stage to fully distinguish phases.

Figure 4.2: [A] ST TSC vs HTC-0.1%S Data, Irish blocks with modal distribution plots [B] key metrics for PHY and BLS groups [C] mean sulphide proportions for groups from mass data

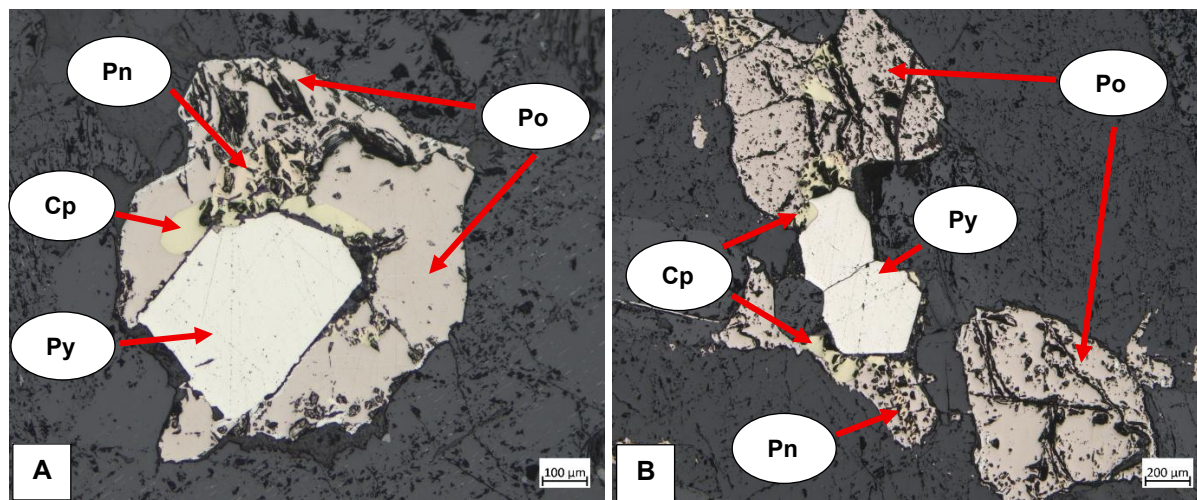
Reflected-light microscopy is performed on the polished pucks at magnifications of up to 1000×. Pyrite, pyrrhotite, chalcopyrite, and pentlandite are distinguished based on characteristic reflectance, color, pleochroism, bireflectance, relief, and anisotropy (Figure 2.1). Pyrite typically appears yellow-white with a smooth texture and weak anisotropy; pyrrhotite displays a creamy pinkish-brown color, higher reflectance, common pitting, and pleochroism; chalcopyrite exhibits a brassy-yellow appearance with weak anisotropy; pentlandite shows a creamy white color with a pinkish to brownish tint and is isotropic [7]. The images can be entered into image software and colorized to calculate the relative percentage of each mineral type by area percent.

Figure 2.1: Representative reflected light images of iron-sulfide minerals. **A)** A single grain composed of four distinct iron-sulfide mineral phases: pyrrhotite enveloping pyrite, chalcopyrite, and pentlandite.

**B)** Pyrrhotite exhibiting its creamy pinkish-brown hue with pitted texture, pyrite showing a smooth, bright reflective texture, and chalcopyrite displaying a brassy yellow; pentlandite is also present. Key: Py = pyrite; Po = pyrrhotite; Cp = chalcopyrite; Pn = pentlandite.

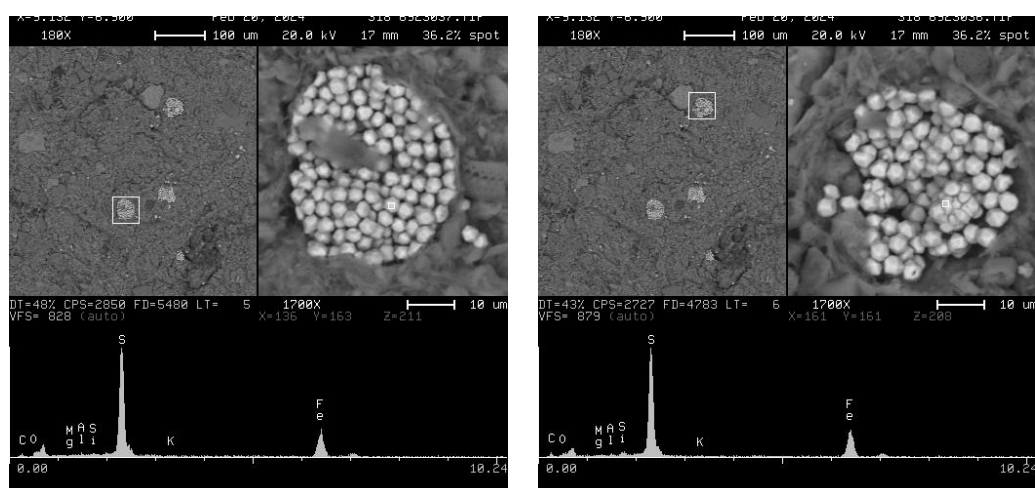
images of framboidal pyrite are shown in Figure 2.2, depicting the type of morphology that SEM/BSE imaging can identify with greater confidence than reflected light alone.

Figure 2.2: Backscattered electron (BSE) images with EDS spectra showing framboidal pyrite composed of packed, rounded microcrystals.

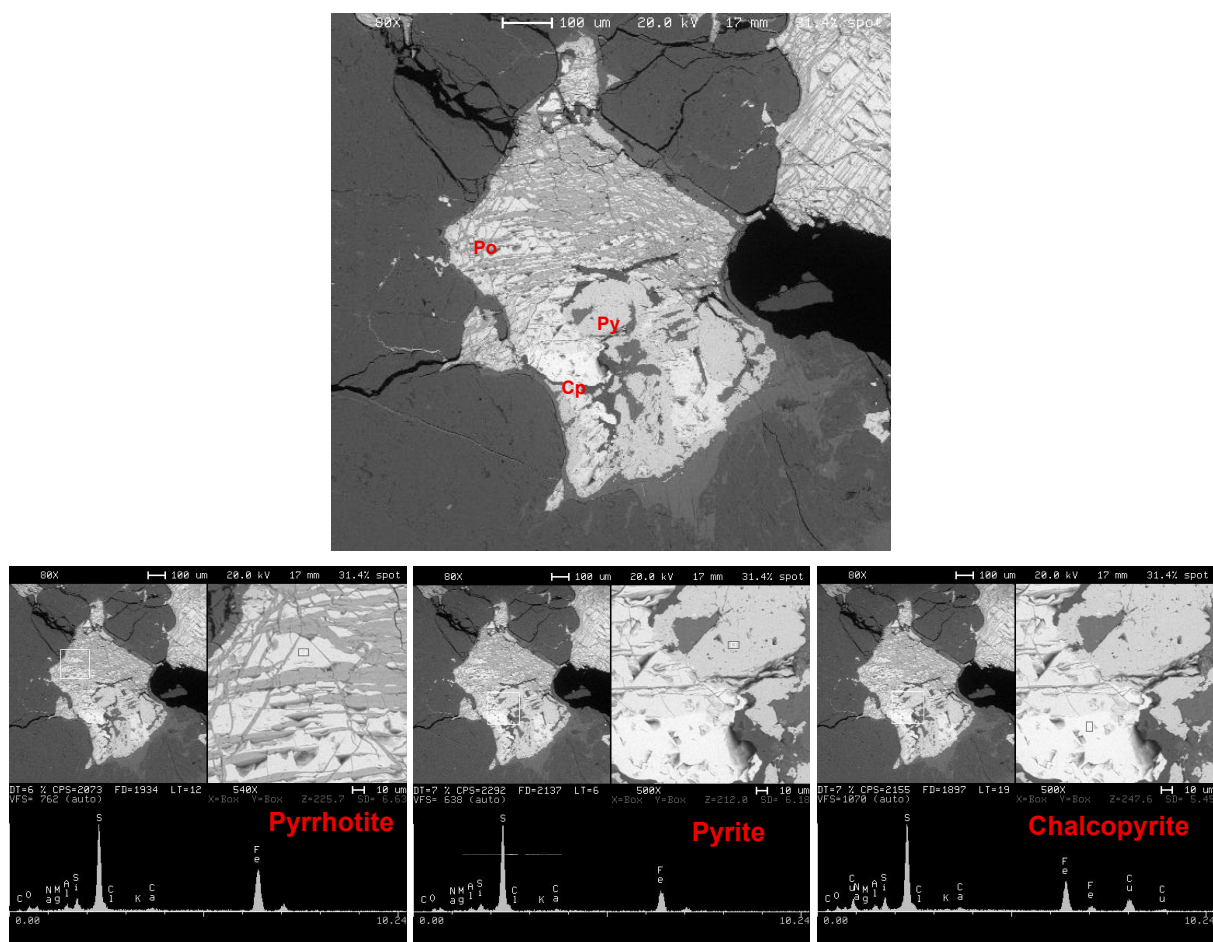
SEM/EDS also enables qualitative evaluation of Fe–S ratios and trace elements, offering compositional distinctions among pyrrhotite, pyrite, chalcopyrite, and related sulfides (Figure 2.3). In BSE, pyrrhotite appears brighter than pyrite due to its higher average atomic number from elevated iron and lower sulfur content, and chalcopyrite appears brightest because of its copper content [9].

Figure 2.3: Backscattered electron (BSE) images with EDS spectra showing multiple iron sulfide mineral phases within an aggregate. Variations in BSE brightness, supported by Fe-S ratios from EDS spectra, allow these sulfides to be distinguished within the same deposit.

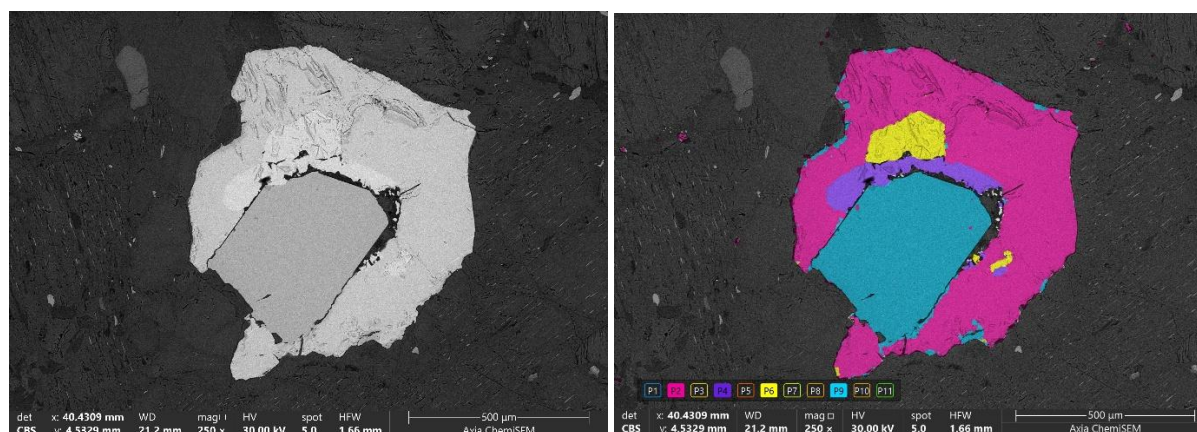
Figure 2.4: Backscattered electron (BSE) image of reflected light image field of view shown in figure 2.1A (left) and EDS x-ray phase map (right) depicting different iron-sulfide mineral phases detected through differentiation of statistically significant spectra.

EDS x-ray mapping creates images showing the spatial distribution of elements in a sample collecting characteristic x-rays at each point and assigning pixel color to elemental concentrations. This tool is used to resolve iron-sulfide phases within complex mineral assemblages as shown in Figures 2.4 and 2.5. Elemental maps of iron, sulfur, and accessory elements were used to identify and color-code individual sulfide phases, improving confidence in phase identification and delineation of micron-scale intergrowths. This approach provides more reliable discrimination among pyrrhotite, pyrite, and related sulfide minerals and supports improved phase quantification in heterogeneous aggregate samples. Analytical software inherent in some EDS software packages or use of other image analyses software can then be used to measure the relative abundance of each sulfide mineral type by area percent.

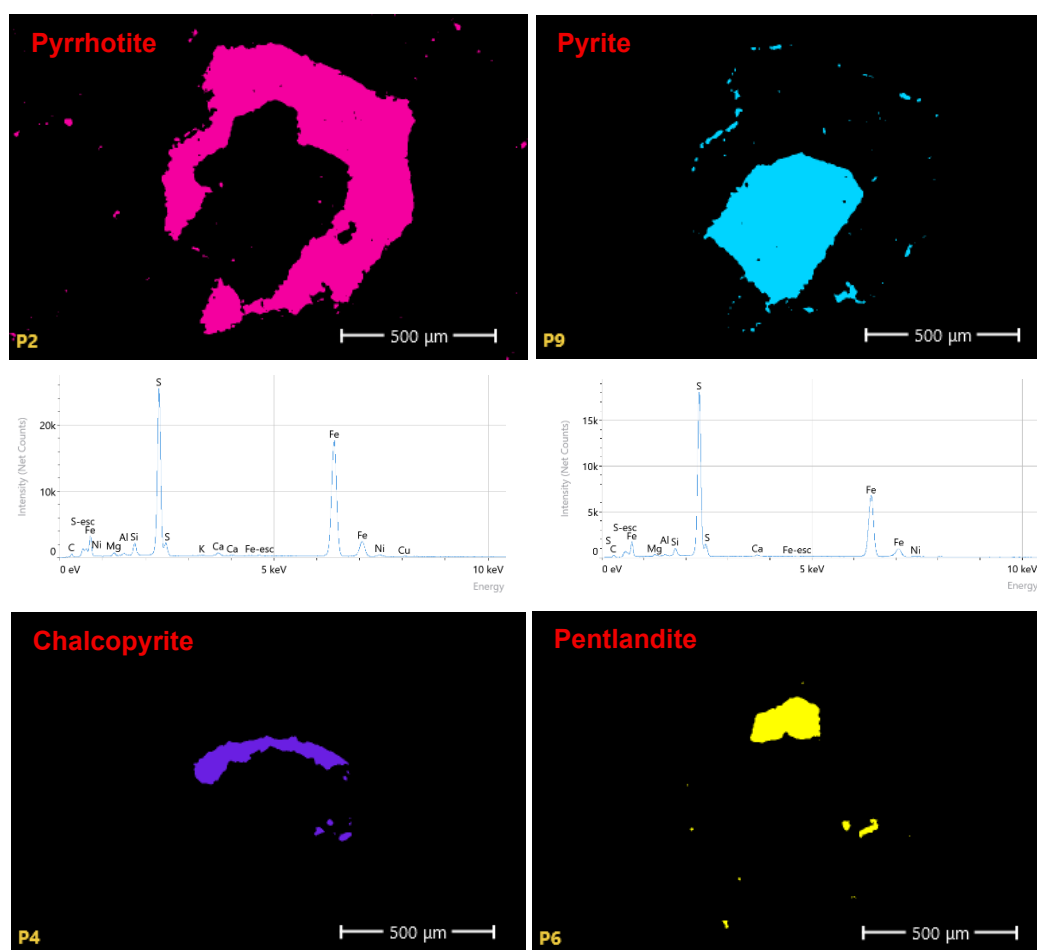
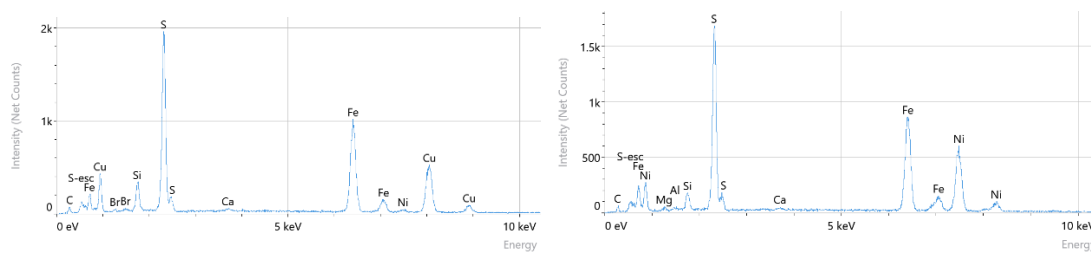
Figure 2.5: Individual phases of x-ray map separated and accompanied by associated spectra.

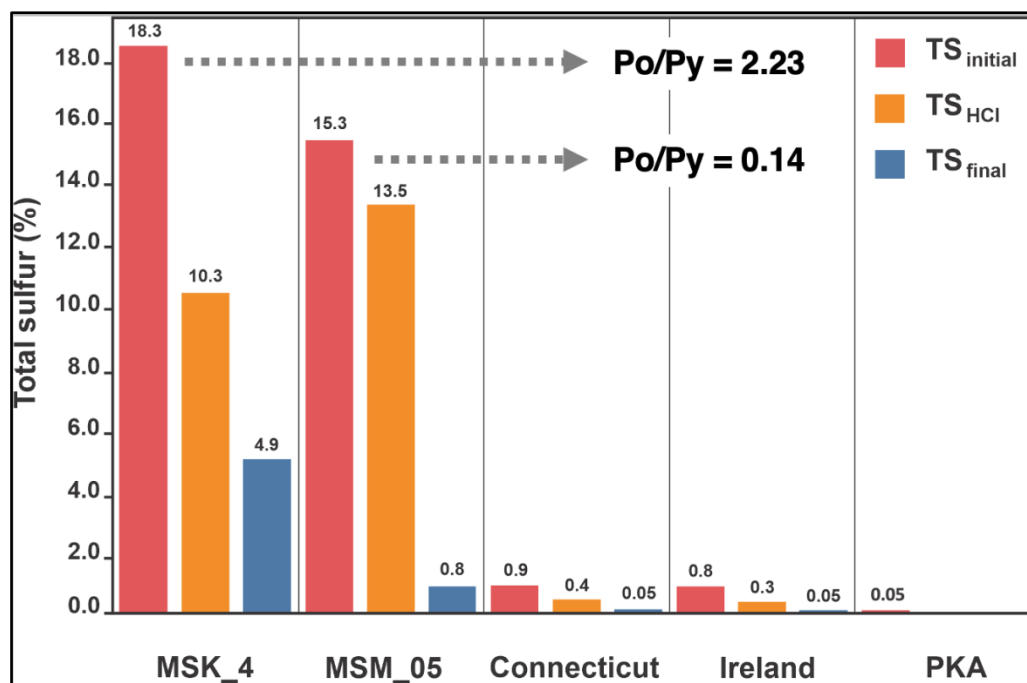
Figure 3.1: Total sulfur (TS%) results for samples with different sulfur contents subjected to the dissolution protocol. The sulfur-rich samples MSK\_4 and MSM\_05 were analyzed by XRD to track mineralogical evolution during the dissolution stages and their respective Po/Py original ratios were independently verified by SEM-QEMSCAN.

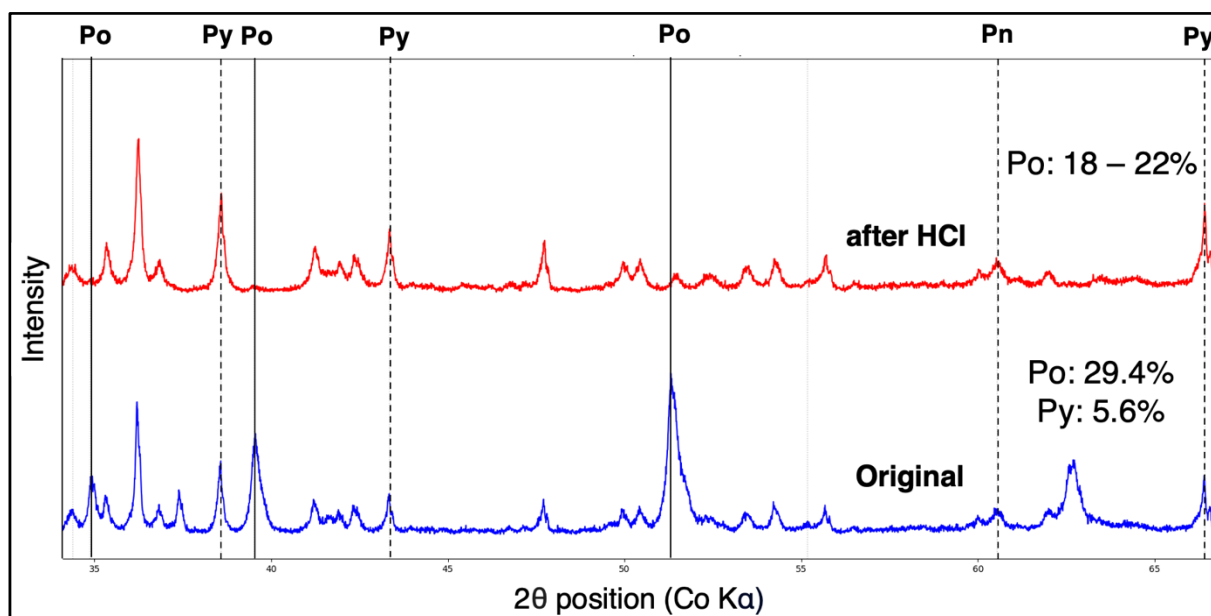
Figure 3.2: XRD diffractograms of sample MSK\_4 before and after the initial HCl dissolution step. Characteristic pyrrhotite peaks disappear following the treatment, while other sulfide peaks remain. The Po content, ranging from 18% to 22%, was determined from calculations using the sulfur concentration obtained from the dissolved sample. Key: Po = pyrrhotite; Py = pyrite; Pn = pentlandite

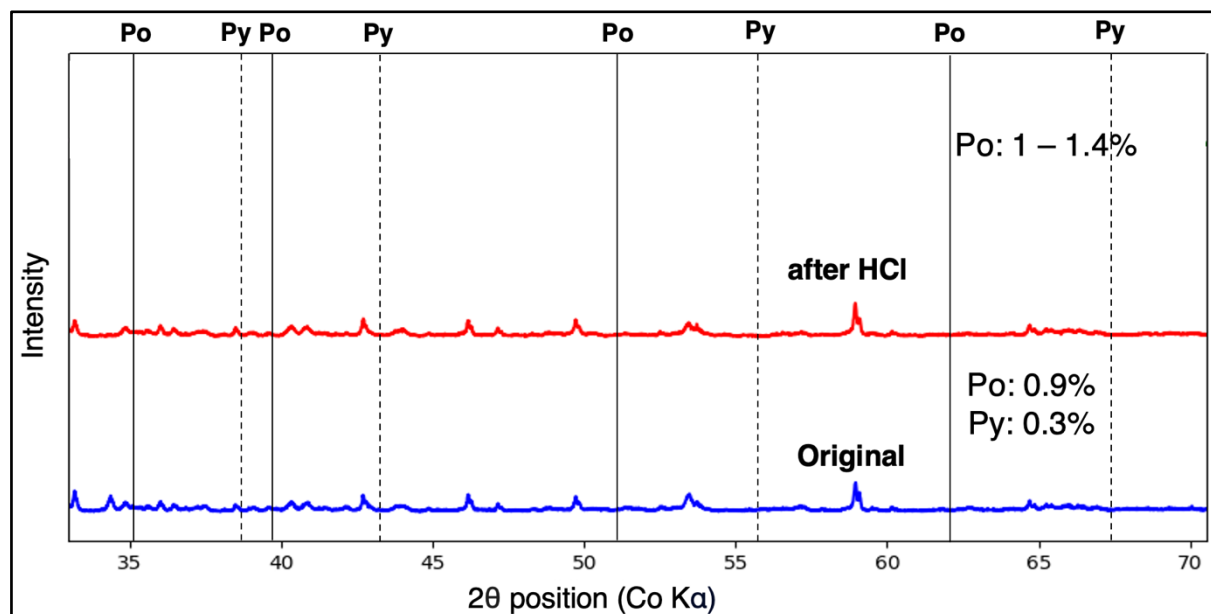
Figure 3.3: XRD diffractograms of sample from Ireland before and after the initial dissolution step. As sulfides represent only a small portion of the total mineral assemblage, their characteristic peaks are not well resolved by XRD.

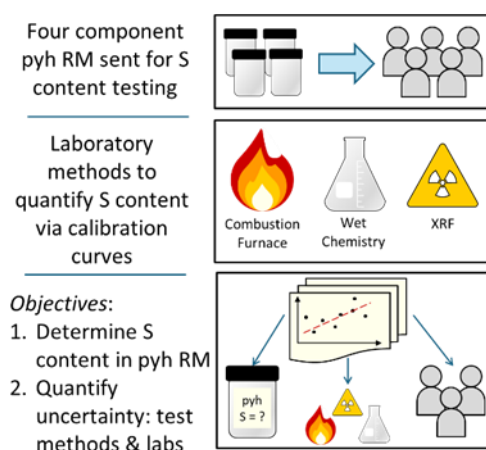
The NIST-led ILS is outlined in Figure 3.1. It will be conducted using common total S test methods: S combustion, XRF pellet and bead, and ASTM C114 wet chemical methods. NIST will instruct participants to generate calibration curves using a defined mix design from the NIST *pyh in concrete* RM. NIST will also provide two unknown concrete specimens to compare the participant calibration curves and corresponding S concentration results.

Figure 3.1: NIST-Led Interlaboratory Study Plan

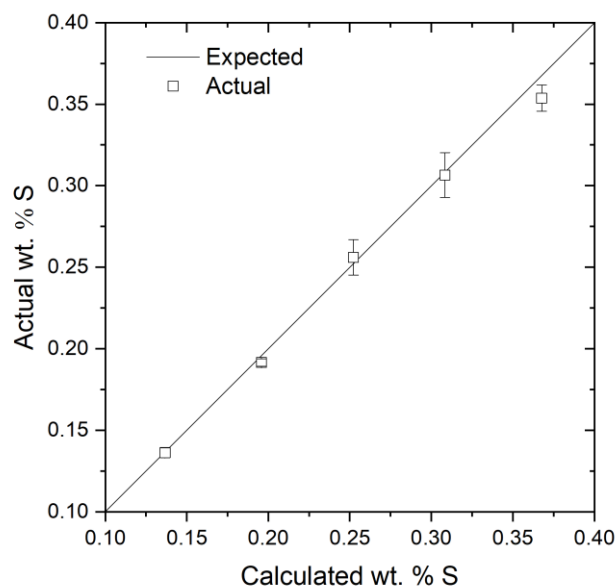
Figure 3.2. Results of component mixture combustion vs. calculated values, based on results of individual RM components. Error bars represent relative standard deviation.

An example of S combustion results from NIST using a mix design of the NIST *pyh in concrete* RM (RM 8154), is shown in Figure 3.2. Combustion analysis of RM 8154 mixtures yielded results within expected parameters of the combustion instrumentation when calculated from combustion results obtained for individual mixture components. These results demonstrated both reliable RM components and mixtures as well as consistent sample preparation and low experimental error.

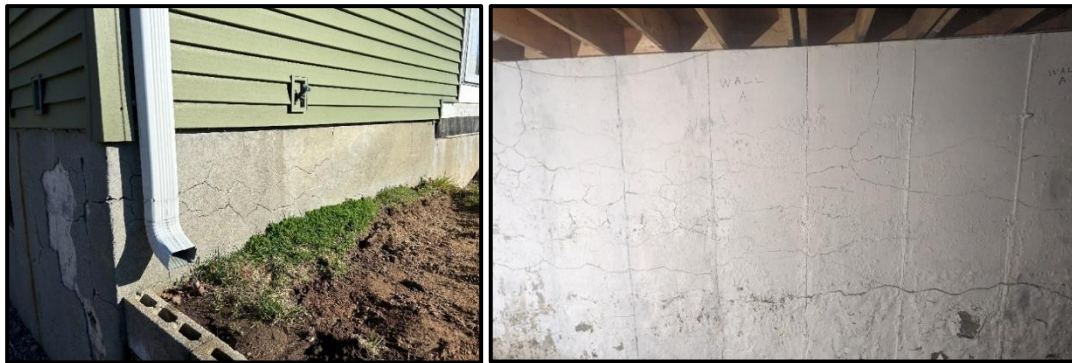
Figure 1.1: Deterioration of concrete foundation due to pyrrhotite

Concrete deterioration associated with the oxidation of iron sulfide minerals has been reported in several regions worldwide [1]. In Connecticut, thousands of residential foundations have been confirmed to exhibit damage attributable to pyrrhotite oxidation [2]. The observed distress typically includes whitish surface deposits, yellowish discoloration, pop-outs, and characteristic map cracking [3–5]. Pyrrhotite ( $\text{Fe}_{1-x}\text{S}$ ) can be naturally present in aggregates. It oxidizes upon exposure to moisture and oxygen, forming iron hydroxides. During this process, sulfate ions ( $\text{SO}_4^{2-}$ ) are released into the surrounding cement matrix, triggering internal sulfate attack [6, 7]. These reactions produce expansive iron corrosion products such as goethite and ferrihydrite, as well as secondary phases including gypsum, ettringite, and thaumasite. The continued accumulation of these products over time leads to progressive expansion, cracking, and deterioration of concrete foundations (see Figure 1.1).

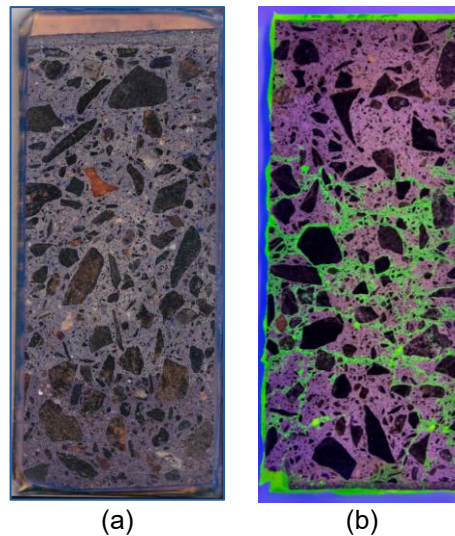
Figure 2.2: Field sample preparation: (a) sliced section; (b) cracked sample

Cores were collected from a deteriorated foundation in Stafford Springs, Connecticut, scheduled for full replacement due to pyrrhotite-related deterioration. Samples were obtained from multiple structural elements, including walls, slabs, and foundation. The specimens were tested for elastic properties via resonance frequency testing (RFT), as well as for compressive strength [12]. Moreover, selected cores were sliced into 10.8 cm by 25.4 cm sections, Figure 2.2 (a), for further evaluation, including carbonation assessment and UV epoxy impregnation to highlight internal crack networks, see Figure 2.2 (b). The sliced sections were further divided into smaller sections and carbon-coated for SEM analysis. Selected

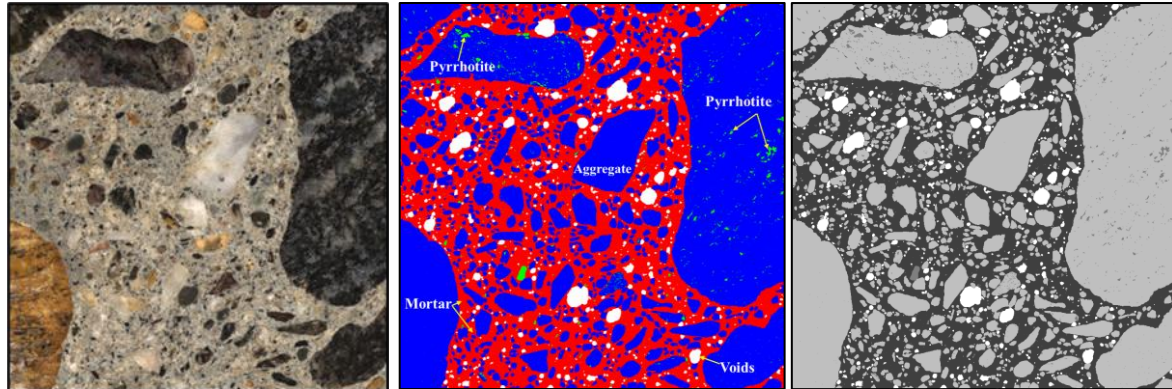
Figure 3.2: (a) Polished cross-section; (b) segmented SEM image (Blue: Aggregate, Red: Mortar, White: void, Green: Pyrrhotite); (c) digital microstructure

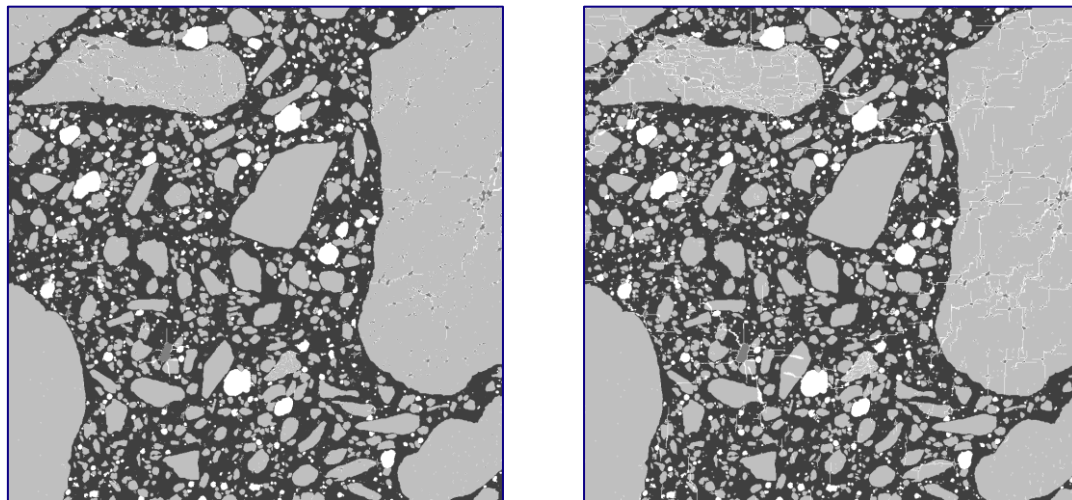
Figure 3.3: Crack formation after (a) 30 iterations and (b) 80 iterations

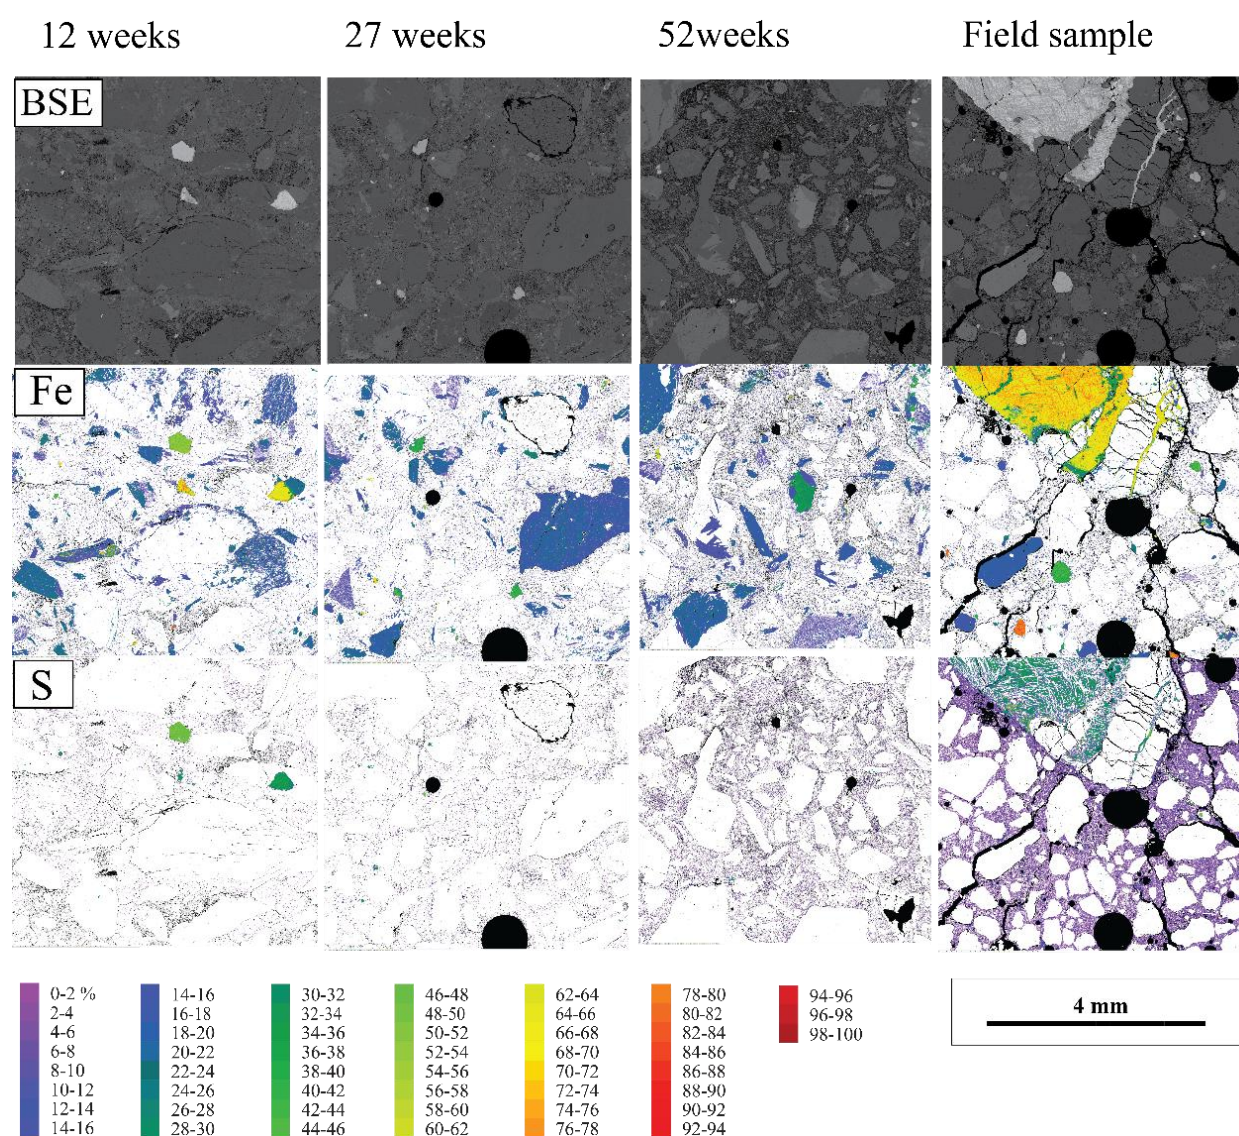
Figure 1: AM field mapping of the AMBT samples and the concrete field sample. Images were acquired with a 2  $\mu\text{m}$  step size. Elemental heat mapping of Fe and S using 2% concentration intervals

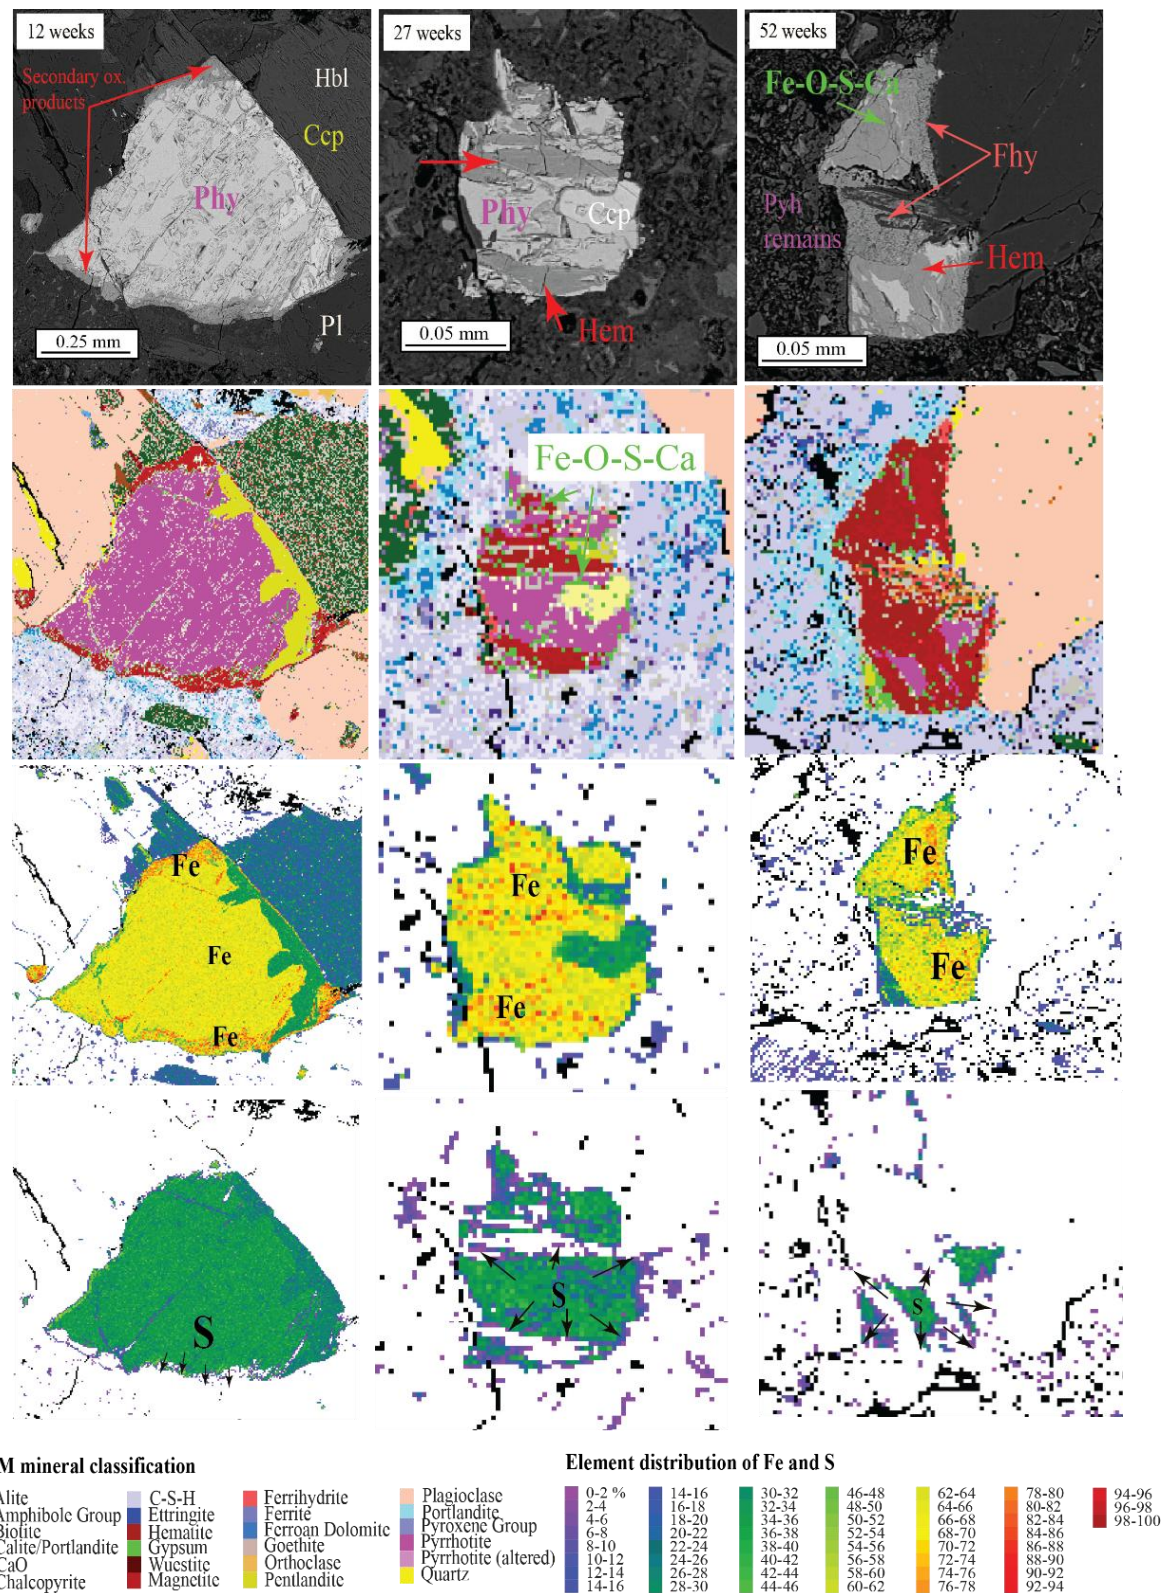
Figure 2: Oxidation progression of pyrrhotite studied in the accelerated mortar bar samples from 12 to 52 weeks. The AM mapping of the AMBT samples was obtained using a 2 µm step size. Phy remains = Pyrrhotite residues after oxidation and alteration to iron oxides and (oxi) hydroxides; Fhy = Ferrihydrite; Ccp = Chalcophyrite; Hbl= Hornblende; Pl = Plagioclase; Hem = Hematite; Fe-O-S-Ca = Composite phase.

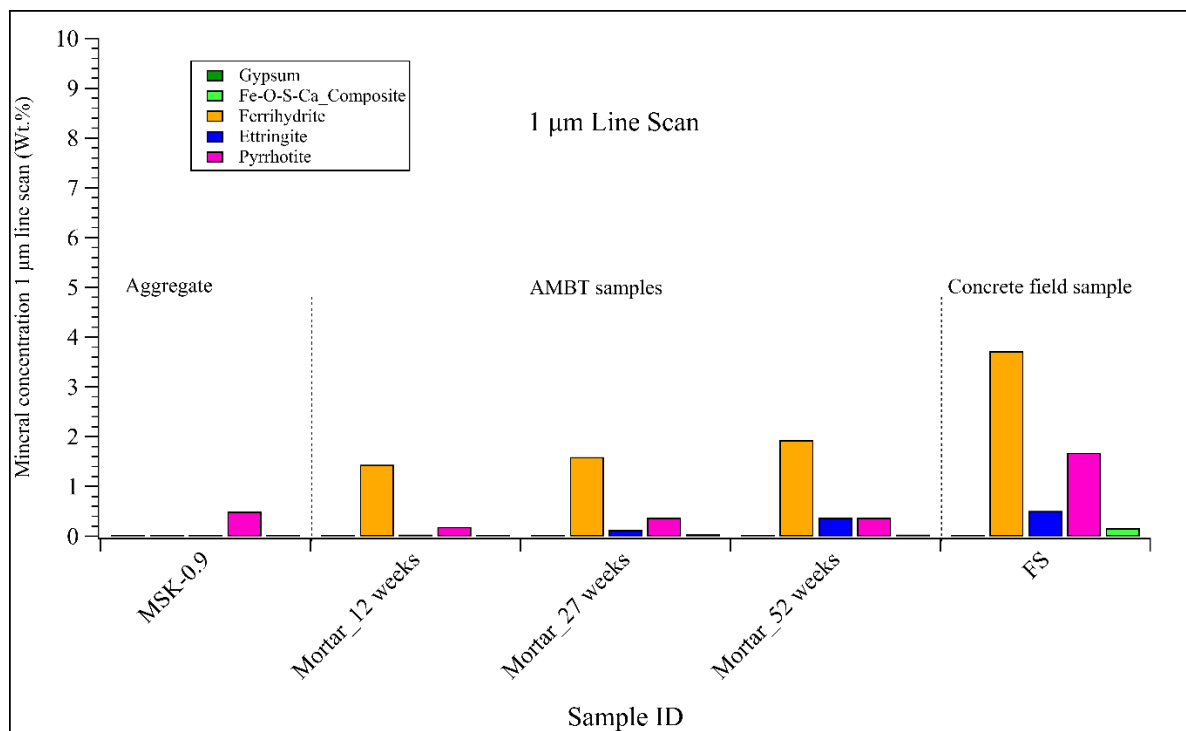
Figure 3: Concentration of pyrrhotite and secondary oxidation minerals present in the fresh aggregate (MSK-0.9), the mortar bar samples, and the concrete field sample (FS), measured by automated mineralogy using 1 µm line scanning mode.

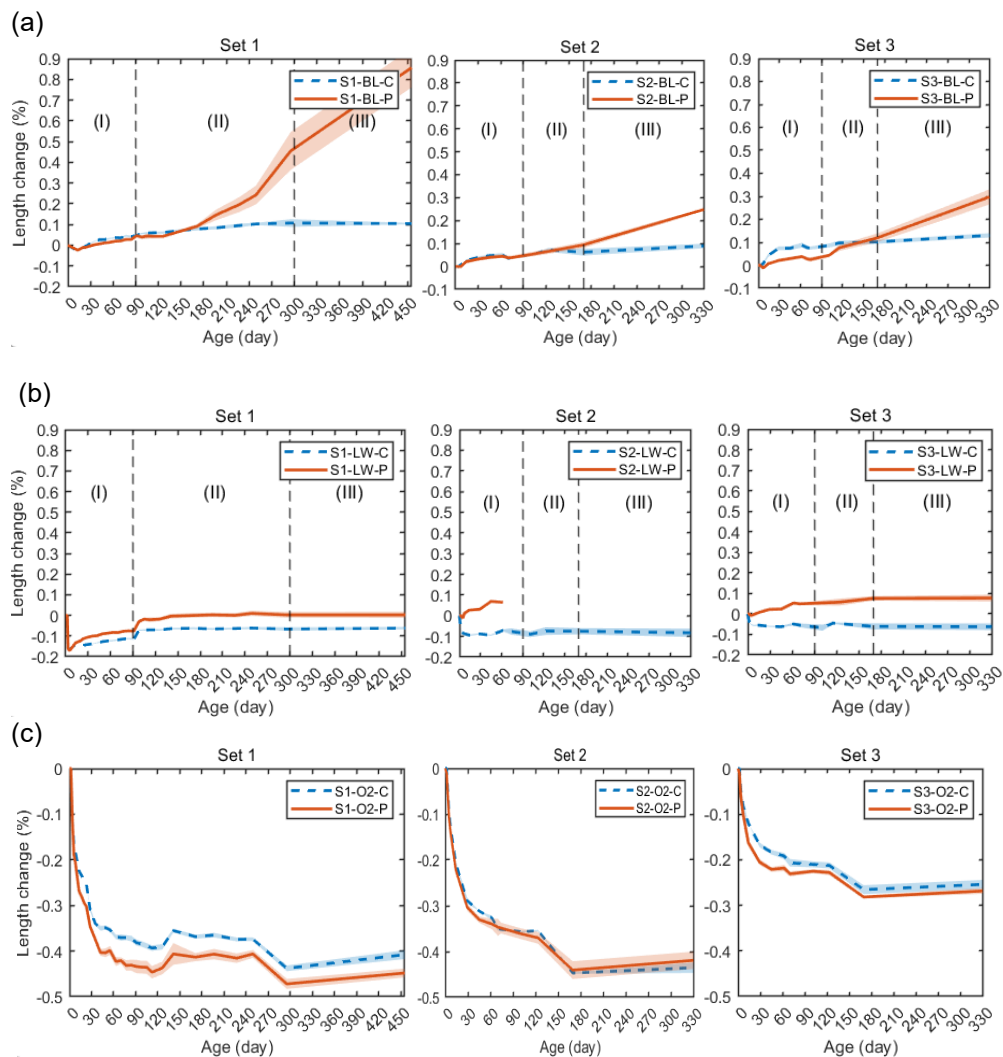
Figure 3.1: Measured length change over time for (a) Condition I: cyclic immersion in bleach solution, (b) Condition II: cyclic immersion in limewater solution, and (c) Condition III: (constant exposure to atmospheric oxygen. Phases I and II involve storage at 80°C/80% RH and 4°C/100% RH, respectively,
