# 2ND INTERNATIONAL CONFERENCE ON IRON-SULFIDE REACTIONS IN CONCRETE

## Proceedings

The 2nd International Conference on Iron-Sulfide Reactions in Concrete — ICISR 2026 — was hosted by the University of Connecticut in Mystic, Connecticut, USA, from May 12 to 14, 2026. Building on the foundation established by the first ICISR, held at Université Laval in Quebec City, Canada, in 2024, ICISR 2026 continued this international exchange by bringing together researchers, practitioners, public agencies, industry partners, homeowners, and policy stakeholders.

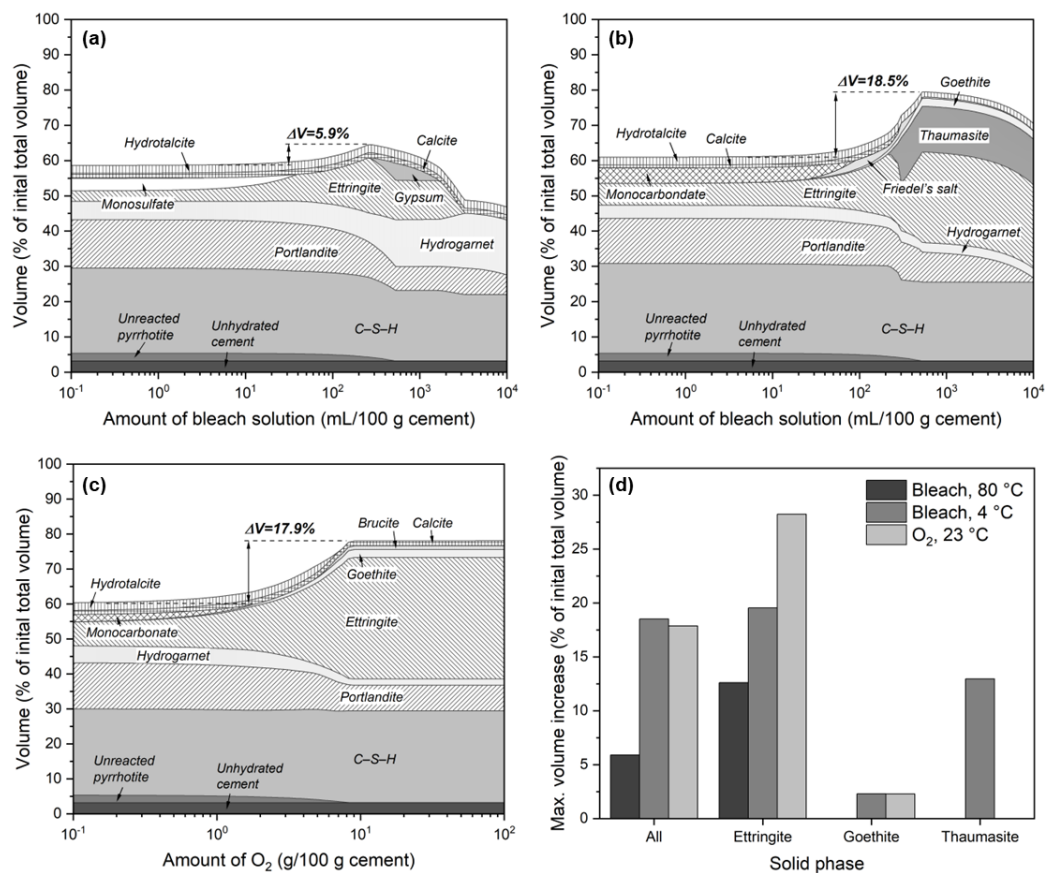
Figure 3.2: Predicted phase assemblages upon exposure to (a) bleach at 80°C, (b) bleach at 4°C, and (c) atmospheric oxygen at 23°C. A comparison of the phase assemblages is summarized in panel (d).

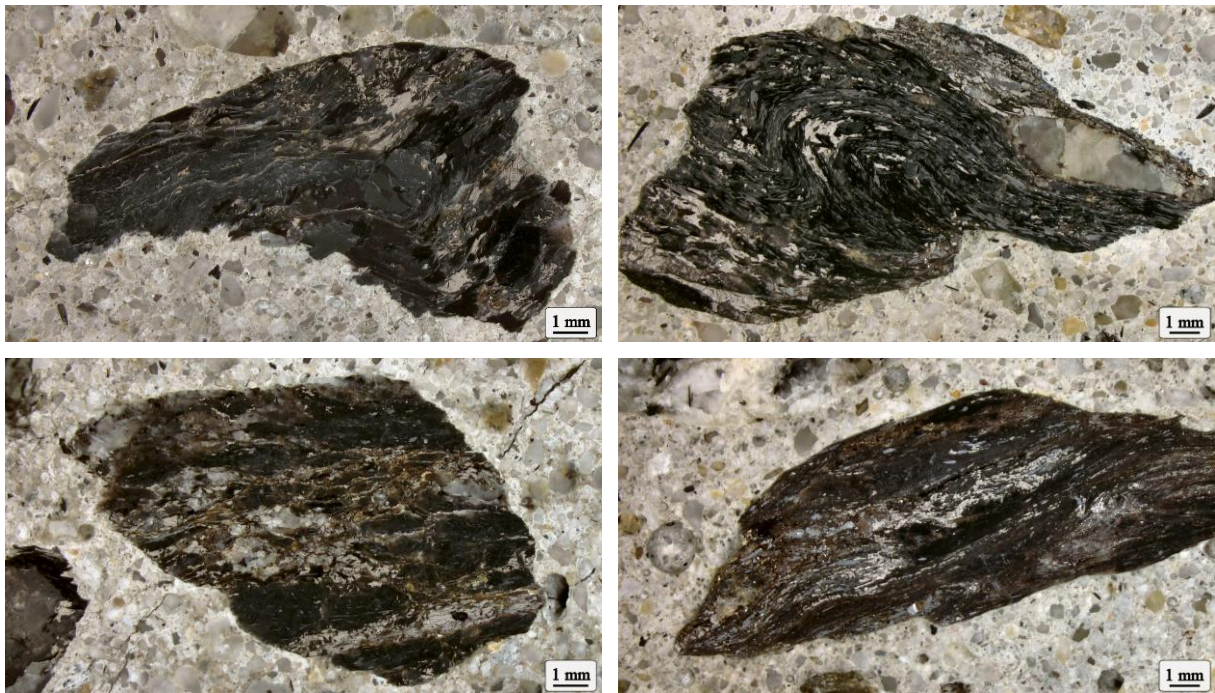
**Figure 2:** Examples of the reactive, pyrrhotite-bearing A/W schist coarse aggregate particles.

The reactive rock consists of schist, gneiss, and quartzite and contains small to moderate amounts of ISMs. The schist often exhibits folding and typically contains biotite and quartz, commonly contains graphite and muscovite, and occasionally contains sillimanite. The gneiss primarily contains quartz, feldspar, and biotite with graphite and sillimanite, occasionally contains muscovite, and rarely contains augite or garnet. The quartzite is dominated by quartz and feldspar and is typically micaceous. The amount of pyrrhotite within individual reactive particles typically ranges from roughly 5 to 50 percent with rare particles containing 85 to 95 percent pyrrhotite. The pyrrhotite in the schist exhibits significant oxidation, and the pyrrhotite at the exterior portions of gneiss and quartzite particles is often oxidized.

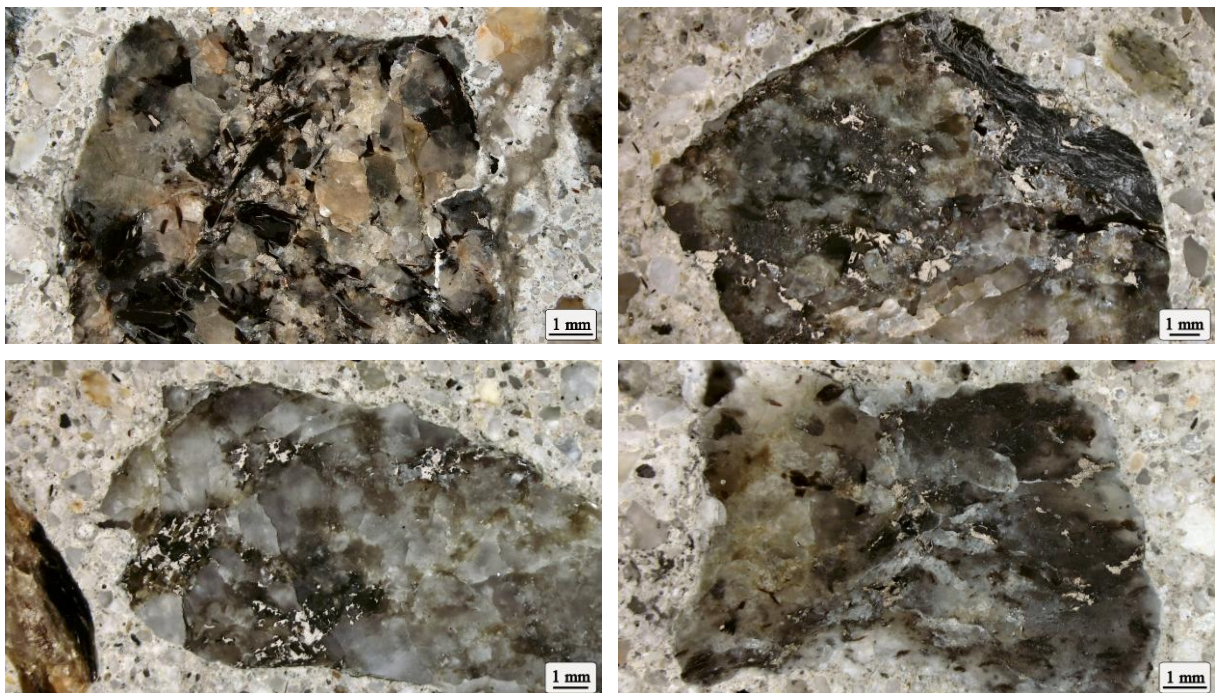
**Figure 3:** Representative examples of the reactive, pyrrhotite-bearing A/W coarse aggregate particles; the upper photos show gneiss particles and the lower photos show micaceous quartzite particles.

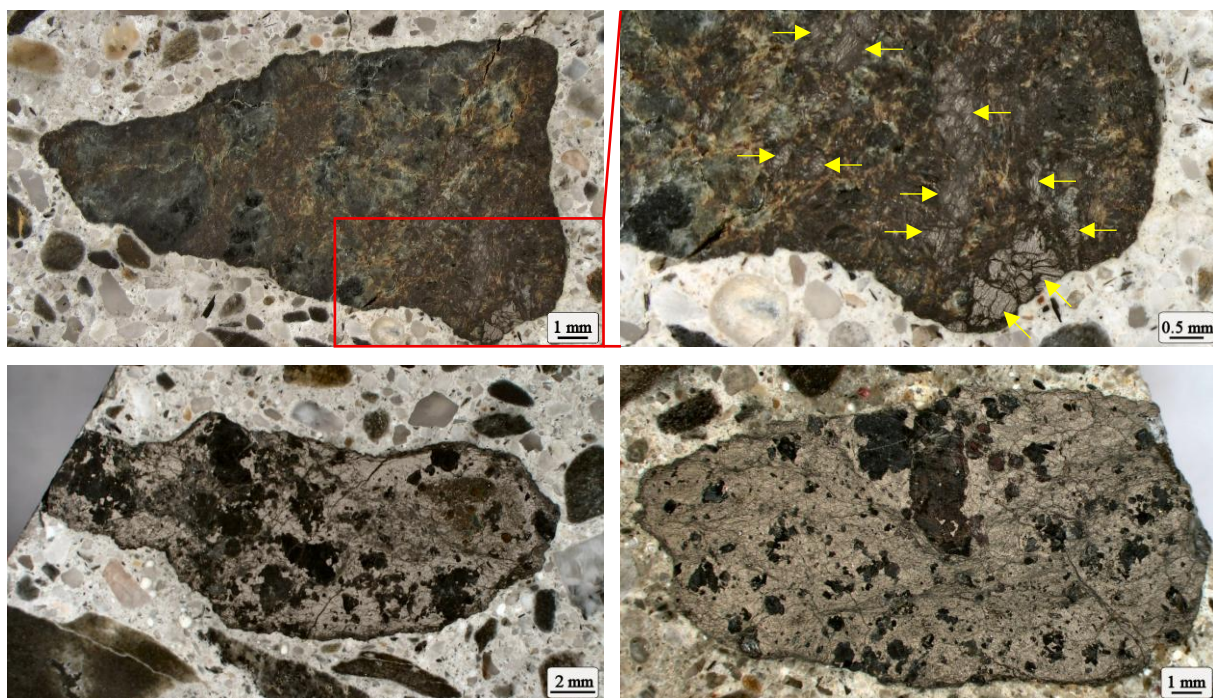
**Figure 4:** Representative examples of the reactive, pyrrhotite-bearing Dracut coarse aggregate particles. The upper photos show a chlorite schist particle with highly oxidized pyrrhotite (arrows), while the lower photos show particles comprised almost entirely of pyrrhotite.

The chlorite schist contains highly variable amounts of pyrrhotite and is judged to be reactive. The chlorite schist matrix is comprised primarily of chlorite, altered clinopyroxene and plagioclase, anthrophyllite, and quartz. The chlorite schist also commonly contains minor to small amounts of sillimanite, biotite, muscovite, calcite, and epidote. Some of the particles are almost entirely comprised of pyrrhotite and also contain olivine altered to serpentine, altered clinopyroxene, chlorite, titanite, quartz, and plagioclase. These reactive aggregate particles range from 2 to 9 percent of the coarse aggregate particles in the examined cores. The pyrrhotite in the reactive particles typically ranges between 20 to 95 percent and is commonly in excess of 50 percent. The pyrrhotite is commonly heavily oxidized.

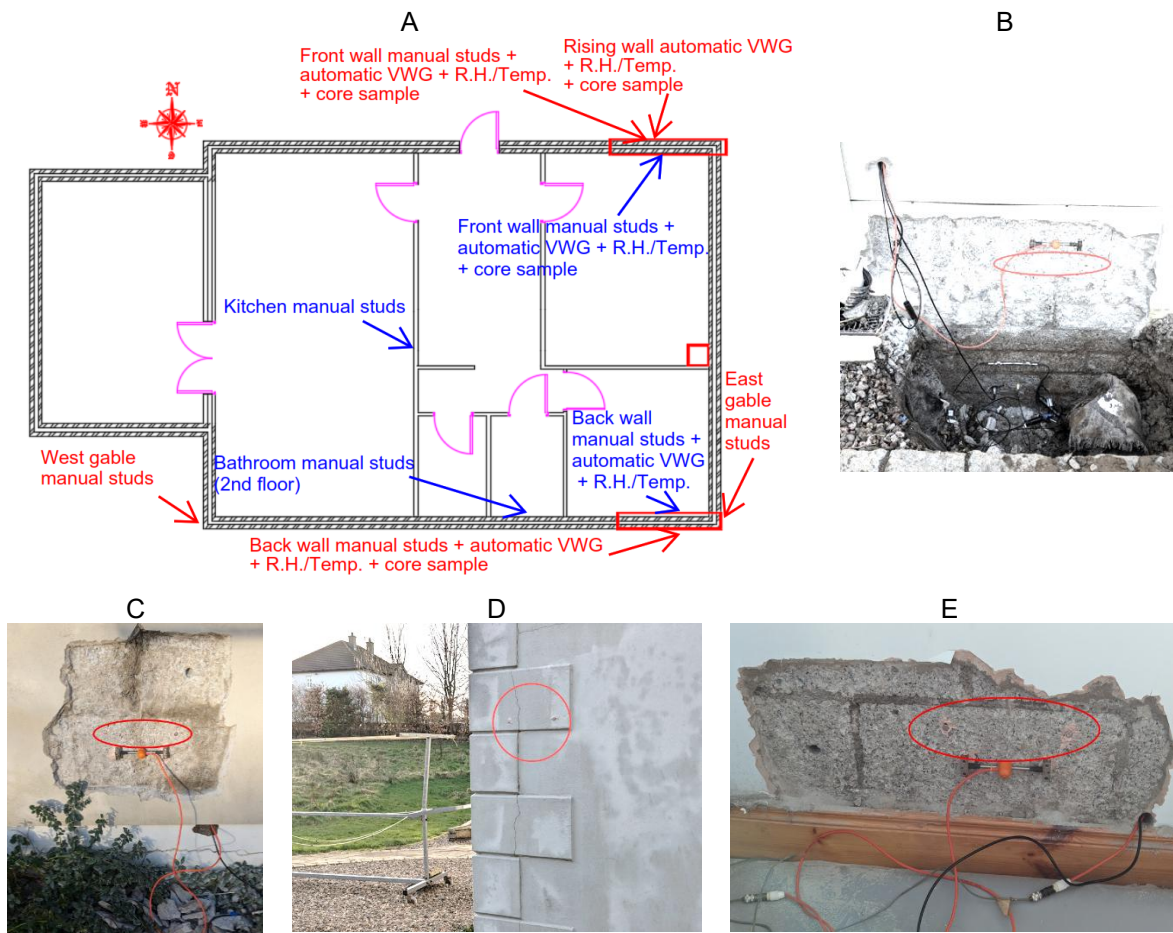
Figure 1.1: Selection of locations of monitoring and core samples within the selected concrete blocks (red circles show locations of manual expansion measurements with studs). A: Schematic of the monitoring and core sample locations, B: Exterior wall outer leaf and rising wall block below, front of house (facing north), C: Exterior wall outer leaf, back of house (facing south), D: Exterior wall outer leaf, east facing gable, E: Exterior wall inner leaf, back of house (facing south).

Cores ( $\varnothing = 100$  mm,  $L \sim 100$  mm) were extracted from the inner leaf (front of home), outer leaf (front and back of home), and rising blocks (front of home) (Figure 1.1 A). Phenolphthalein testing showed that the two samples from the outer leaf were partially carbonated, samples from the inner leaf were fully carbonated and the sample from the rising blocks was not carbonated. The concrete is typical for the blocks produced in Ireland with a high share of voids, as reported in [2,3].

Figure 1.1 shows some of the selected monitoring locations. 19mm holes were drilled to the width center of the selected outer leaf blocks (50mm,  $\sim 60$  mm at angle) upward at 45° (to reduce the risk of rain water ingress), in which a plastic sleeve was inserted for temperature, R.H. and other fibre optics sensors installation (Vaisala HMP60, Sylex, HS-01). In the inner leaf blocks, 19mm holes were drilled perpendicular (since there was no risk of rain water ingress) to the surface at the center of the widest part of the block (50mm). VWG (Geosense-2000, 150mm nominal) and studs for manual expansion monitoring were also installed and fixed with fast-set epoxy resin within the same selected block locations in the outer and inner leaf and internal partition wall. All electrical sensor measurements were logged into a datalogger and computer. The inner leaf bathroom monitoring location is directly placed over a radiator below a window. The rising wall location was drilled at 110mm in depth (center of height of the block, placed aside) perpendicular to the surface and installed with R.H. and temperature sensors in addition to the VWG fibre optic strain sensor. That location was carefully backfilled with sand and gravel once the sensors installation was completed. Zero measurements were taken once the epoxy was adequately cured at all locations. All sensors installation locations were within a selected block (between mortar joints), with the exception being the corners of the gable walls of the home. Manual

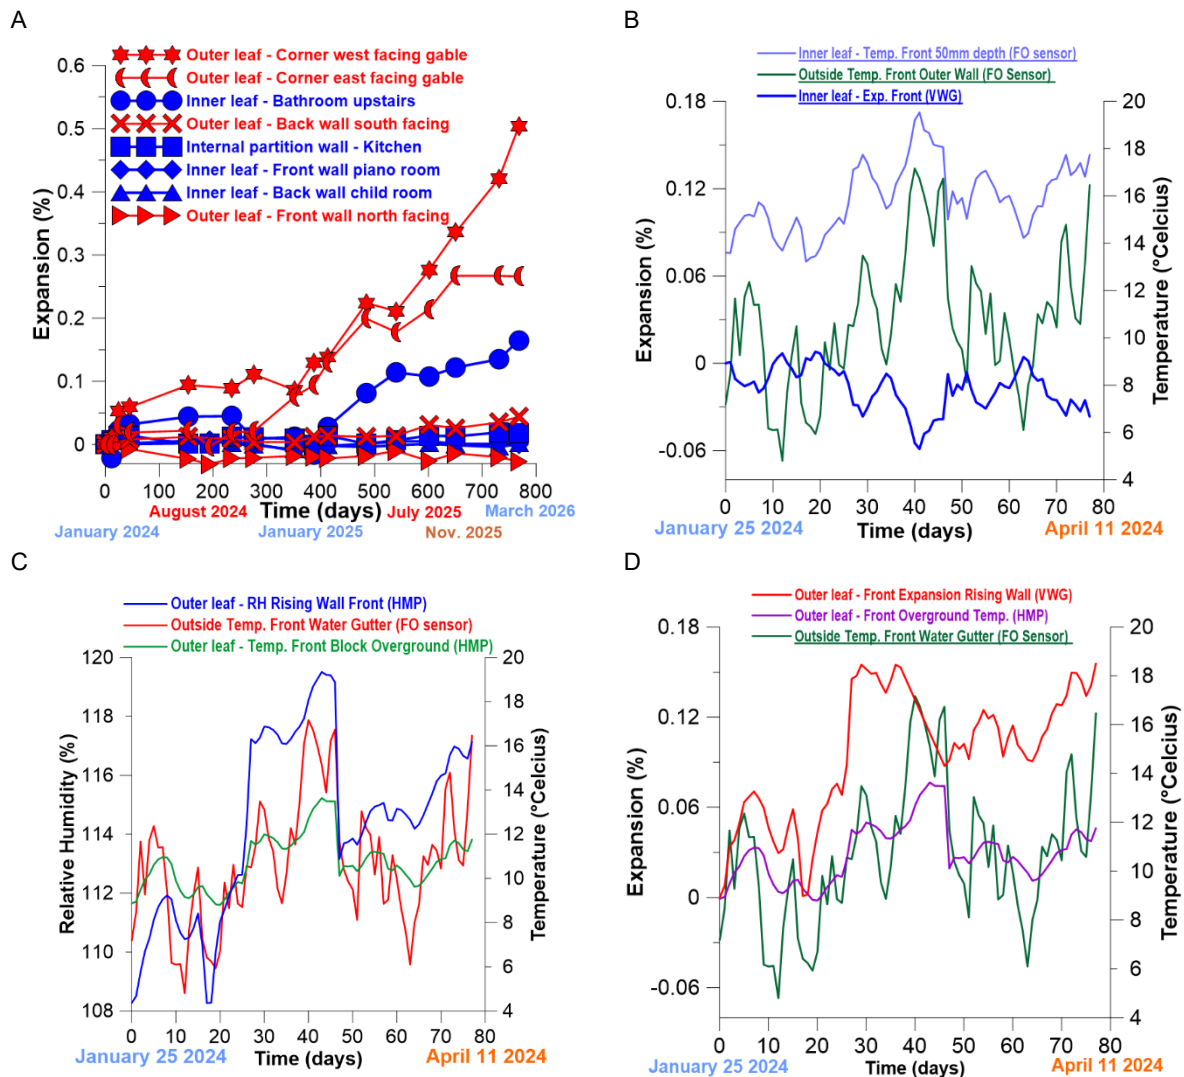
Figure 3.3: Graphs of expansion, temperature and R.H. monitoring A: Manual expansion measurements over almost two years, B: Inner leaf and outside temperature data, along with VWG (automatic) expansion measurements (first three months), C: Outer leaf and outside temperature data, along with rising wall R.H. (first three months), D: Outer leaf and outside temperature data, along with VWG rising wall expansion (first three months).

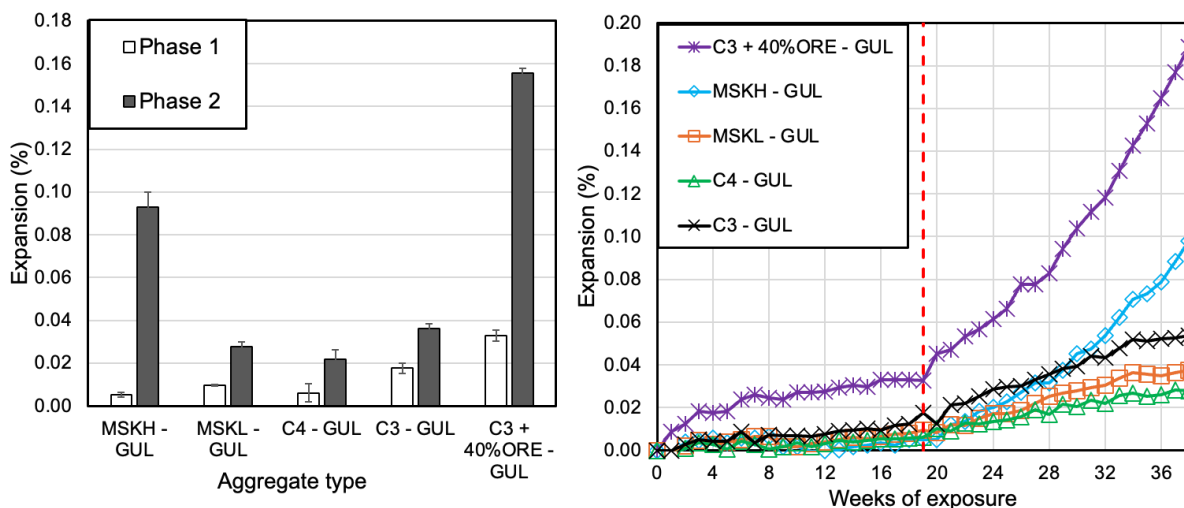
Figure 2-2: Bleach-Injection Conditioning of Concrete Micro-Prism Specimens under a Two-Phase Exposure System (19 Weeks per Phase)

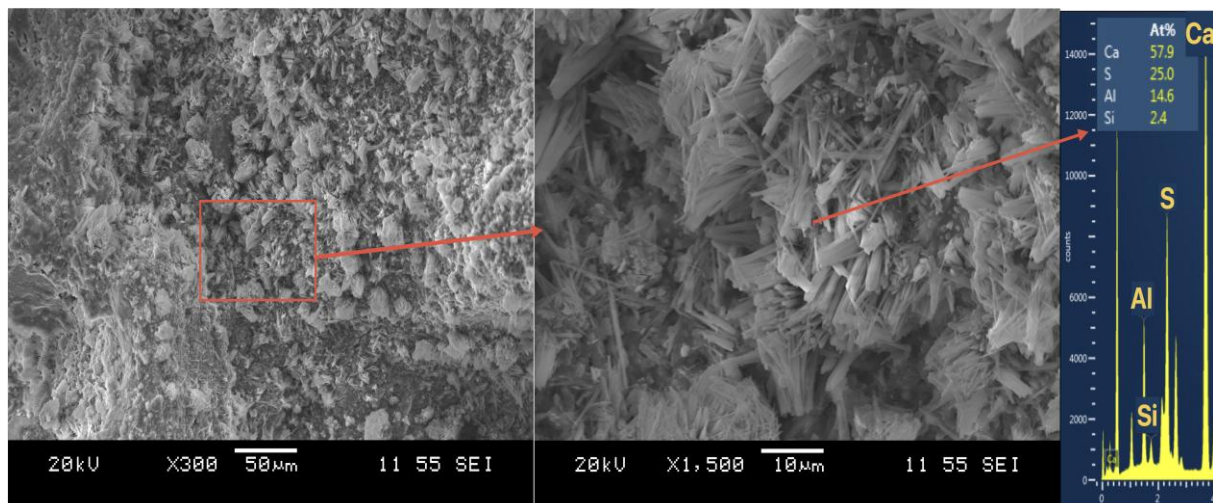
Figure 2-3: SEM-EDS of a fractured concrete surface showing ettringite-like needles in the paste adjacent to MSKH aggregates.

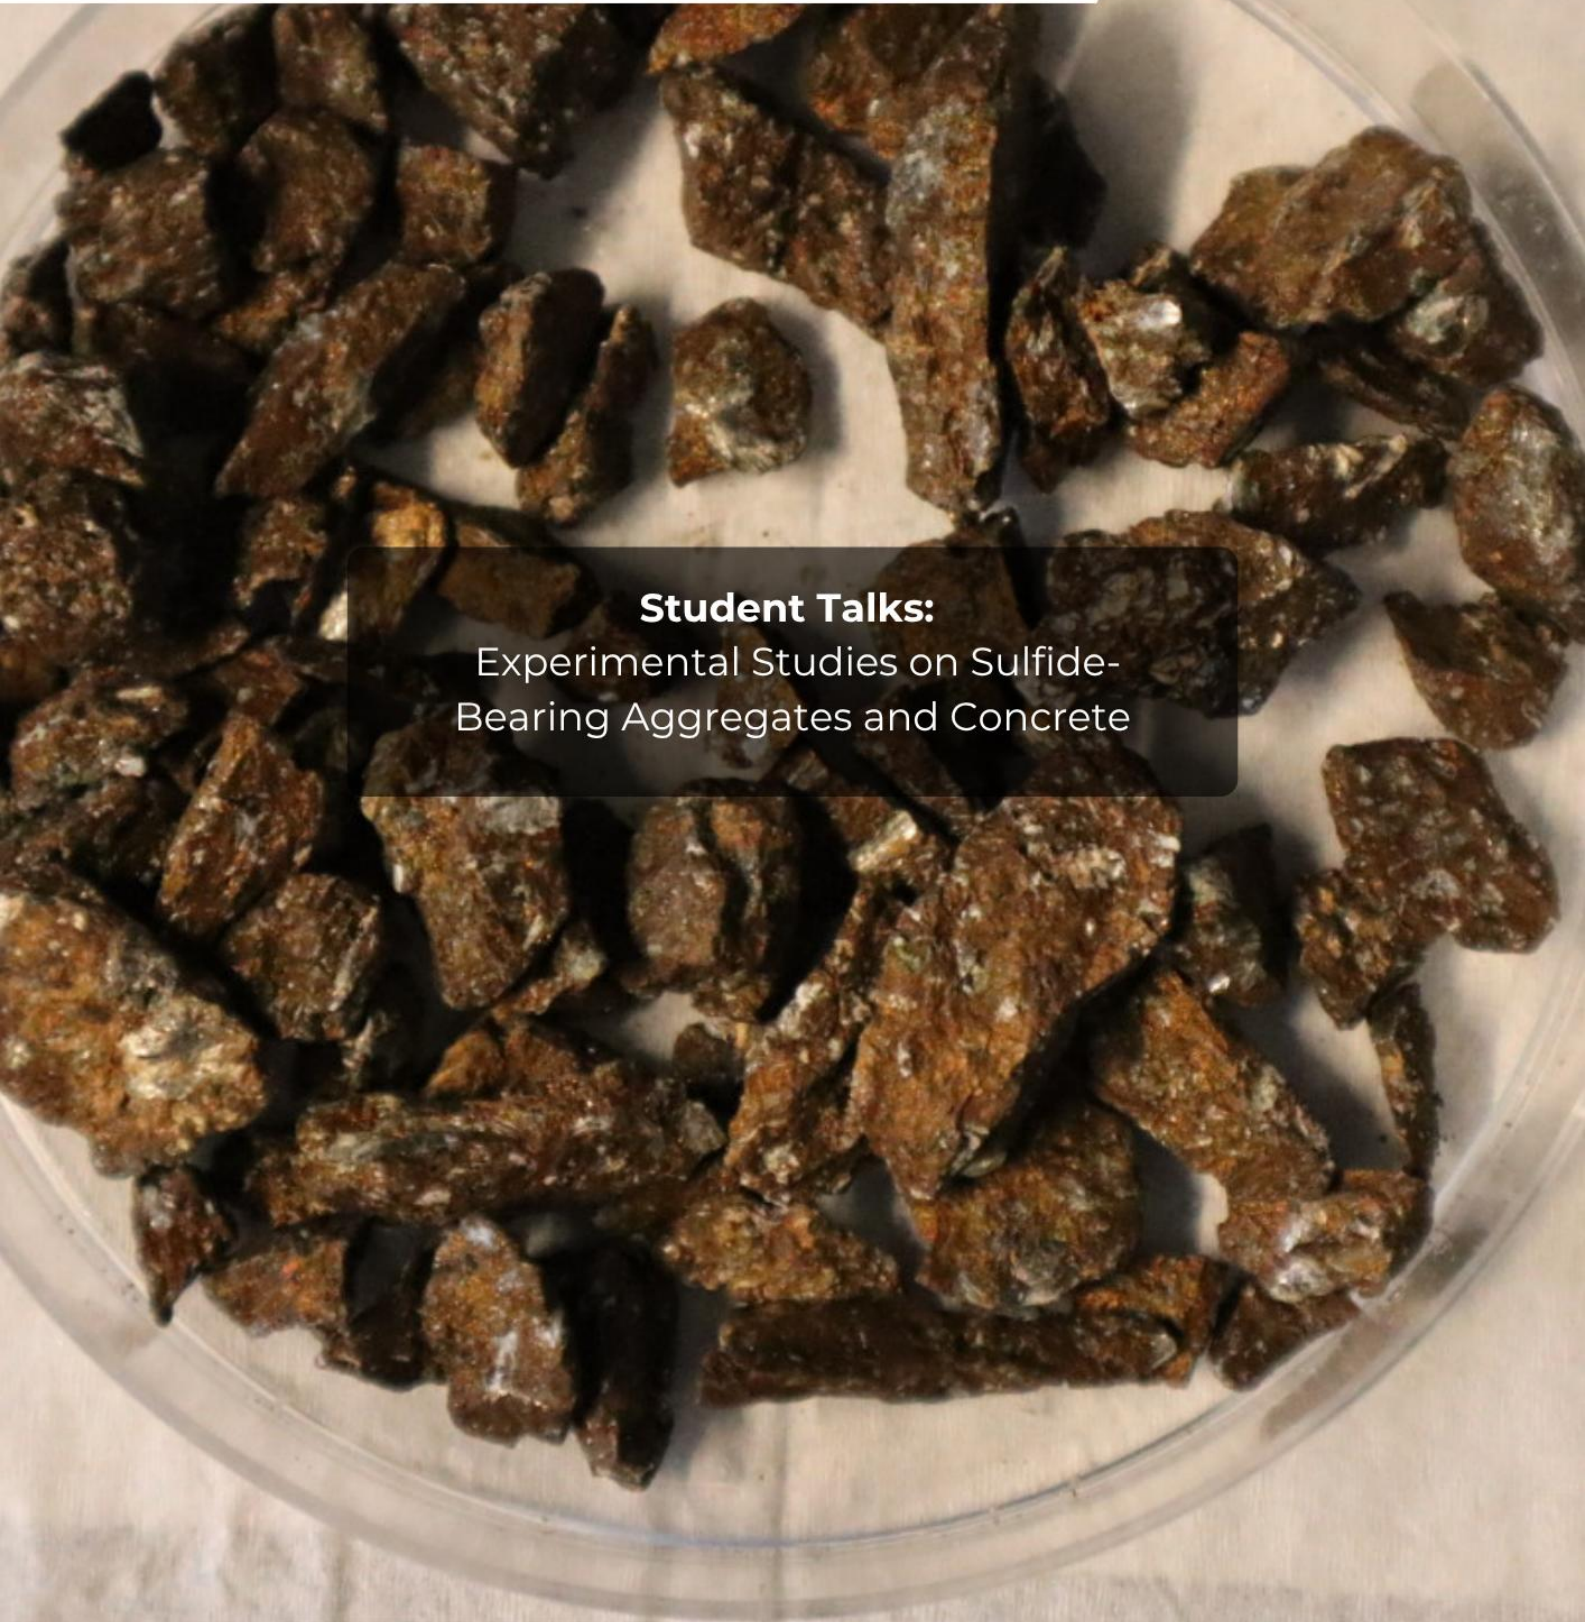
A photograph showing numerous dark brown, irregularly shaped concrete aggregates scattered in a clear petri dish. The aggregates have a rough, porous texture and are heavily corroded, with a thick, dark, and somewhat crystalline layer of rust (iron sulfide) covering their surfaces. The background is a light-colored, slightly textured surface.

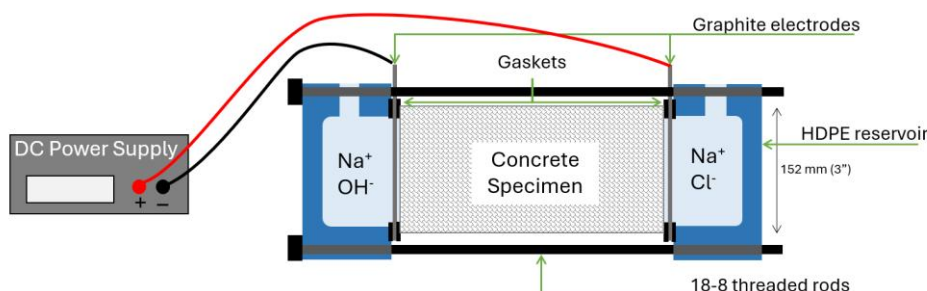
Figure 2.1. Configuration of experimental procedure (Adapted from Ojo et al. [9])

An electrochemical accelerated testing setup based on the procedure described in [9] was used to impose ionic migration through the concrete cylinder. The concrete cylinders were subjected to an applied potential of 60 V for three days between a NaOH cathodic chamber and a NaCl anodic chamber. This configuration is referred to as the OH–Cl reverse exposure condition because the hydroxide-rich

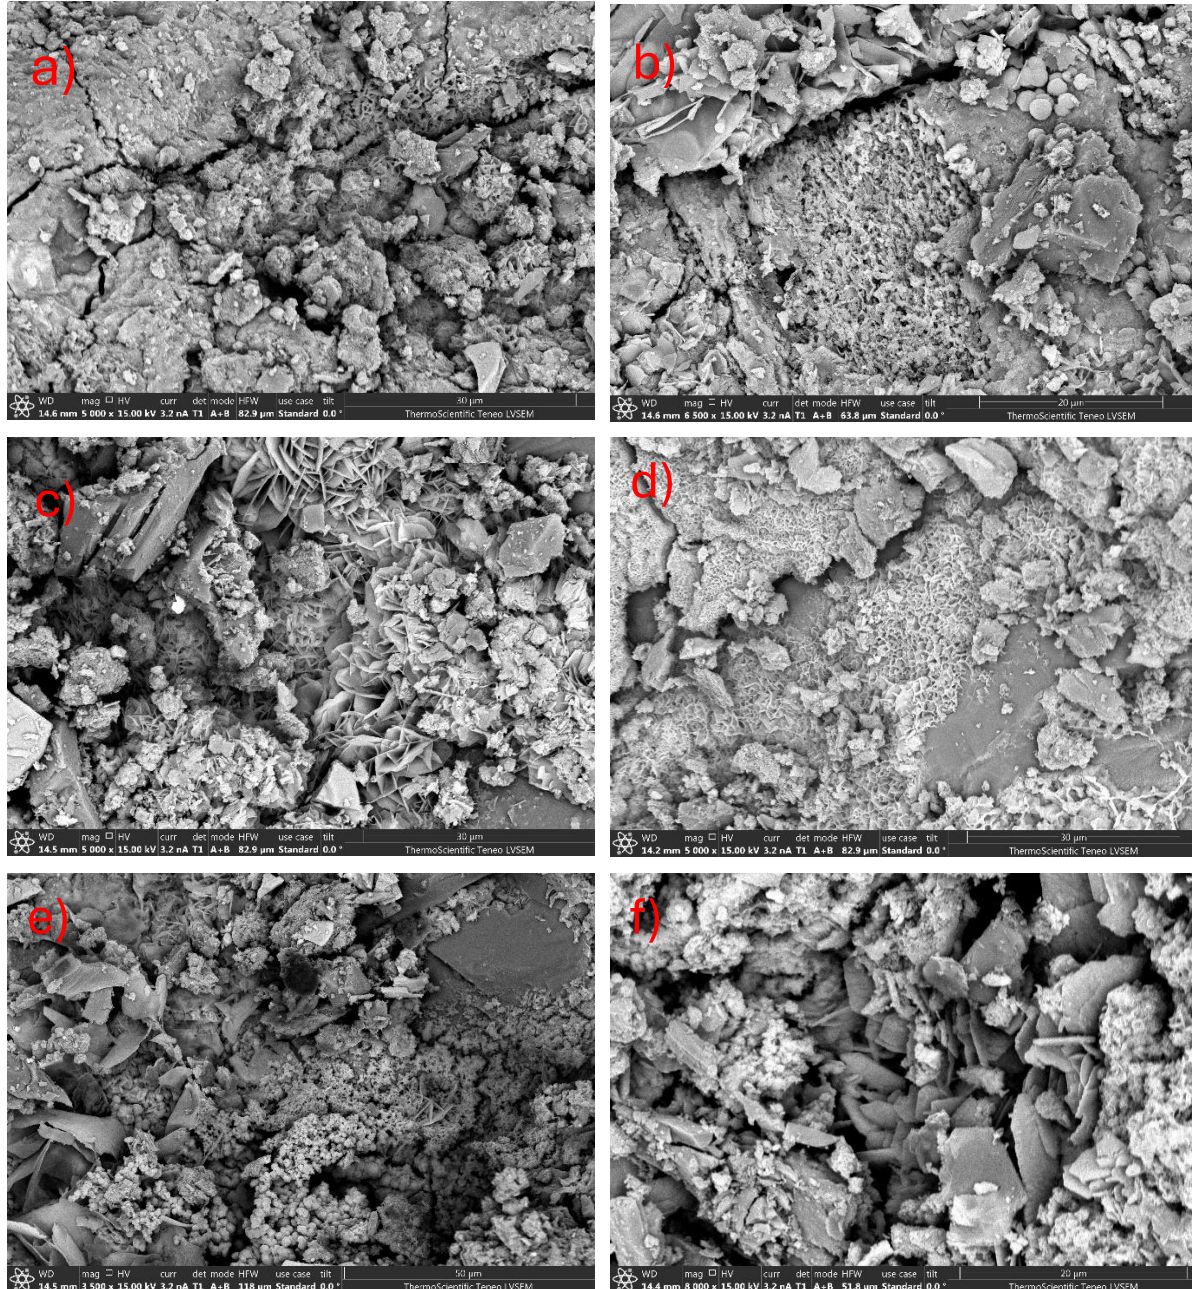
Figure 3.1. SEM micrographs showing representative Fe-rich corrosion products observed after electrochemical acceleration: (a) cotton ball-like morphology consistent with ferrihydrite-like products; (b) Fe-rich corrosion front; (c) transitional FeOOH-like morphology; (d) plate-like morphology consistent with lepidocrocite-like products; (e) acicular morphology consistent with goethite-like products; and (f) oxide-like Fe-rich product morphology.

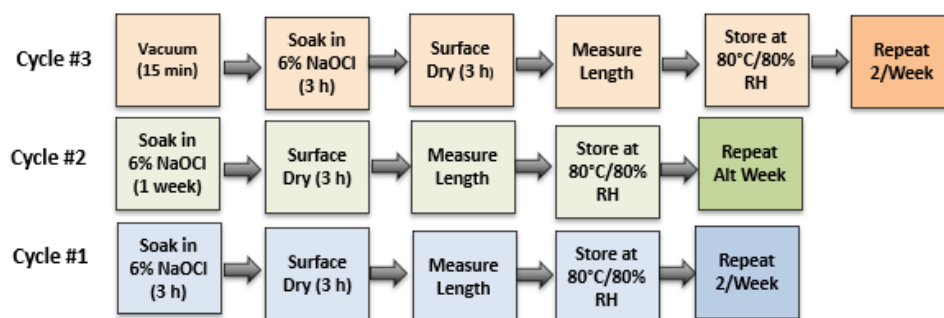
**Figure 2.1.** Schematic representation of accelerated oxidation–expansion testing cycles (Cycle #1: baseline after Rodrigues et al. [8]; Cycles #2–3: parametric investigations).

Each cycle represents an independent exposure condition applied to separate sets of specimens. The specimens were not subjected sequentially to multiple cycles.

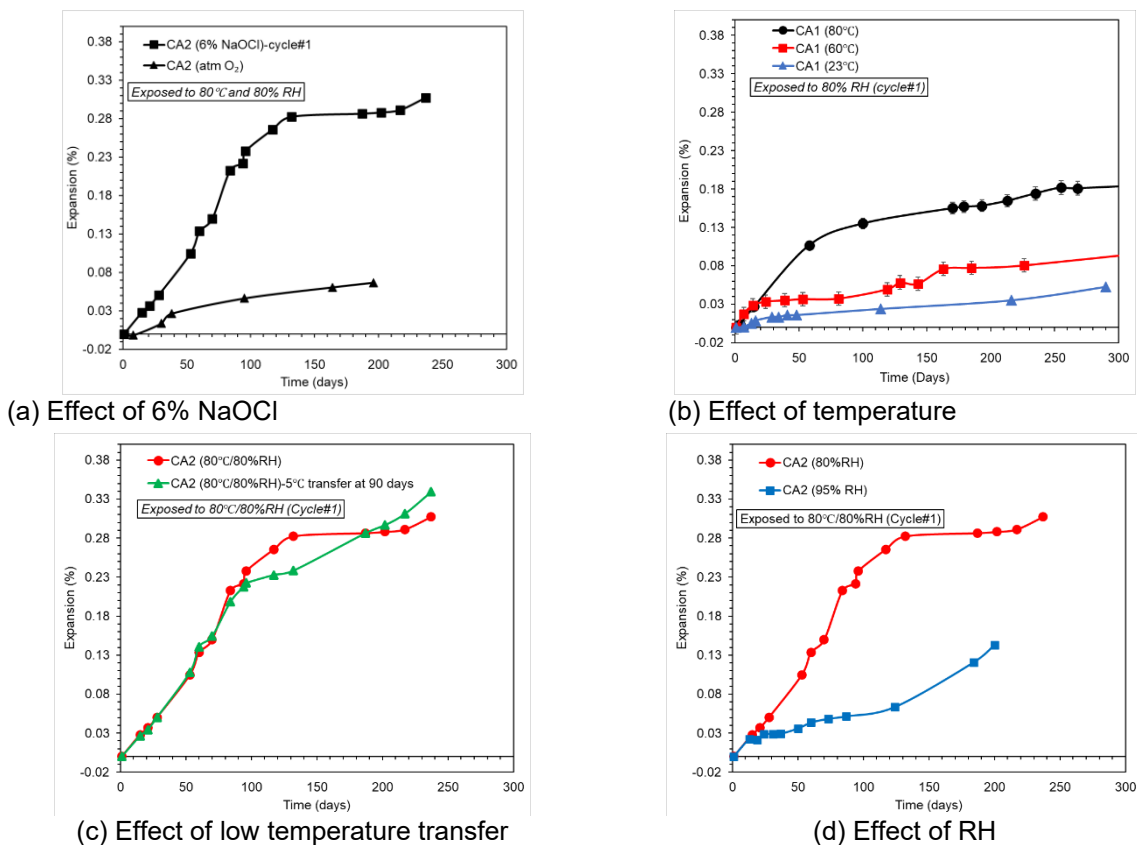
**Figure 3.1.** Effect of environmental exposures on the expansion of sulfide-bearing aggregate.

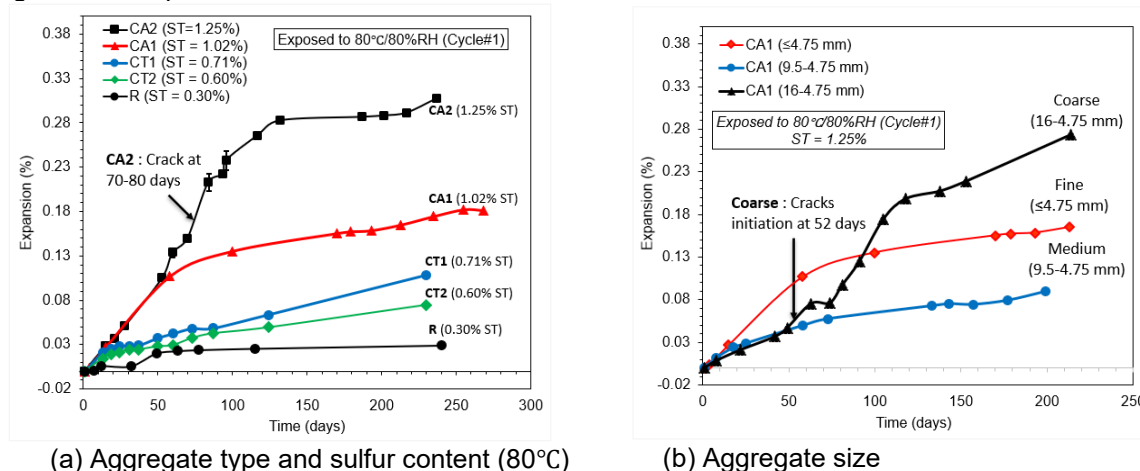
**Figure 3.2.** Effect of sulfur content and aggregates size on the expansion of sulfide-bearing aggregate.

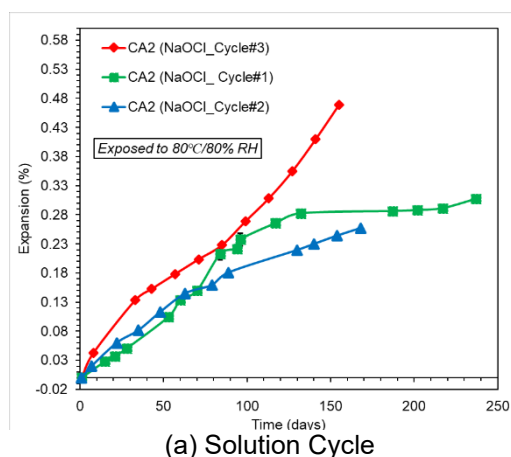
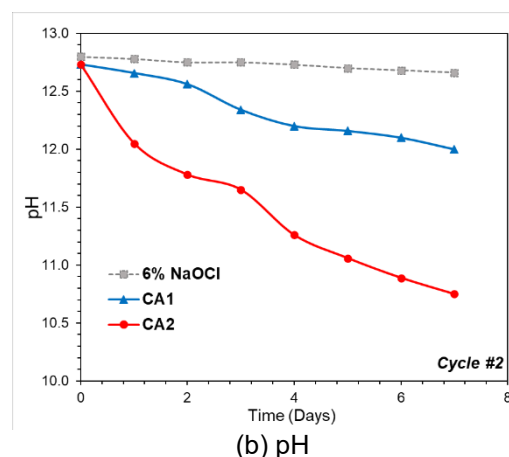
**Figure 3.3.** Effect of 6% NaOCl exposure protocols on mortar-bar expansion and corresponding changes in solution pH.

As shown in Figure 3.3a, Cycle #2 highlights a key limitation associated with prolonged static submersion (1 week) in 6% NaOCl. A progressive reduction in solution pH was observed during the exposure period (Figure 3.3b), indicating that the chemical environment was not maintained under stable oxidizing conditions. The evolution of a reference 6% NaOCl solution (without specimens), also included in Figure 3.3b, exhibits only minor pH variation over time. In contrast, substantially greater pH reductions occur in specimen-containing systems, particularly for mixtures incorporating high-sulfide aggregates (CA2). This pH reduction is critical because sulfide oxidation in cementitious systems is strongly pH dependent. As reported by Divet and Davy [15], oxidation rates increase exponentially above  $\text{pH} \approx 12.5$  and can reach up to 50 times higher at  $\text{pH} \approx 13.7$ . Consequently, as the NaOCl solution pH decreased below this highly alkaline regime during Cycle #2, the effective oxidizing capacity diminished, transitioning the system from a kinetically accelerated state to a chemically depleted condition. This effect is most pronounced in mixtures incorporating high-sulfide aggregates (CA2), which exhibited rapid early expansion followed by a clear reduction or plateau in expansion rate despite the continued presence of unreacted sulfide. This behavior indicates that expansion kinetics became governed by oxidant availability rather than intrinsic material reactivity. As a result, prolonged static NaOCl exposure leads to an underestimation of deterioration severity in systems with high oxidation demand. Accordingly, the observed trends in Cycle #2 primarily reflect oxidant depletion and pH reduction rather than material-controlled reactivity.

In contrast, Cycle #3 enhanced oxidant ingress and sustained early-stage expansion without inducing the chemical exhaustion observed in Cycle #2. By limiting immersion duration while improving transport, this protocol preserved solution alkalinity and oxidizing efficiency. However, Cycle #3 is best interpreted as a short-term intensification method rather than a stand-alone long-term exposure condition. Overall, these results demonstrate that chemical acceleration must be balanced against solution stability. Short-duration NaOCl exposure (Cycle #1) provides a reliable baseline for comparative evaluation, while vacuum-assisted exposure (Cycle #3) enhances sensitivity without compromising chemical control. In contrast, prolonged static submersion (Cycle #2) alters solution chemistry and obscures intrinsic material behavior, limiting its suitability for reliable reactivity assessment.

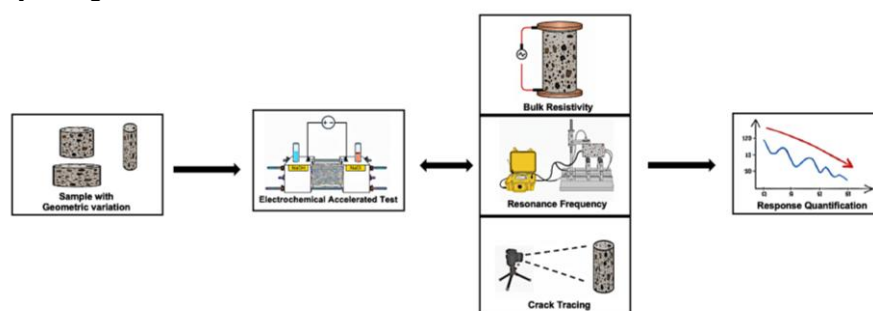
Figure 1: Experimental workflow for accelerated deterioration testing.

Accelerated deterioration was induced using a longitudinal electrochemical configuration in which specimens were polarized end-to-end at a constant 60 V DC. Sodium chloride (1.7 M) and sodium hydroxide (0.3 M) solutions were used at the cathode and anode, respectively, and replaced weekly. Bulk electrical resistivity was measured periodically using a direct-contact configuration following ASTM C1876 [9]. Dynamic elastic modulus was determined using the resonance frequency test method in accordance with ASTM C215 [10]. Surface cracking was documented photographically at predefined intervals, with images taken at fixed 45° increments around the cylindrical surface and at both end faces. The photographs were used to qualitatively track crack initiation and surface damage during electrochemical exposure. The overall experimental workflow, including specimen geometry variation, electrochemical acceleration, and multi-modal deterioration measurements, is summarized schematically in Figure 1.

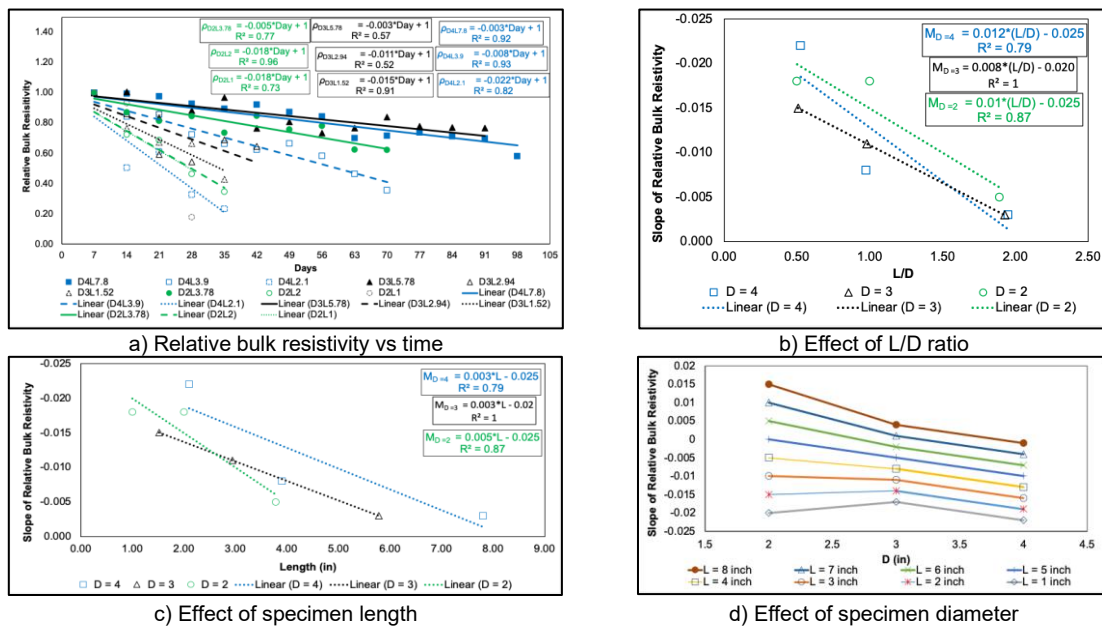
Figure 2: Influence of sample geometry on bulk electrical resistivity evolution of CA1 concrete

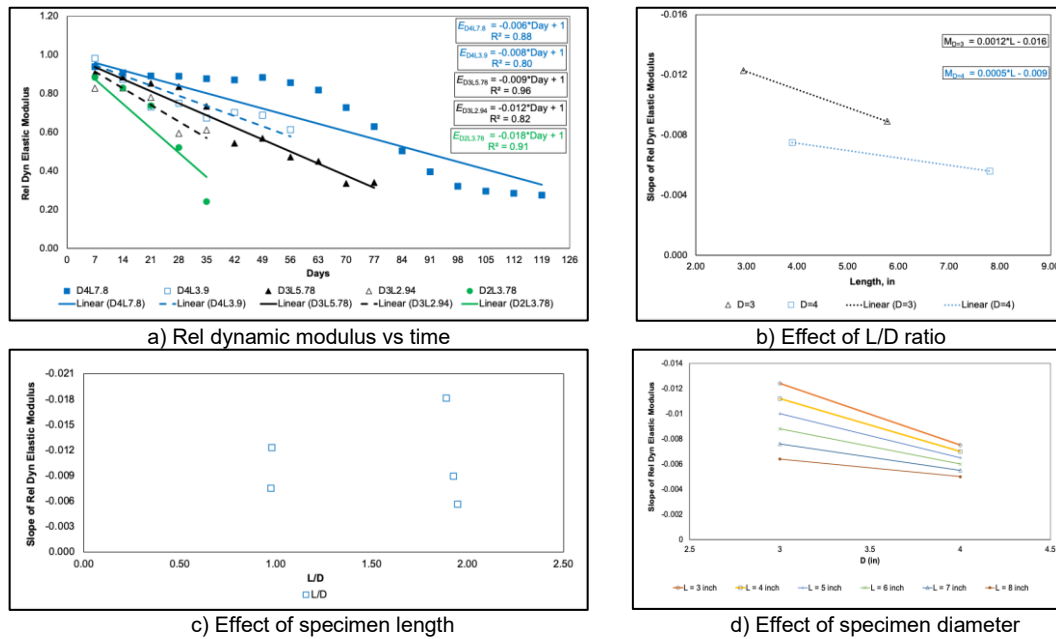
Figure 3: Effect of specimen geometry on dynamic elastic modulus degradation of CA1 concrete

Figure 3 presents the time-dependent evolution of the relative dynamic elastic modulus of CA1 concrete cylinders subjected to electrochemical exposure. Due to resonance testing constraints, measurements were obtained for five geometries: 102 mm (4") diameter specimens with  $L/D = 1.95$  and  $0.98$ , 76 mm (3") diameter specimens with  $L/D = 1.93$  and  $0.98$ , and 51 mm (2") diameter specimens with  $L/D = 1.89$ .

For all tested geometries, the relative dynamic elastic modulus decreases with exposure time (Figure 3a), indicating progressive stiffness loss associated with iron sulfide oxidation.

As shown in Figure 3(b), the relationship between modulus degradation rate and L/D ratio exhibits greater scatter than that observed for bulk electrical resistivity, indicating that L/D alone does not uniquely govern stiffness loss. In contrast, replotting the data as a function of absolute specimen length (Figure 3c) reveals a more consistent dependence, with shorter specimens exhibiting systematically faster modulus degradation across all diameters. The influence of specimen diameter is secondary, with only modest reductions in degradation rate for larger diameters at a given length (Figure 3d). The reduction in dynamic elastic modulus reflects the cumulative mechanical effects of iron sulfide oxidation, as expansive reaction products induce microcracking at the aggregate-paste interface and progressive crack interaction over a shorter axial distance more rapidly disrupts the load-bearing skeleton. Unlike bulk electrical resistivity, which is sensitive to transport-driven damage, dynamic modulus captures the mechanically significant cracking. Consequently, shorter specimens reach this critical damage state more rapidly, whereas longer specimens delay stiffness degradation by distributing damage over a greater length.

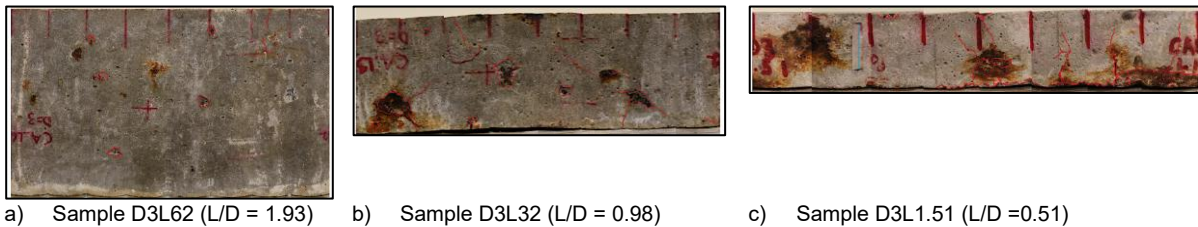
Figure 4: Surface cracking of 76 mm diameter specimens with varying L/D after 3 weeks of electrochemical exposure.

Figure 4 presents representative surface cracking after three weeks of electrochemical exposure for 76 mm (3") diameter concrete cylinders with varying L/D ratios, demonstrating a clear geometry dependence. The shortest specimen (L/D = 0.51) exhibits severe, early surface cracking with dense, interconnected crack networks (Figure 4c), whereas the intermediate specimen (L/D = 0.98) shows moderate cracking (Figure 4b). In contrast, the longest specimen (L/D = 1.93) displays only sparse, isolated surface cracks at the same exposure time (Figure 4a). These observations are consistent with the geometry-dependent trends observed in bulk electrical resistivity and dynamic elastic modulus. Shorter specimens accumulate damage more rapidly, promoting early crack initiation and formation of interconnected crack networks, while longer specimens delay crack development by distributing

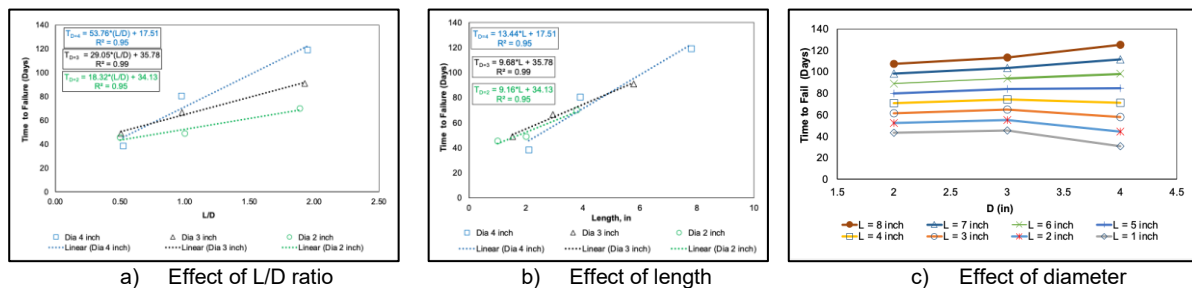
Figure 5: Effect of specimen geometry on time to failure of CA1 concrete

The combined results in Table 3 and Figure 5 summarize the influence of specimen geometry on deterioration progression and time to failure of CA1 concrete under electrochemical exposure. Time to failure (T<sub>F</sub>) is defined as the exposure duration at which electrochemical testing was discontinued due to severe specimen damage accompanied by negligible further change in resonance frequency. Table 3 integrates specimen geometry with key deterioration milestones, including oxidation onset (T<sub>0</sub>), time to first cracking (T<sub>C</sub>), crack severity, and ultimate time to failure (T<sub>F</sub>), while Figure 5 isolates the effects of L/D ratio, specimen length, and diameter on failure kinetics. As shown in Table 3, oxidation onset (T<sub>0</sub>), identified by visible surface discoloration, was first observed at approximately 7 days (initial inspection interval), indicating that oxidation initiation is governed primarily by material chemistry and exposure conditions rather than geometry. Visual crack initiation likewise occurred at approximately 7 days for most specimens, with the exception of the longest specimen (102 mm diameter, L/D = 1.95), for which cracking was delayed to 14 days. In contrast to initiation, oxidation severity at T<sub>0</sub> and subsequent crack severity exhibited a strong geometry dependence, increasing systematically as specimen length and L/D ratio decreased. These severity trends are reflected in the time-to-failure results. As summarized in Table 3 and Figure 5a, T<sub>F</sub> decreases markedly with decreasing L/D ratio for all diameters. For 102 mm (4") diameter specimens, T<sub>F</sub> decreases from 119 days at L/D = 1.95 to 38.5 days at L/D = 0.52, representing an approximately three times reduction, with similar reductions observed for 76 mm (3") and 51 mm (2") specimens. When expressed as a function of absolute specimen length (Figure 5b), T<sub>F</sub> increases consistently with increasing length, indicating that longer specimens require more time for oxidation-induced damage to accumulate and develop into through-cracking. In contrast, specimen diameter exerts only a minor influence on T<sub>F</sub> for a given length (Figure 5c). Collectively, these results demonstrate that specimen length and L/D ratio dominate deterioration progression and failure kinetics, while oxidation initiation remains largely geometry independent.

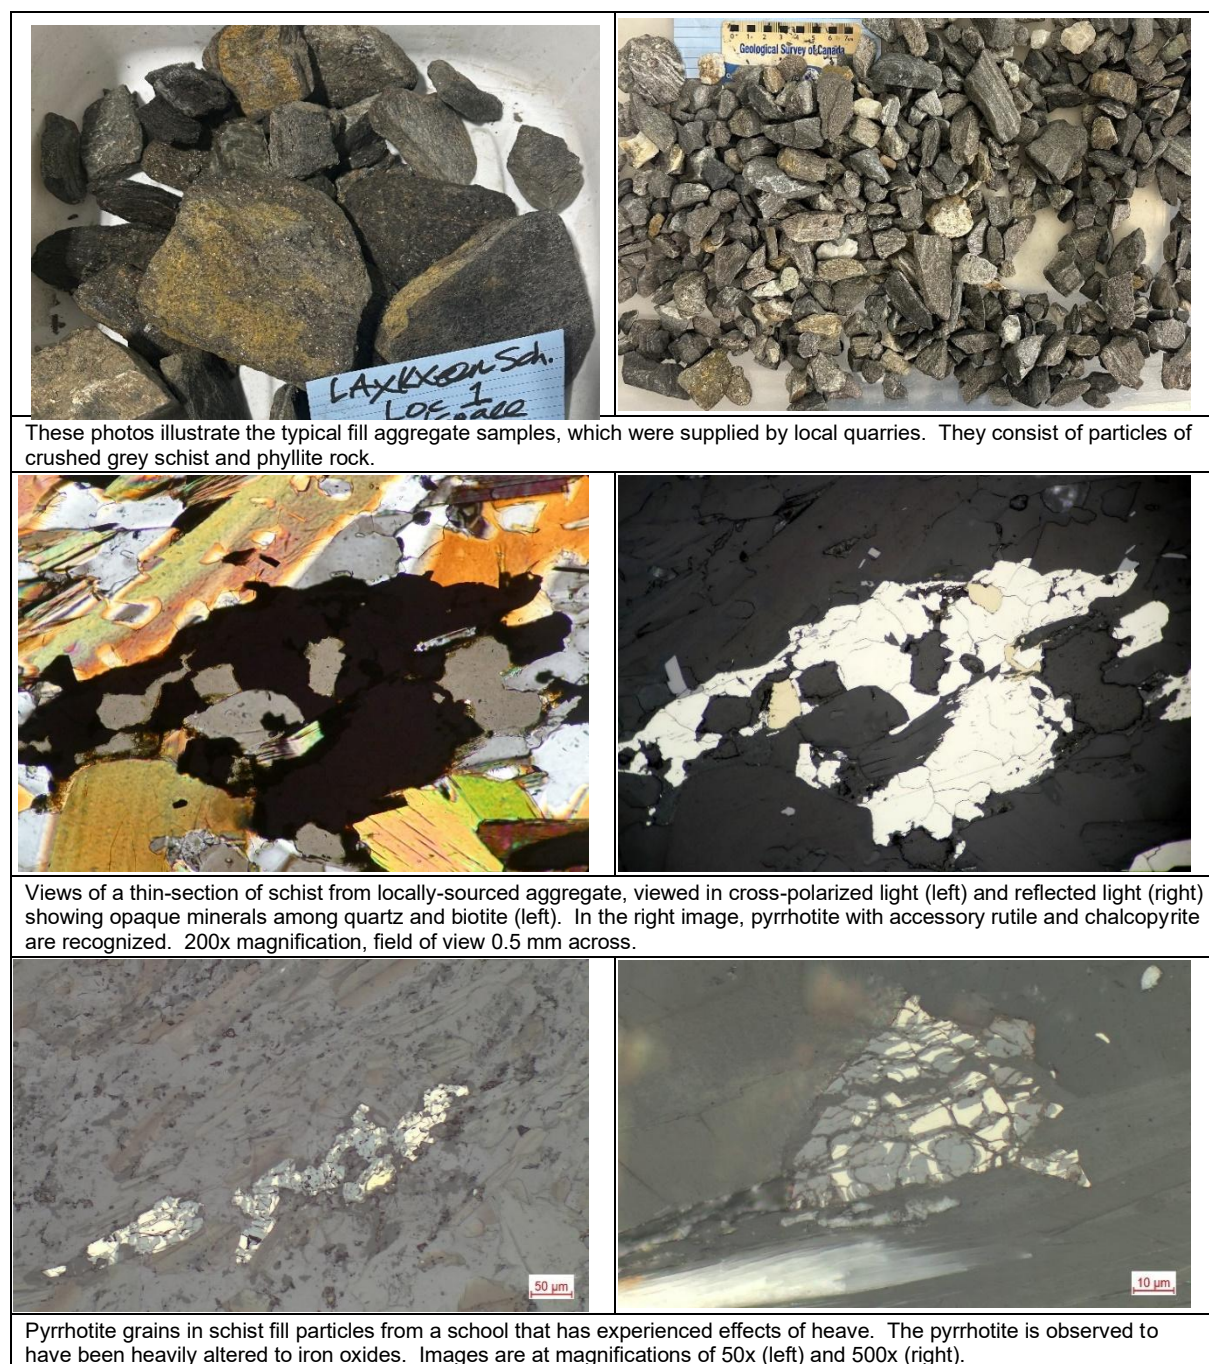
Petrographic examination determined that the rock from the quarries and from the samples of fill share general characteristics. They range from phyllites to schists and gneisses, are of variable texture, and broadly similar mineral composition. Virtually all of the rocks include iron sulphides and oxides, including pyrite, ilmenite and pyrrhotite. Varieties of garnet were identified in small amounts.

Figure 2.1: Sample images from petrographic examinations
