# 2ND INTERNATIONAL CONFERENCE ON IRON-SULFIDE REACTIONS IN CONCRETE

## Proceedings

The 2nd International Conference on Iron-Sulfide Reactions in Concrete — ICISR 2026 — was hosted by the University of Connecticut in Mystic, Connecticut, USA, from May 12 to 14, 2026. Building on the foundation established by the first ICISR, held at Université Laval in Quebec City, Canada, in 2024, ICISR 2026 continued this international exchange by bringing together researchers, practitioners, public agencies, industry partners, homeowners, and policy stakeholders.

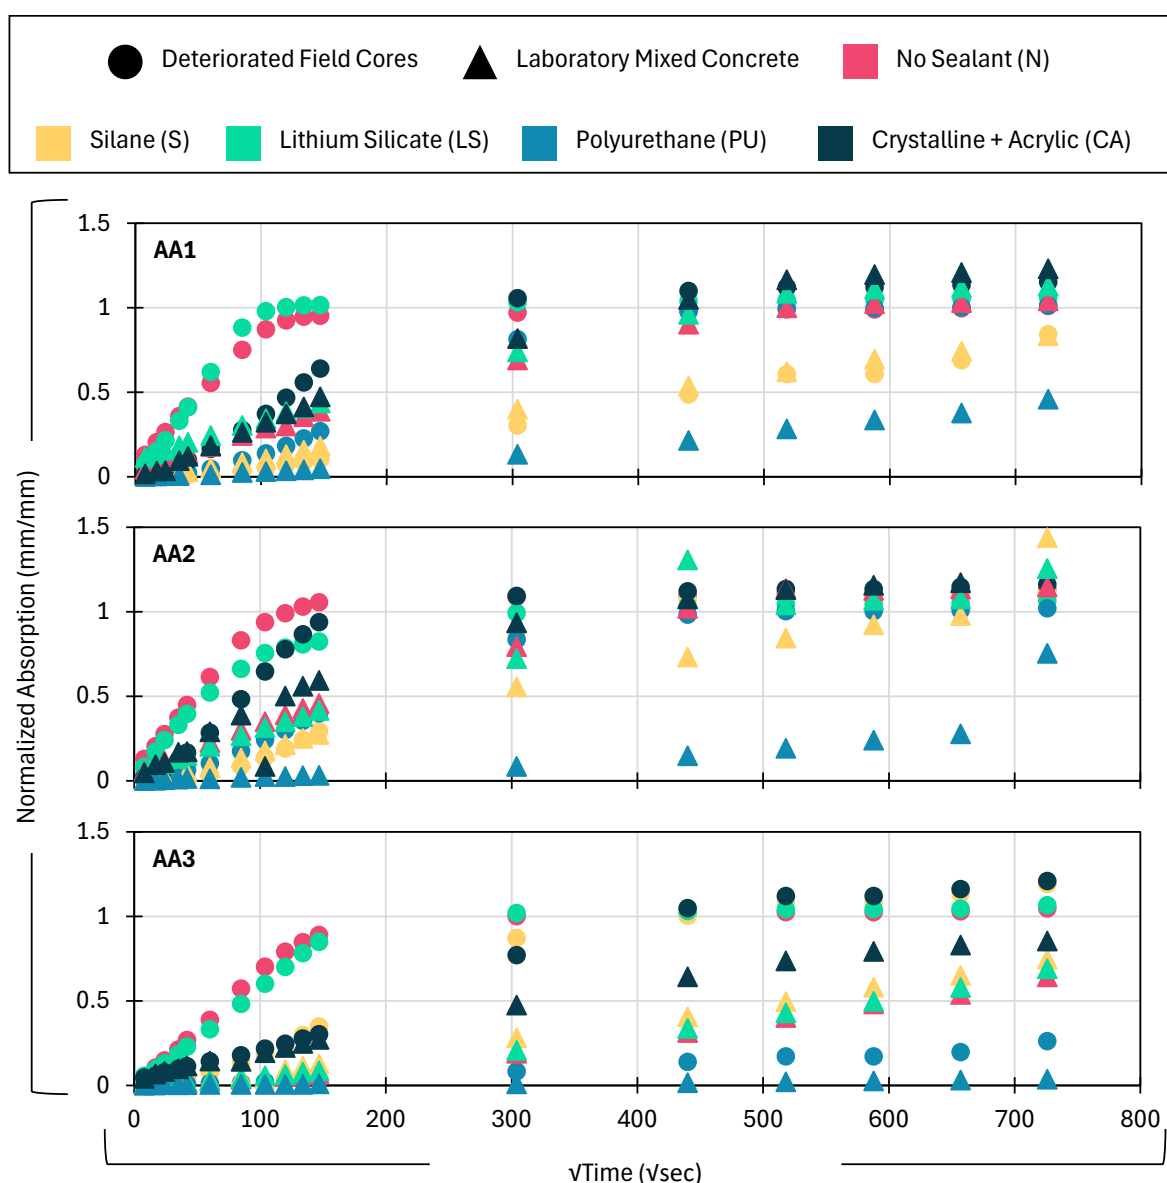
Figure 3.1. Initial and secondary absorption for different sealants. The uncertainty (relative standard deviation) for absorption value series was 5% for the field cores and was 3% for the lab cores.

When evaluating the trends, it was clear that deteriorated field concrete absorbed water at a faster rate than identically cured laboratory mixed concrete, even with the different absorption capacity. This was expected as the deteriorated field concrete had a greater internal cracking network compared to laboratory mixed concrete. The standard deviation of the normalized initial absorption values for field cores was, on average, 0.131 mm/mm greater than laboratory concrete indicating that field cores were much more variable. When evaluating secondary absorption values, the findings were not as informative. Since most field cores were fully saturated by the end of the initial absorption period, the secondary absorption values were nearly constant, leading to a higher standard deviation for laboratory cast specimens. It should be noted that the purpose of this study is to determine if or when sealants can be applied to a foundation to be useful to slow pyrrhotite related deterioration.

Generally, silane (S) and polyurethane (PU) had the lowest normalized absorptions for both field and laboratory concrete and trended this way for all accelerated laboratory aging protocols evaluated. This could be a result of the aging protocol not being aggressive enough to age the concrete. However, the aging protocols in this study were intended to age the sealants to evaluate efficacy over time. ASTM C1585 appears to be capable of distinguishing between sealant performance and should be further evaluated as a potential test for a performance-based specification for sealants.

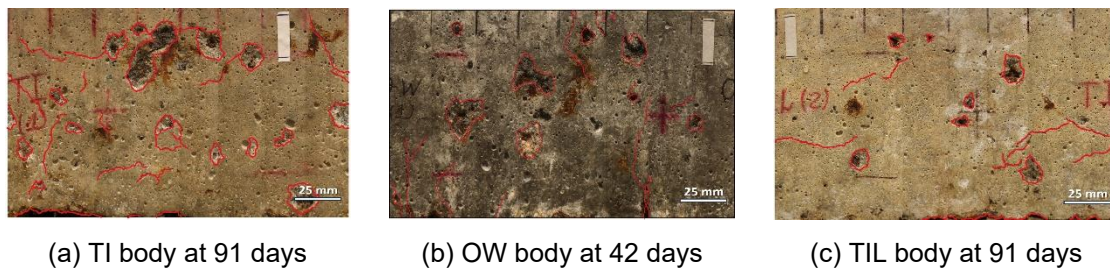
Figure 3.1 shows specimens cast with reactive aggregates using Oil Well Class G, Type I, and Type IL cements at the end of testing. Specimens cast with the limestone cement exhibited less visible cracking and fewer popouts, while Type I and Oil Well Class G specimens showed comparable damage. Testing of the Oil Well Class G specimens was stopped after 42 days due to increase in temperature during electrochemical exposure, which occurred after extensive surface cracking. Heating was observed during handling of the specimens, and testing was stopped as a precaution to prevent uncontrolled degradation. Specimens cast with nonreactive aggregates showed no visible cracking or oxidation after 91 days.

Figure 3.1: Crack mapping at the end of EAT (Group 1)

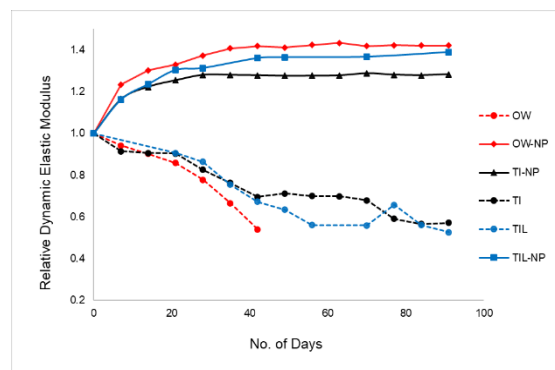
Figure 3.2 presents the evolution of  $E_{dyn,c}$  during testing. Specimens cast with nonreactive aggregates showed an initial increase in  $E_{dyn,c}$ , followed by stabilization after approximately 40 days. In contrast, specimens with reactive aggregates exhibited an immediate decrease in  $E_{dyn,c}$ . Despite reduced surface damage, specimens cast with Type IL cement still experienced progressive loss of  $E_{dyn,c}$ , indicating that changes in cement chemistry alone did not prevent deterioration.

Figure 3.2: Relative  $E_{dyn,c}$  over number of days (Group 1)

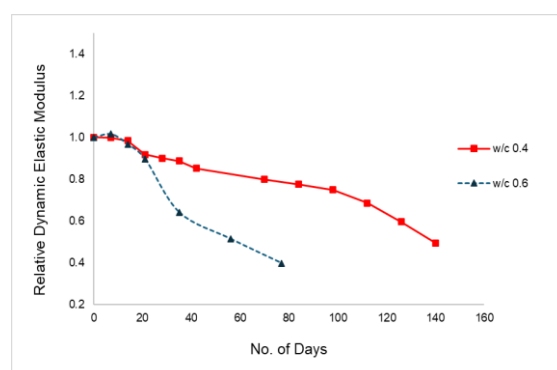
The effect of the water-to-cement ratio was examined using concrete mixtures with  $w/c = 0.6$  and  $w/c = 0.4$ . Specimens with  $w/c = 0.6$  developed visible cracks within the first week of electrochemical exposure. In contrast, cracking in specimens with  $w/c = 0.4$  was first observed after approximately 14 days. Both mixtures showed surface discoloration associated with iron oxidation. Figure 3.3 shows the measurements of  $E_{dyn,c}$ . The  $w/c = 0.6$  specimens experienced rapid stiffness loss, reaching approximately 65 percent of the initial value by day 35 and about 40 percent by day 77. The  $w/c = 0.4$  specimens retained nearly their initial stiffness at day 35 and remained above 75 percent through day 100. Stiffness decreased 50 percent at the end of testing, at 140 days, indicating delayed deterioration compared to  $w/c = 0.6$  specimen.

Figure 3.3: Relative  $E_{dyn,c}$  over number of days (Group 2)

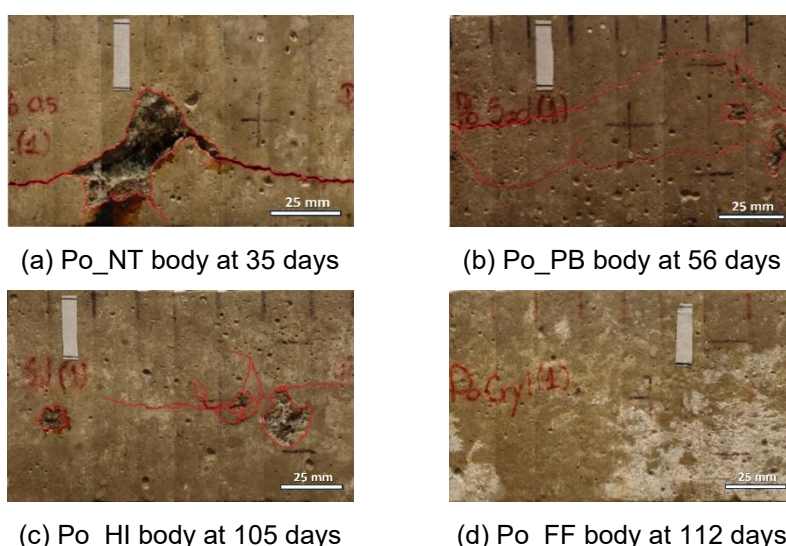
Surface treatment performance was evaluated by comparing three treated specimens with an untreated specimen containing pyrrhotite after exposure to the Electrochemical Accelerated Testing (EAT). Figure 3.4 shows the condition of the specimens at the end of testing. The untreated specimen (Po\_NT) developed continuous cracking and popouts, leading to failure at 35 days despite the reduced test voltage. The pore blocking treatment (Po\_PB) also showed continuous cracking and popouts, with failure at 56 days. The hydrophobic impregnation (Po\_HI) delayed damage, with localized cracking observed after 105 days. In contrast, the acrylic film forming coating (Po\_FF) showed no visible oxidation, cracking, or popouts after 112 days.

Figure 3.4: Crack mapping at the end of EAT (Group 3)

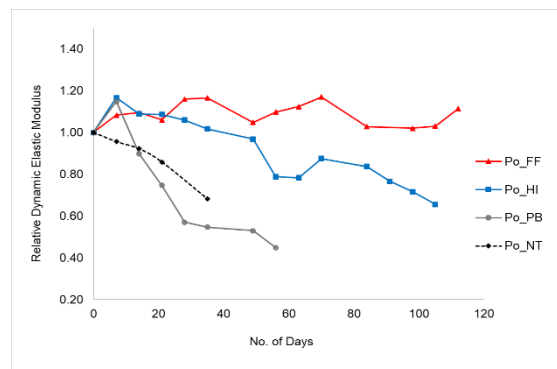
Figure 3.5 shows the relative  $E_{dyn,c}$  of all specimens during the testing period. At 35 days, specimens that developed cracking showed reductions of 32 percent (Po\_NT) and 45 percent (Po\_PB), while Po\_HI showed an increase of 2 percent. Po\_NT specimen failed at 35 days, and Po\_PB reached a 55 percent reduction by the end of testing. Po\_HI progressively decreased to a 45 percent reduction by the end of testing. In contrast, Po\_FF, which showed no visible damage, exhibited an increase of 11 percent at the end of testing.

Figure 3.5: Relative  $E_{dyn,c}$  over number of days (Group 3)
